**REDESIGNED AIR BAG SPECIAL STUDY (RABSS)  
SCI TECHNICAL SUMMARY REPORT**

**NASS RABSS CASE NO. 1998-11-809E**

**RABSS VEHICLE - 1998 DODGE STRATUS**

**CRASH DATE - SEPTEMBER, 1998**

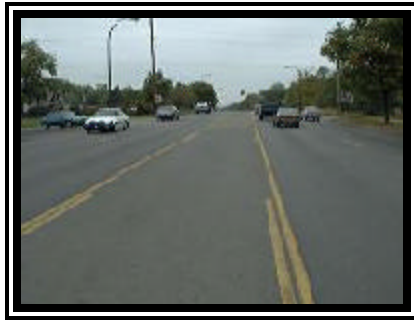
The 25 year old male driver of the 1998 Dodge Stratus was operating the vehicle westbound on the inboard lane of the five lane urban roadway at a (driver reported) speed of 56 km/h (35 mph) when he maneuvered the vehicle into the center turn lane (**Figure 1**) and observed the northbound Mercury exit a private drive to proceed west. Upon recognition of the impending harmful event, the Dodge driver braked in avoidance remaining in the center turn lane prior to the collision. The 29 year old female driver of the 1998 Mercury

**Figure 1. Westbound approach for the 1998 Dodge Stratus.**

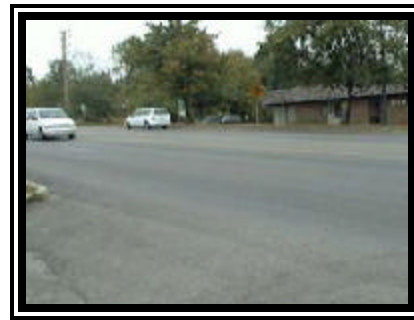
Tracer exited the private driveway (**Figure 2**) in a northerly direction and proceeded to turn left (west) onto the multi-lane roadway when she entered the center turn lane (across the path of the westbound Dodge) and came to a complete stop. The front right seating position of the Mercury was occupied by a 35 year old female.

**Figure 2. Northwest approach for the 1998 Mercury Tracer LS.**

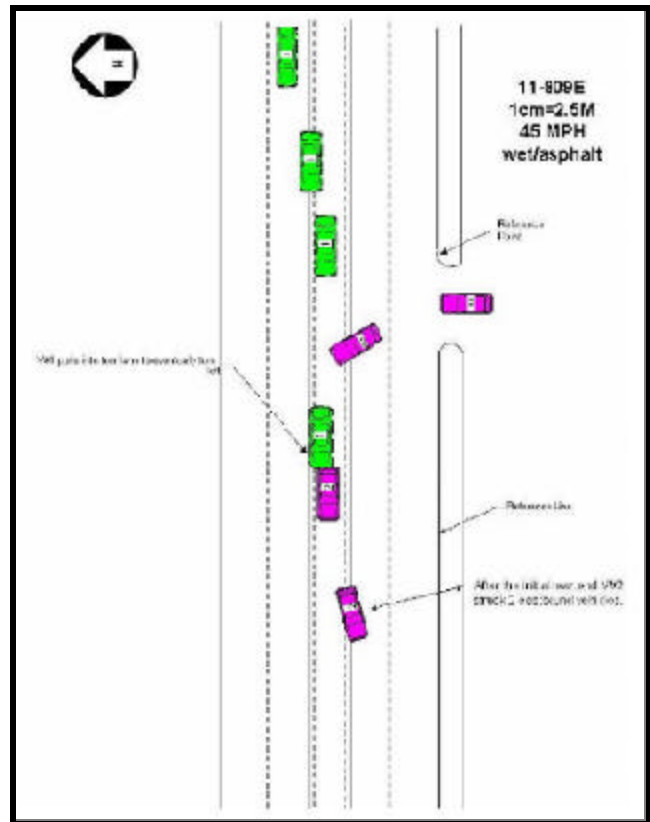
**Figure 9. NASS Scene Diagram.**

This two vehicle crash occurred during the early evening hours of September, 1998. At the time of the crash, it was daylight with intermittent rain as the roads were wet. The crash occurred in the center turn lane of a straight (asphalt) five lane east/west urban roadway (**see Figure 9 - page 5**) with a positive grade for westbound traffic. The roadway was bordered by barrier curbs and private driveways. No traffic control was present at the scene which had a posted speed limit of 72 km/h (45 mph).
