**REDESIGNED AIR BAG SPECIAL STUDY (RABSS)
SCI TECHNICAL SUMMARY REPORT**

NASS CDS CASE NO. 1998-12-150E

RABSS VEHICLE - 1998 BUICK LESABRE LIMITED

CRASH DATE - AUGUST, 1998

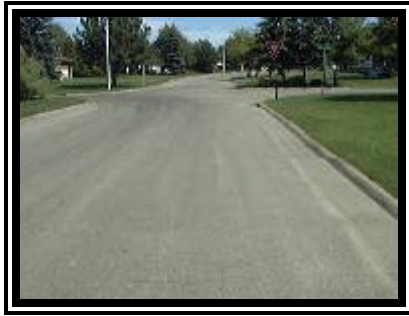
The 74 year old female driver of the 1998 Buick LeSabre was operating the vehicle eastbound (**Figure 1**) when she failed to observe the yield sign or southbound Dodge as she proceeded straight through the 4-leg intersection. She reported to police that she thought she had the right-of-way and didn't notice the stop sign. The Buick driver reported no avoidance maneuvers in anticipation of the impending crash. The 30 year old female driver of the 1997 Dodge van was operating the vehicle southbound (**Figure 2**) on approach to the 4-leg intersection at a (driver reported) speed of 40 km/h (25 mph) when she observed the Buick cross her path of travel. The Dodge driver also reported no avoidance maneuvers in anticipation of the impending crash. The front right seating position of the Dodge was occupied by a 5 year old female.

Figure 1. Eastbound approach for the 1998 Buick LeSabre.

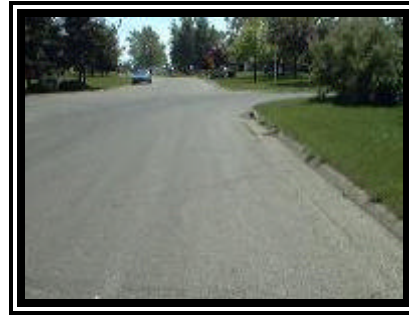
Figure 2. Southbound approach for the 1997 Dodge B250 van.

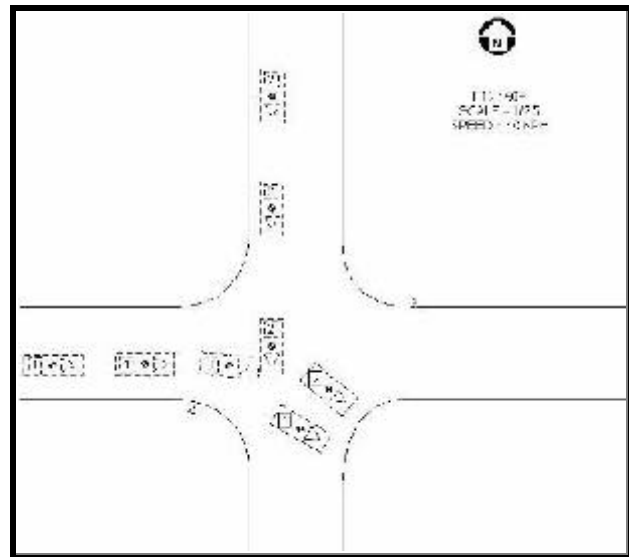
This two vehicle crash occurred during the afternoon hours of August, 1998. At the time of the crash, it was daylight with no adverse conditions as the roads were dry. The crash occurred in a straight and level 4-leg asphalt intersection (see **Figure 7 - page 4**). Traffic flow through the intersection was controlled by yield signs for east/westbound traffic. The posted speed limit at the crash site was 64 km/h (40 mph).

Figure 7. NASS Scene Diagram.
