**REDESIGNED AIR BAG SPECIAL STUDY (RABSS)
SCI TECHNICAL SUMMARY REPORT**

NASS RABSS CASE NO. 1998-12-807G

RABSS VEHICLE - 1998 CHEVROLET S-10 PICKUP TRUCK

CRASH DATE - OCTOBER, 1998

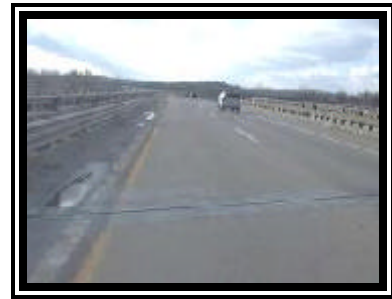
approach from behind at a high rate of speed and released the brakes in avoidance. The 33 year old male driver of the 1998 Chevrolet pickup was operating the vehicle westbound (behind the Ford) in the inboard lane (**Figure 1**) at a driver reported speed of 72 km/h (45 mph). The driver stated during the NASS interview that he was looking at eastbound traffic when he failed to notice traffic slowing ahead. Upon recognition of the impending harmful event, he steered left in avoidance (no braking reported).

Figure 1. Westbound approach for the 1998 Chevrolet S-10 pickup truck.

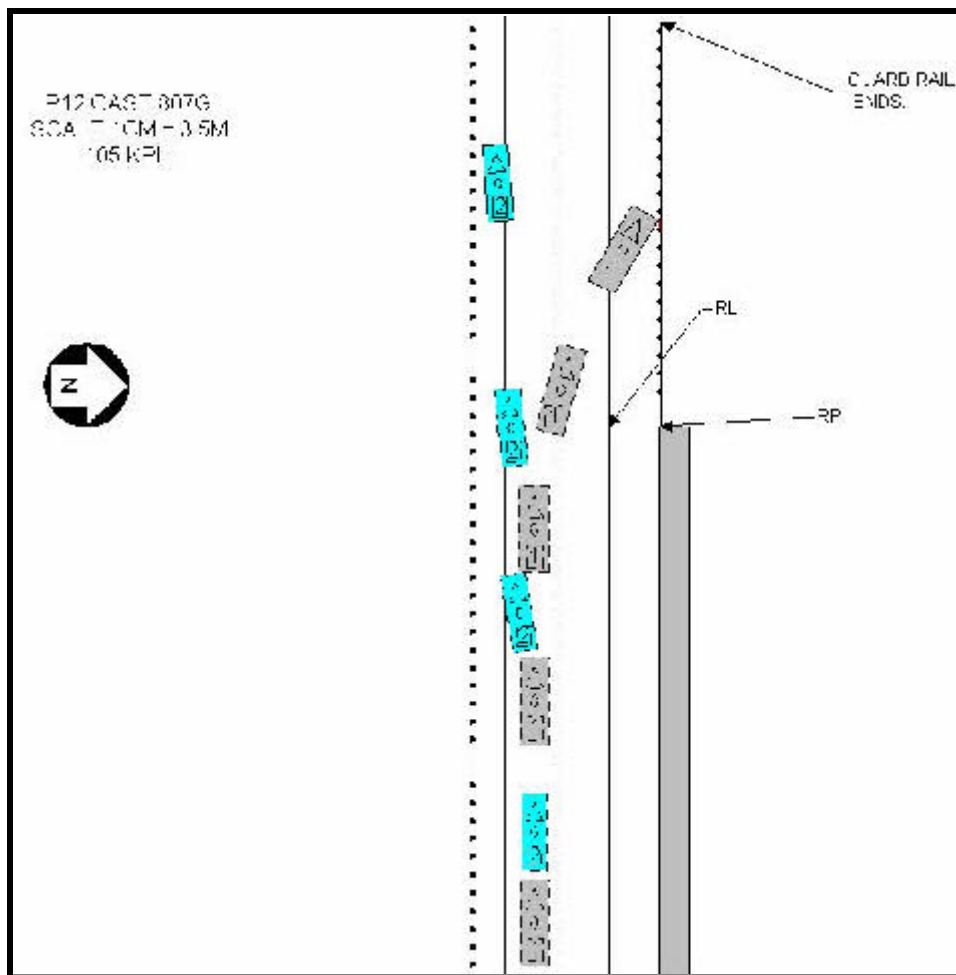
Figure 8. NASS Scene Diagram.

This two vehicle crash occurred during the afternoon hours of October, 1998. At the time of the crash, it was daylight with no adverse conditions as the roads were dry. The crash occurred in the inboard westbound lane of a four lane east/west (level) asphalt interstate highway (see **Figure 8 - page 5**) which was divided by W-beam median guardrails. The police report stated that the outboard (westbound) lane was closed due to construction improvements. A bridge was documented just west of the crash site which was bordered by raised abutments. No traffic control was present at the scene which had a posted speed limit of 105 km/h (65 mph).
