Remote, Redesigned Air Bag Special Study
Dynamic Science, Inc., Case Number (1998-48-117J)
1998 Mazda B2500 Pickup Truck
Alabama
November/1998

Summary

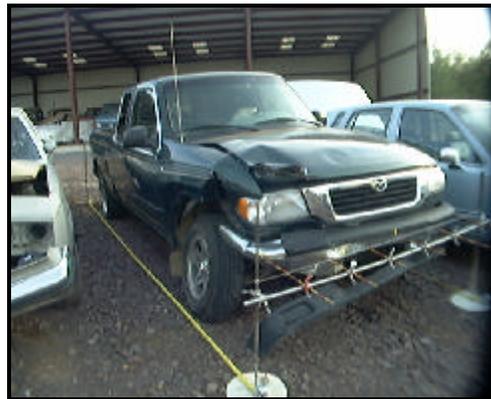
Figure 6. Exterior, Vehicle 2 (case vehicle-1998 Mazda B2500 pickup)

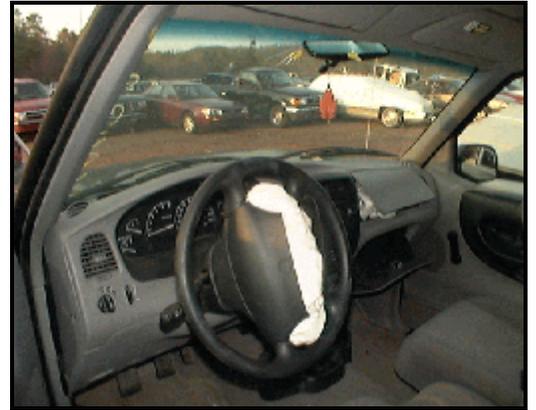
The interior of the Mazda B2500 pickup truck sustained minor damage due to occupant contacts. The occupant compartment maintained its integrity and there were no intruding components due to the frontal impact. The laminated windshield glazing was cracked due to the drivers right hand loading the rear view mirror. The mirror corner subsequently impacted and cracked the windshield due to this contact. There was a permanent scuff mark noted to the lower instrument panel/knee bolster and the floor mounted transmission selector knob was scuffed due to contact.

Figure 8. Interior of case vehicle through open drivers door

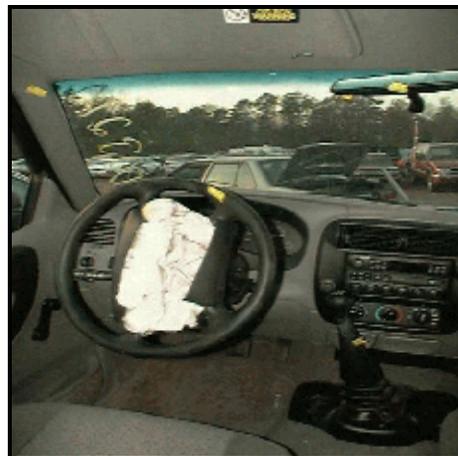
Figure 10. View showing drivers position and air bag

The front, left drivers air bag was housed in the steering wheel hub and was concealed by symmetrical double horizontal module cover flaps. The circular air bag was tethered two straps, and was equipped with two exhaust vent port holes. The lower instrument panel is equipped with a rigid plastic knee bolster. There was a scuff mark noted to the lower left knee bolster and there were blood fluid transfers noted to the lower right quadrant of the air bag.

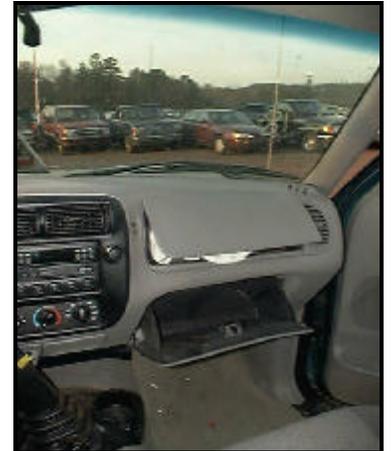
Figure 11. View showing front, right of case vehicle and passenger air bag module

The front, right air bag was located at the mid-instrument panel level. The module cover flap is hinged at the top and is rectangular in shape. The module cover, apparently did not contact the windshield during deployment. There was no residual damage to the air bag or the single module cover flap. The air bag fabric was devoid of any detectable areas of occupant contact. The adult passenger in this seated position, reportedly was uninjured.

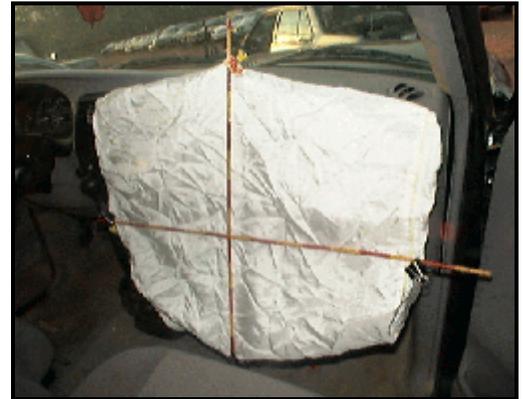
Figure 14. View showing deployed drivers air bag
