Remote, Redesigned Air Bag Special Study

Dynamic Science, Inc., Case Number (1998-49-176A)

1998 Ford Mustang GT

November/1998

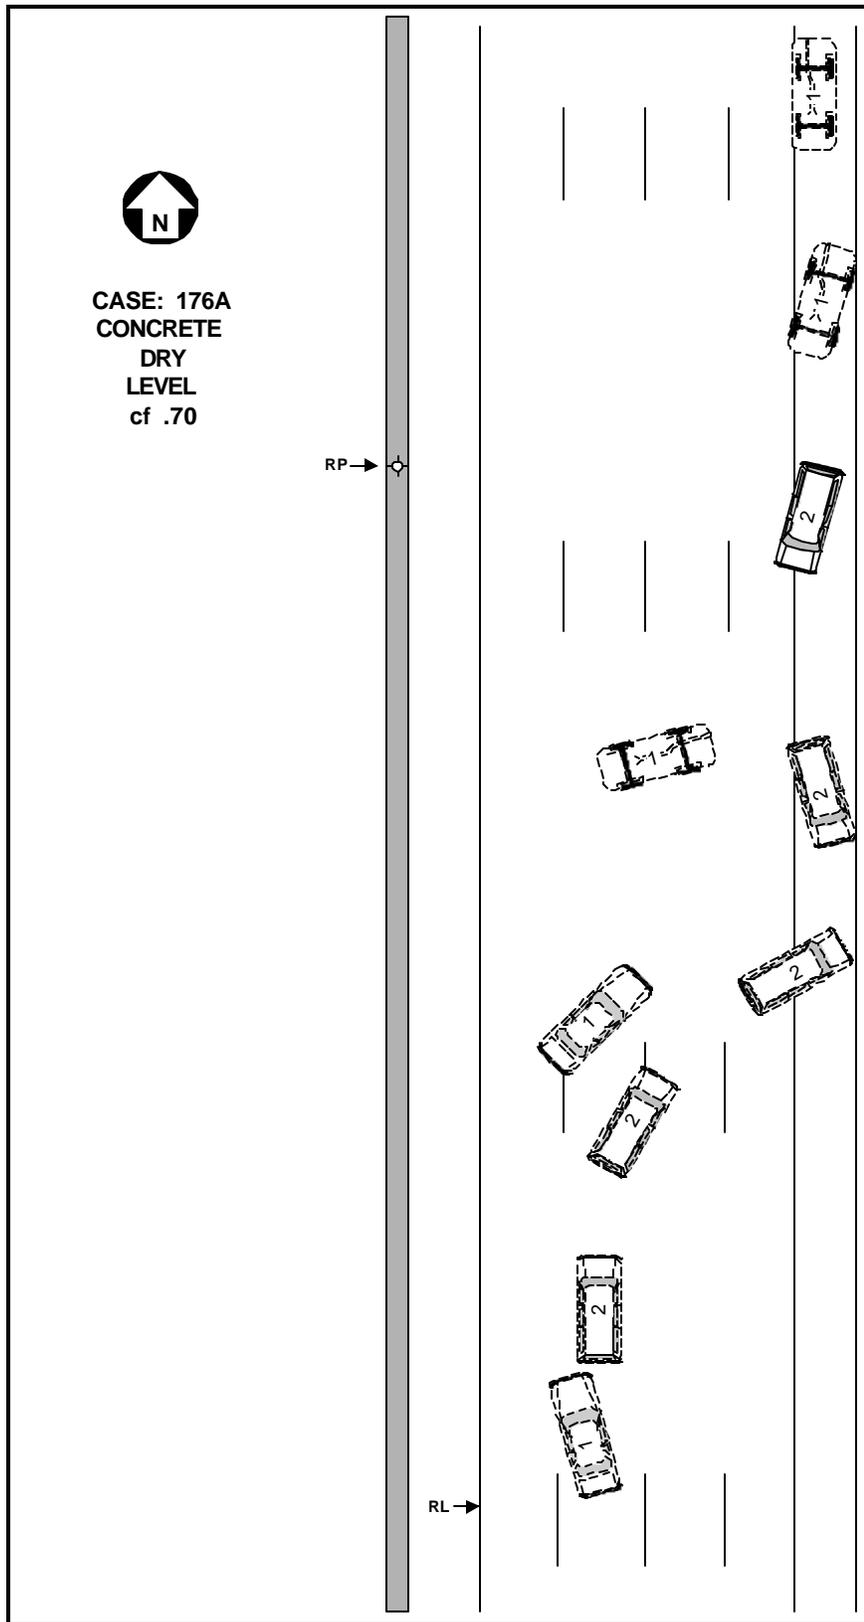
Scene Diagram

seatback supports. The case vehicle impacted its roof panel as it initiated an extended slide of approximately 182.9 m (600 ft.). The drivers head passed through the backlight opening impacting the concrete roadway surface with the right side of his head. His lower torso and legs were entangled between the seatback supports which probably prohibited a full ejection. As a result of his head vs. ground impact he sustained numerous severe head injuries which included; a scalp laceration which measured 10 cm (3.9 in.) in length (AIS-2), a right parietal /temporal and occipital skull fracture with the brain and dura exposed (AIS-4), a cerebral laceration (AIS-4), subdural hematoma (AIS-4), a subarachnoid hemorrhage (AIS-3) and multiple cerebral contusions (AIS-3). The driver was fatally injured and succumbed to his injuries at the crash location.
