Remote, Redesigned Air Bag Special Study

Dynamic Science, Inc., Case Number (1998-049-805E)

1998 Buick Regal

Summary

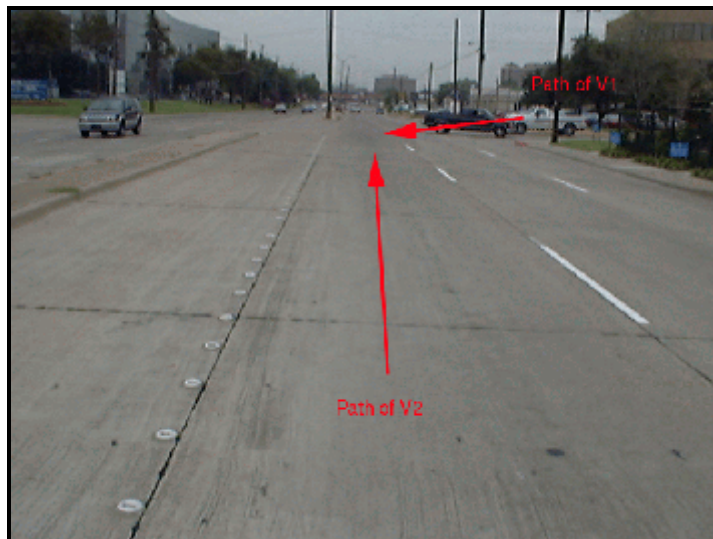
Figure 1. Paths of both vehicles to area of impact

As Vehicle 2 reached the intersection, Vehicle 1 pulled out from the stop sign to begin a left turn to go north. The right front of Vehicle 2 (12FREE9) struck the front of Vehicle 1 (11FDEW2).
