Remote, Redesigned Air Bag Special Study

Dynamic Science, Inc., Case Number (1998-073-132C)

1998 Plymouth Breeze

October/1998

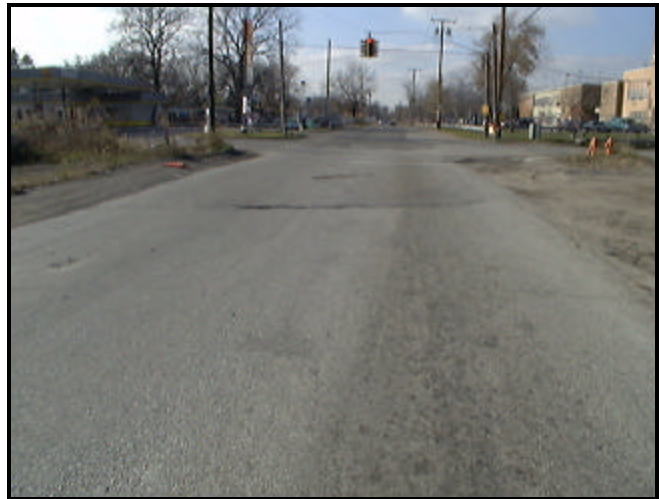
The driver of Vehicle 1 failed to see Vehicle 2 approaching and initiated the left turn in the path of the oncoming vehicle. The front plane of Vehicle 2 (12FYEW2) struck the front plane of Vehicle 1 (01FYEW1) in the intersection. Vehicle 1 came to rest in the intersection facing northeast. Vehicle 2 came to rest in the intersection facing west.

Figure 3. Crash scene. Vehicle 2 approach path.
