Remote, Redesigned Air Bag Special Study

Dynamic Science, Inc., Case Number (1998-73-804F)

1998 Dodge Dakota Pick-up Truck

October/1998

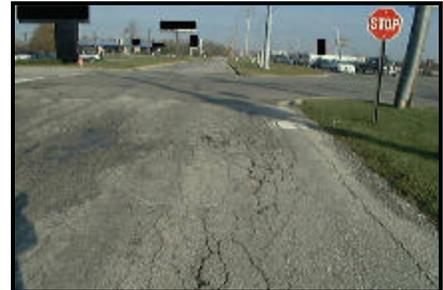
Figure 1. Pre-impact Trajectory of Vehicle 1 (point of impact /foreground)

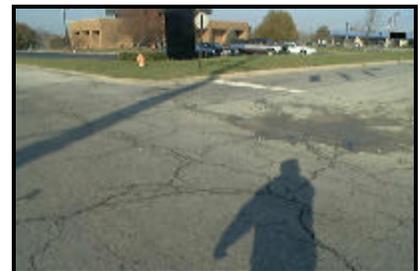
Vehicle 3, a 1998 Mercedes Benz sport utility vehicle, was driven by a 52 year-old-female who was reportedly restrained by the lap and shoulder belt. Vehicle 3 was stopped at the north leg of the intersection and was headed southbound.

Figure 2. View showing location of Vehicle 3 (stopped at intersection)
