Remote, Redesigned Air Bag Special Study

Dynamic Science, Inc., Case Number (1998-081-802G)

1998 Honda CR-V

Summary

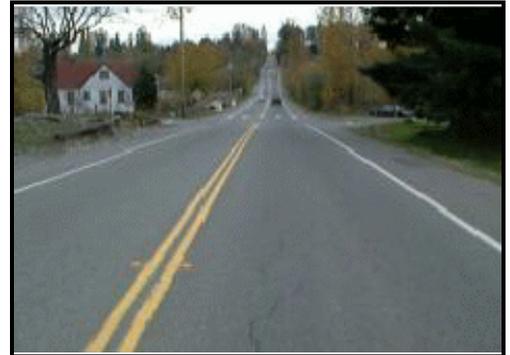
Vehicle 1, a 1998 Honda CR-V Sport Utility Vehicle, was driven by a 27 year-old-male (188 cm/ 74 in., 91 kg/201 lbs.) who was fully restrained by the available three-point manual lap and shoulder belt. The front, right seated position was occupied by a fully restrained 38 year-old-female (170 cm/67 in., 54 kg./120 lbs.). Driver 1 was traveling northbound and did not detect that the traffic in front of him had stopped.

Vehicle 2, a 1984 Ford Mustang three-door hatchback was driven by an 18 year-old-male (168 cm/ 66 in., 64 kg/ 140 lbs.) who was reportedly wearing the available three-point manual lap and shoulder belt. Driver 2 was stopped in the northbound travel lane and waiting for the vehicle that was in front of him to complete a left turn at the intersection.

Figure 1. Pre-impact trajectories of Vehicle 1 (Honda CR-V) and Vehicle 2 (Ford Mustang)
