Remote, Redesigned Air Bag Special Study  
Dynamic Science, Inc., Case Number (1998-081-804G)  
1998 Toyota Camry  
Washington  
November/1998

**Summary**

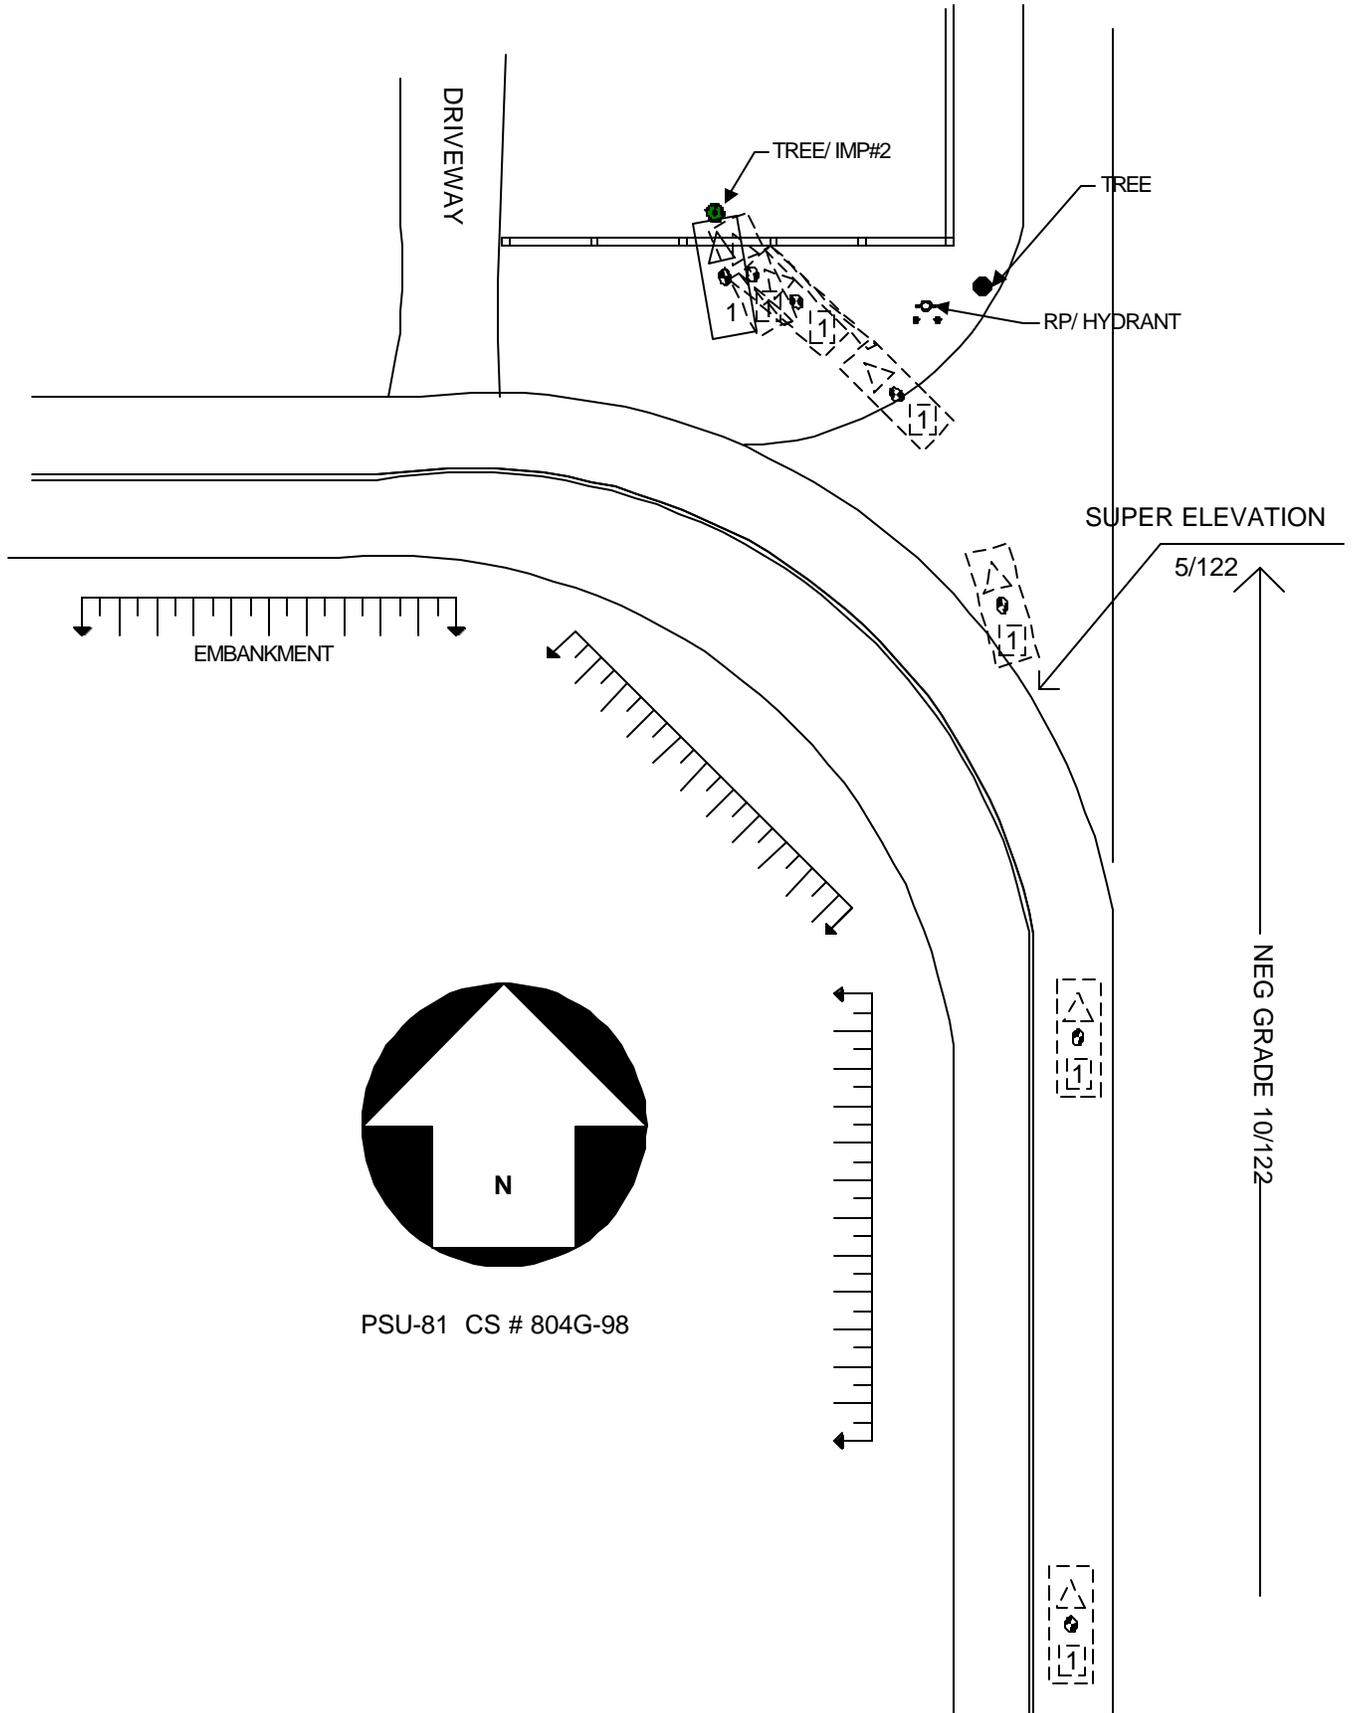
Scene Diagram

The driver of the case vehicle attempted to negotiate the curve in the roadway at an unsafe speed and the vehicle departed the right roadside where the front plane (12FDEW1) struck a concrete wall (event 1). Vehicle 1 then continued through the wall and came to rest after striking a tree (event 2) with its front plane (12FR999). Vehicle 1 came to rest up against the struck tree facing northwest.
