TRANSPORTATION RESEARCH CENTER

ON-SITE CHILD AIR BAG-RELATED FATALITY INVESTIGATION

CASE NUMBER - IN98-001
LOCATION - MISSISSIPPI
VEHICLE - 1994 PONTIAC GRAND PRIX
CRASH DATE - January, 1998

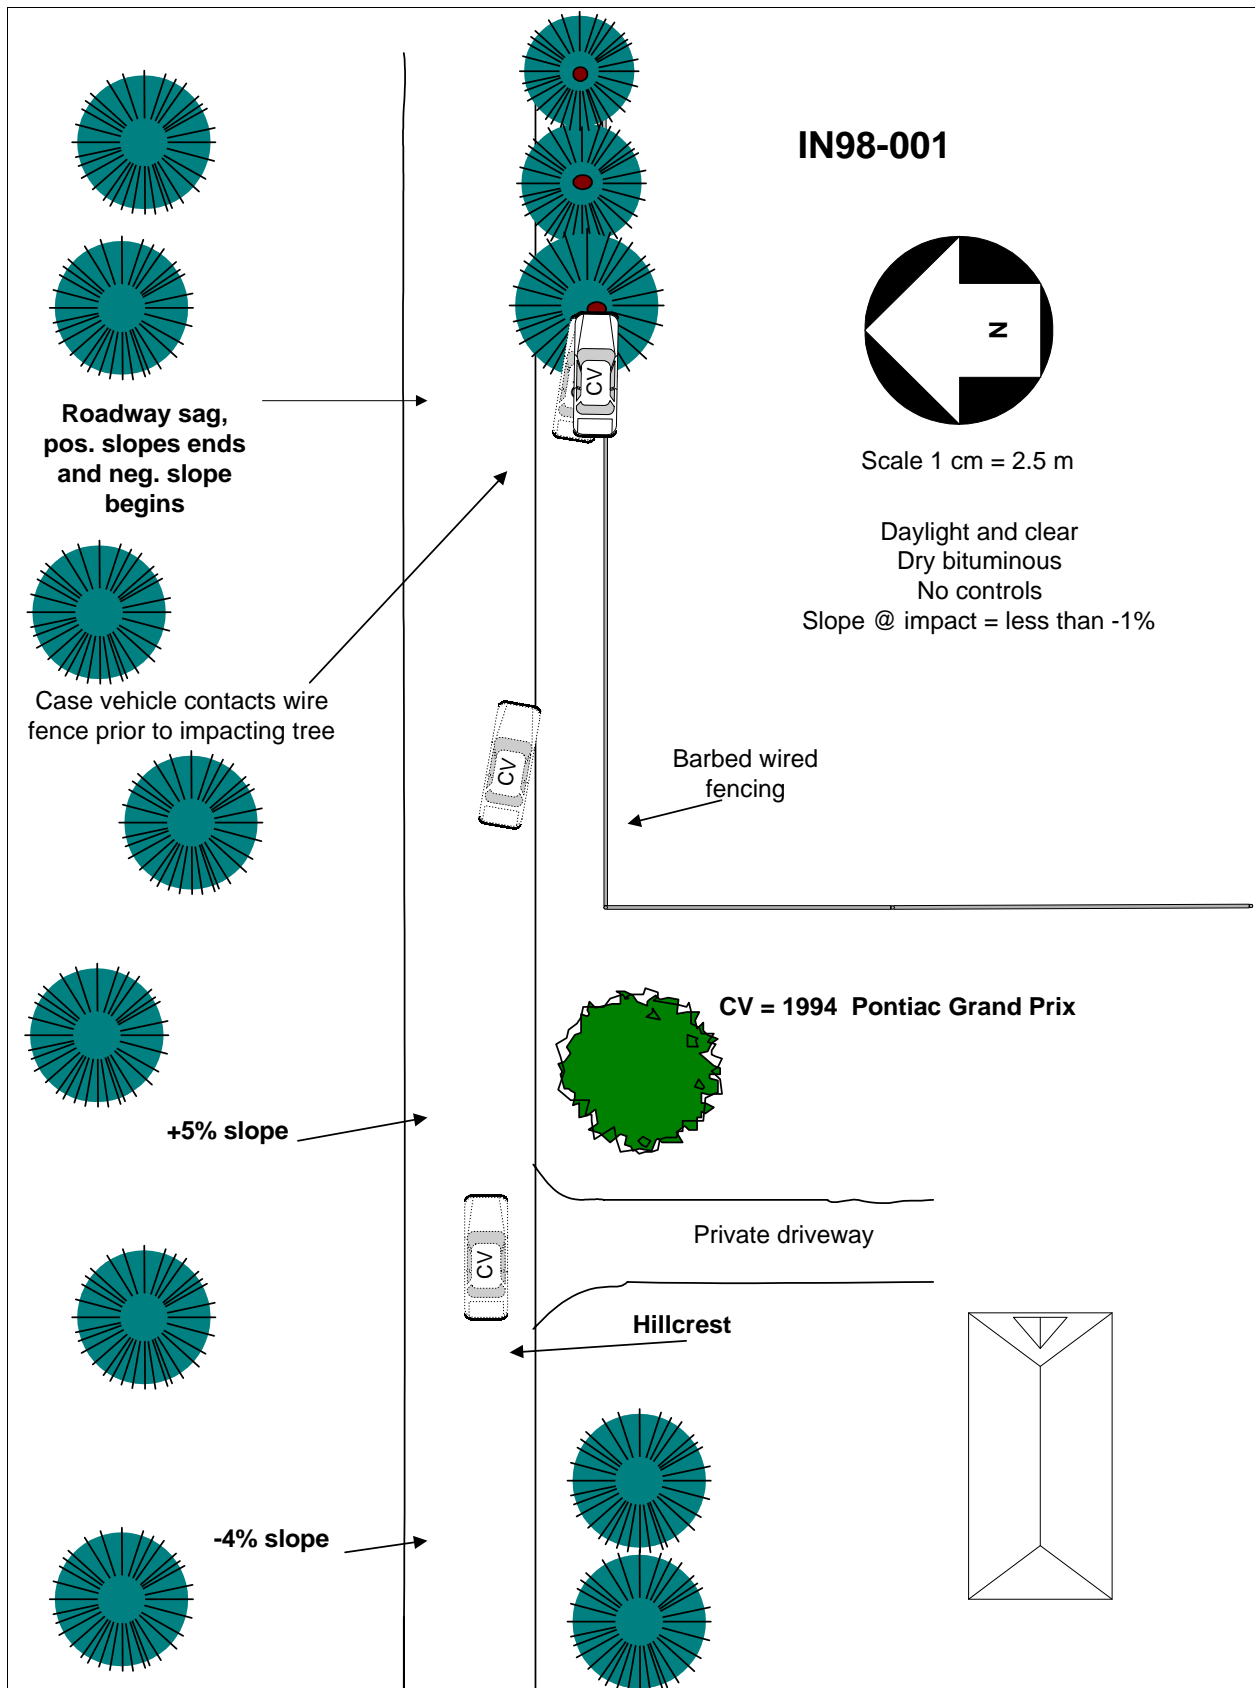
- The SIR Warning Light was OFF at the time of the deployment (i.e., no malfunctions).
- The SIR Warning Light was not ON prior to the crash (i.e., no malfunctions).
- The air bags deployed 30.0 milliseconds after the collision was first detected by the SDM.
- The maximum change in velocity (Delta V) the SDM recorded was 44.9 km.p.h. (27.9 m.p.h.). The maximum Delta V the SDM is capable of recording is 44.9 km.p.h. (27.9 m.p.h.). It reached this maximum value at 80 milliseconds after the crash was first detected.
- Normal criteria were met which triggered the SDM to command the deployment of the air bags.
- The crash occurred on ignition cycle number 14656. This is one (1) cycle prior to when the SDM was read on February 23, 1998 (14657).
- The driver's seat belt was unlatched at the time the deployment occurred.

In addition to the Deployment Crash Event, the SDM also stored a Near-Deployment Event that occurred sometime during the same ignition cycle (14656) as the crash in question. The maximum Delta V for this event was 2.1 km.p.h. (1.3 m.p.h.). The driver seat belt was also unlatched during this event.
