**CALSPAN ON-SITE ROLLOVER INVESTIGATION  
CALSPAN CASE NO. CA98-003  
VEHICLE: 1998 MERCEDES-BENZ ML 320  
LOCATION: ALABAMA  
CRASH DATE: JANUARY, 1998**

1. <i>Report No.</i> CA98-003	2. <i>Government Accession No.</i>	3. <i>Recipient's Catalog No.</i>	
4. <i>Title and Subtitle</i> Calspan On-Site Rollover Investigation Vehicle: 1998 Mercedes-Benz ML 320 Location: Alabama		5. <i>Report Date:</i> November, 1998

16. <i>Abstract</i>  This on-site investigation focused on the rollover initiation type for a 1998 Mercedes-Benz ML 320 sport utility vehicle that was involved in a on-road rollover crash in Alabama. The driver initiated a rapid left-right steering input which induced a clockwise yaw. The left front alloy wheel subsequently gouged into the raised edge of the asphalt road surface which tripped the vehicle into a lateral side-over-side rollover event. The Mercedes completed seven (7) quarter turns prior to coming to rest on its right side. The belted female driver sustained soft tissue injuries and was treated at a local hospital and released. The ML 320 was equipped with frontal and side impact air bag systems. Both the left and right door-mounted side impact air bags depl

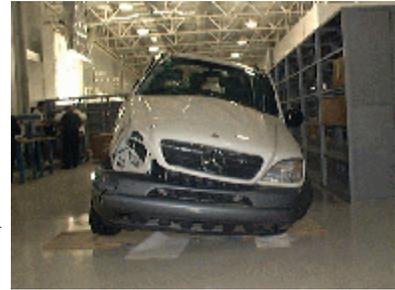
The involved vehicle was a 1998 Mercedes-Benz ML 320, 4-door sport utility vehicle (**Figure 3**). The vehicle was leased by a Mercedes employee. His wife was the primary driver of the vehicle and she was responsible for the majority of the estimated (4-5,000 miles) on the odometer. The Mercedes was manufactured in July 1997, and was identified by vehicle identification number 4JGAB54EXWA (production number deleted). The Mercedes-Benz was equipped with a full-time all wheel drive system with an electronic traction system. Power was transferred from the 3.2 liter gasoline V-6 engine by an electronically controlled 5-speed automatic transmission. Braking was obtained through four-wheel power disc brakes with anti-lock (ABS). The vehicle's suspension system was a four-wheel independent system with front and rear anti-sway bars. The Mercedes-Benz was equipped with General Grabber ST 255/65R16 mud and snow tires mounted on five spoke aluminum-alloy wheels.

**Figure 3. Frontal view of the involved Mercedes-Benz ML 320 sport utility vehicle.**
