On-scene Investigation / Vehicle to Vehicle  
Dynamic Science, Inc. / Case Number: DS98011  
1998 BMW 740i  
Texas  
March 1998

1. Report No. DS98011		2. Government Accession No.		3. Recipient Catalog No.	
4. Title and Subtitle In-Depth Accident Investigation				5. Report Date May 1998

**Dynamic Science, Inc.**  
**Accident Investigation**  
**Case Number: DS98011**

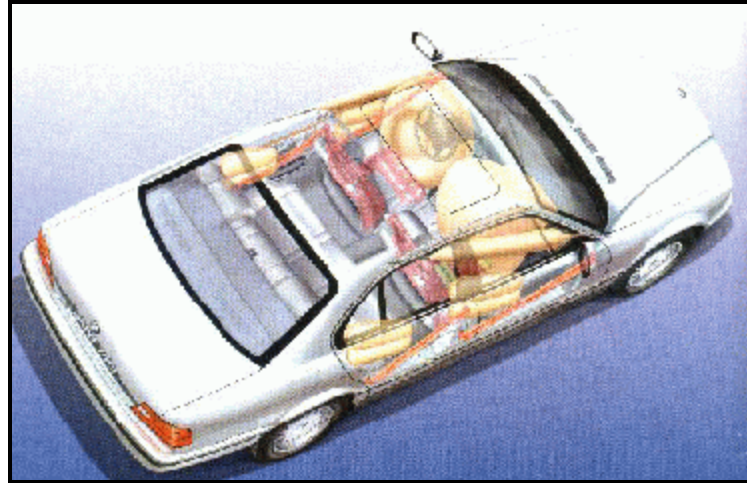
**Figure 7.** Overview of air bag locations. Note: rear torso air bags are an option.

The case vehicle was equipped with front seat automatic safety belt pretensioners and six air bags: a driver's side steering mounted air bag, a passenger side dash-mounted air bag, left and right door-mounted 17 liter (0.60 cu. ft.) torso air bags, and left and right Inflatable Tubular Structure (ITS) type air bags. The front air bags include a "smart" dual-threshold deployment system (i.e., when the belts are in use, the air bag will not deploy at a lower crash severity). The front air bags are set to deploy at a delta V in

excess of 29 km/h (18 MPH) for a belted occupant and 19 km/h (12 MPH) for an unbelted occupant. Also, if the front passenger seat is not occupied, that air bag is not normally triggered. There is a sensor which determines if a weight greater than 7 kg (15 lbs.) is present on the seat. In this case, this position was not occupied and there was no front passenger air bag deployment. The side air bags are set to deploy with a delta V in excess of 15 km/h (9 MPH)—regardless of whether or not the seat position is occupied. The ITS is entirely concealed above the front doors and within the A-pillar and roof cladding or upholstery. The ITS is a hollow, flexible, essentially airtight tube 152 cm (60 in.) long and 3.8 cm (1.5 in.) in diameter. At one end, this tube is anchored inside the vehicle's A-pillar, near the bottom of the pillar. At the other end, it is anchored in the roof just above the rear door. Upon side impact, the inflator, mounted on one end of the tube, inflates the tube with an inert gas. A relatively airtight inner tube of silicon material manages the inflation; a woven Polyamid outertube manages the tube's shape. The diameter increase forced by inflation causes the length to decrease.
