On-scene Investigation / Vehicle to Vehicle  
Dynamic Science, Inc. / Case Number: DS98027  
1998 Chevrolet Cavalier v. 1998 Chevrolet Cavalier  
Oregon  
November 1998

1. Report No. DS98027		2. Government Accession No.		3. Recipient Catalog No.	
4. Title and Subtitle In-Depth Accident Investigation				5. Report Date December 10, 1999

**Dynamic Science, Inc.**  
**Accident Investigation**  
**Case Number: DS98027**

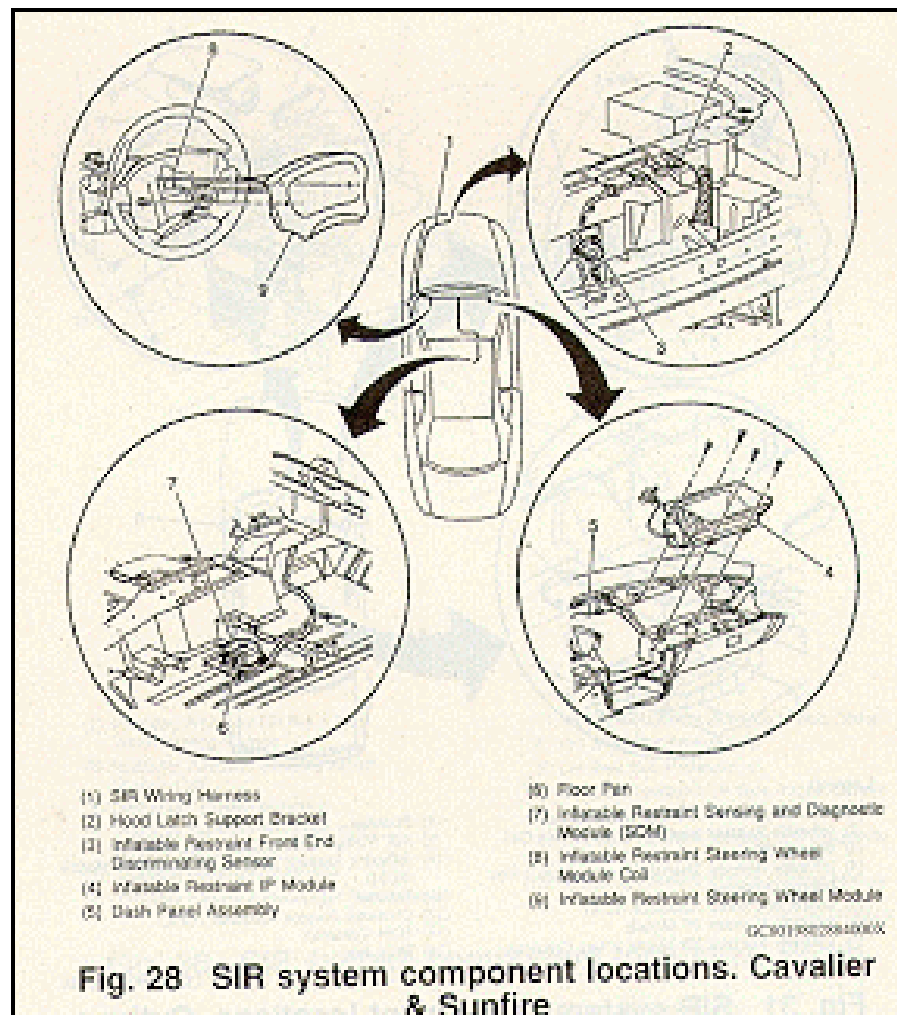
Figure 6. SIR System Component Locations, 1998 Chevrolet Cavalier

The rectangular front right air bag was mounted in the top of the instrument panel and measured 53 cm wide by 65 cm high. There were no vents or internal tether straps. The single module cover flap opened at the designed tear points and there was no damage to the cover.
