**TRANSPORTATION SCIENCES  
CRASH RESEARCH SECTION**

**CALSPAN ON-SITE AIR BAG/INFANT FATALITY INVESTIGATION  
CALSPAN CASE NO. CA98-028  
VEHICLE: 1995 SATURN SC1  
LOCATION: FLORIDA  
CRASH DATE: APRIL, 1998**

| 15. <i>Supplementary Notes</i><br>On-site investigation of an air bag deployment death that involved a 3 week old infant positioned in a rear-facing child safety seat in a 1995 Saturn SC1. | | | |

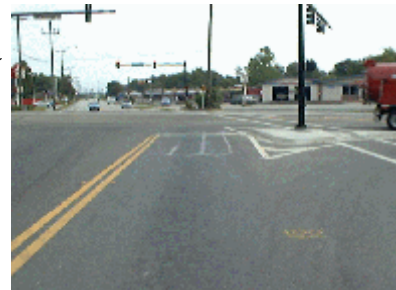
**Figure 3. Pre-crash trajectory of the Saturn SC1.**

The driver of the Saturn departed her residence and was traveling in a northerly direction on the local road. She stated that she was traveling at a speed of approximately 48 km/h (30 mph) as she traversed an at-grade railroad crossing on an approach to the four-leg intersection. As she approached the intersection, the driver stated that the overhead traffic signal changed from a red to a green phase for north/southbound traffic flow. Her travel required her to pass straight through the intersection en route to the elementary school (**Figure 3**).

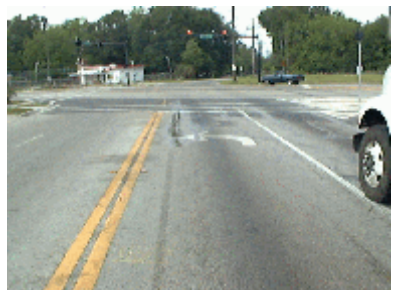
**Figure 4. Trajectory of the 1986 Chevrolet pickup truck.**

The driver of the 1986 Chevrolet S-10 pickup truck was traveling in a southerly direction on the local road (**Figure 4**). The driver was stopped behind two non-contact vehicles at the red signal phase waiting to initiate a left turn (eastbound) onto the state route. As the signal phase changed to green, the lead vehicle and the second vehicle accelerated and completed the left turn. The driver of the 1986 Chevrolet pickup truck accelerated and initiated the left turn.
