**VERIDIAN ON-SITE FAIL-TO-DEPLOY INVESTIGATION
VERIDIAN CASE NO. CA98-60
VEHICLE: 1998 HONDA CIVIC EX
LOCATION: PENNSYLVANIA
CRASH DATE: OCTOBER, 1998**

1. <i>Report No.</i> CA98-60	2. <i>Government Accession No.</i>	3. <i>Recipient's Catalog No.</i>	
4. <i>Title and Subtitle</i> Veridian On-Site Fail-To-Deploy Investigation Vehicle: 1998 Honda Civic EX Location: Pennsylvania		5. <i>Report Date:</i> July, 1999

14. <i>Sponsoring Agency Code</i>	
15. <i>Supplementary Notes</i> On-site investigation of a severe run-off-road crash with tree that failed to deploy the frontal air bag system in a 1998 Honda Civic EX.

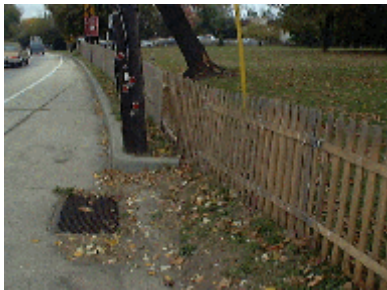
This on-site investigation focused on issues related to the non-deployment of the frontal air bag system in a 1998 Honda Civic. The vehicle was involved in off-road frontal impacts with a picket fence, utility pole guy wire, and a large diameter [68.6 cm (27.0")] tree (**Figure 1**). The frontal impact with the tree resulted in severe damage to the Honda Civic, (**Figure 2**) but failed to deploy the vehicle's frontal driver and right front passenger air bag system. The Honda was operated by an unrestrained 24 year old male. The driver loaded the steering assembly during the impact with the tree. This loading resulted in severe deformation of the steering wheel and in multiple internal injuries of the abdomen (AIS-5) and thorax (AIS-4). The driver survived these injuries and was hospitalized for 137 days.

Figure 1. Impact trajectory of the Honda Civic.

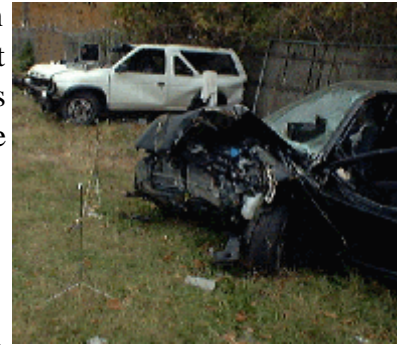
Figure 3. Profile view of the vehicle's damage pattern.

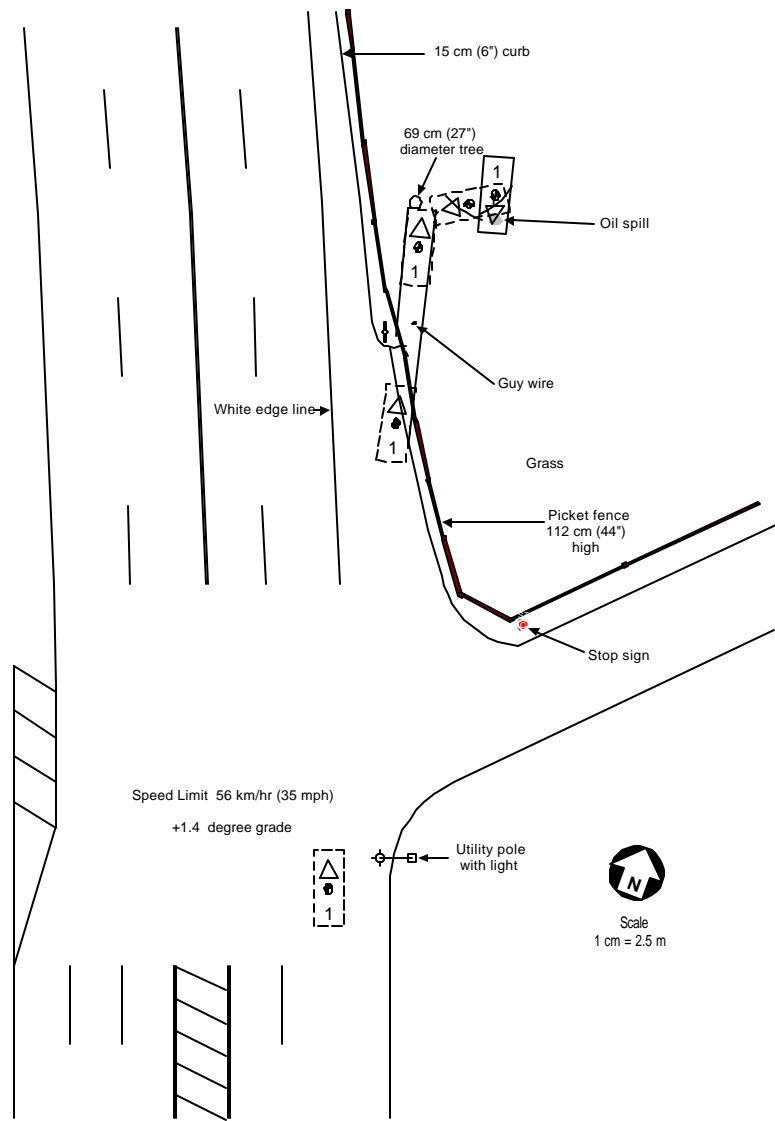
trajectory algorithm of the WinSMASH program. This impact induced a counterclockwise rotation in the Honda which rotated off the tree, spinning approximately 180 degrees, and then came to rest approximately 3.5 m (11.4') west of the tree, facing in a southerly direction. The crash schematic is attached as **Figure 11 (Page 12)** of this summary report.

Figure 11. Crash Schematic
