**REDESIGNED AIR BAG SPECIAL STUDY (RABSS)
SCI TECHNICAL SUMMARY REPORT**

NASS CDS CASE NO. 1999-04-057J

RABSS VEHICLE - 1998 CHEVROLET S-10 PICKUP TRUCK

LOCATION - STATE OF NEW JERSEY

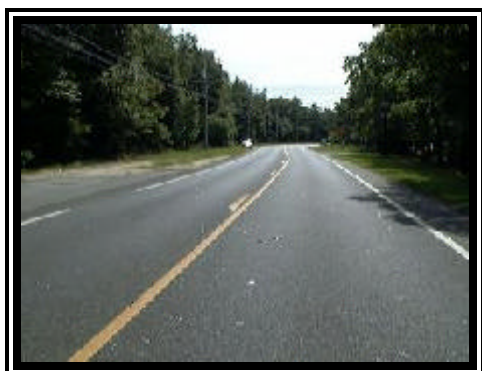
The 22 year old female driver of the 1998 Chevrolet pickup truck was operating the vehicle southbound (**Figure 1**) and negotiating a left curve when she entered the straightaway and allowed the vehicle to cross the centerline into the path of the northbound Isuzu. The police reported no brake marks at the scene indicative of driver avoidance maneuvers.

Figure 1. Southbound approach for the 1998 Chevrolet S-10 pickup truck.

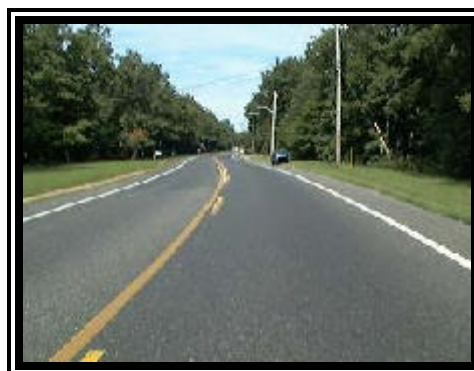
The 45 year old female driver of the 1995 Isuzu Trooper 4x4 4-door sport utility vehicle was operating the vehicle northbound (**Figure 2**) and negotiating a left curve when she entered the straightaway and observed the southbound Chevrolet encroach into her lane of travel. The police reported no brake marks at the scene indicative of driver avoidance maneuvers. The front right passenger position was occupied by a 44 year old male.

Figure 2. Northbound approach for the 1995 Isuzu Trooper sport utility vehicle.

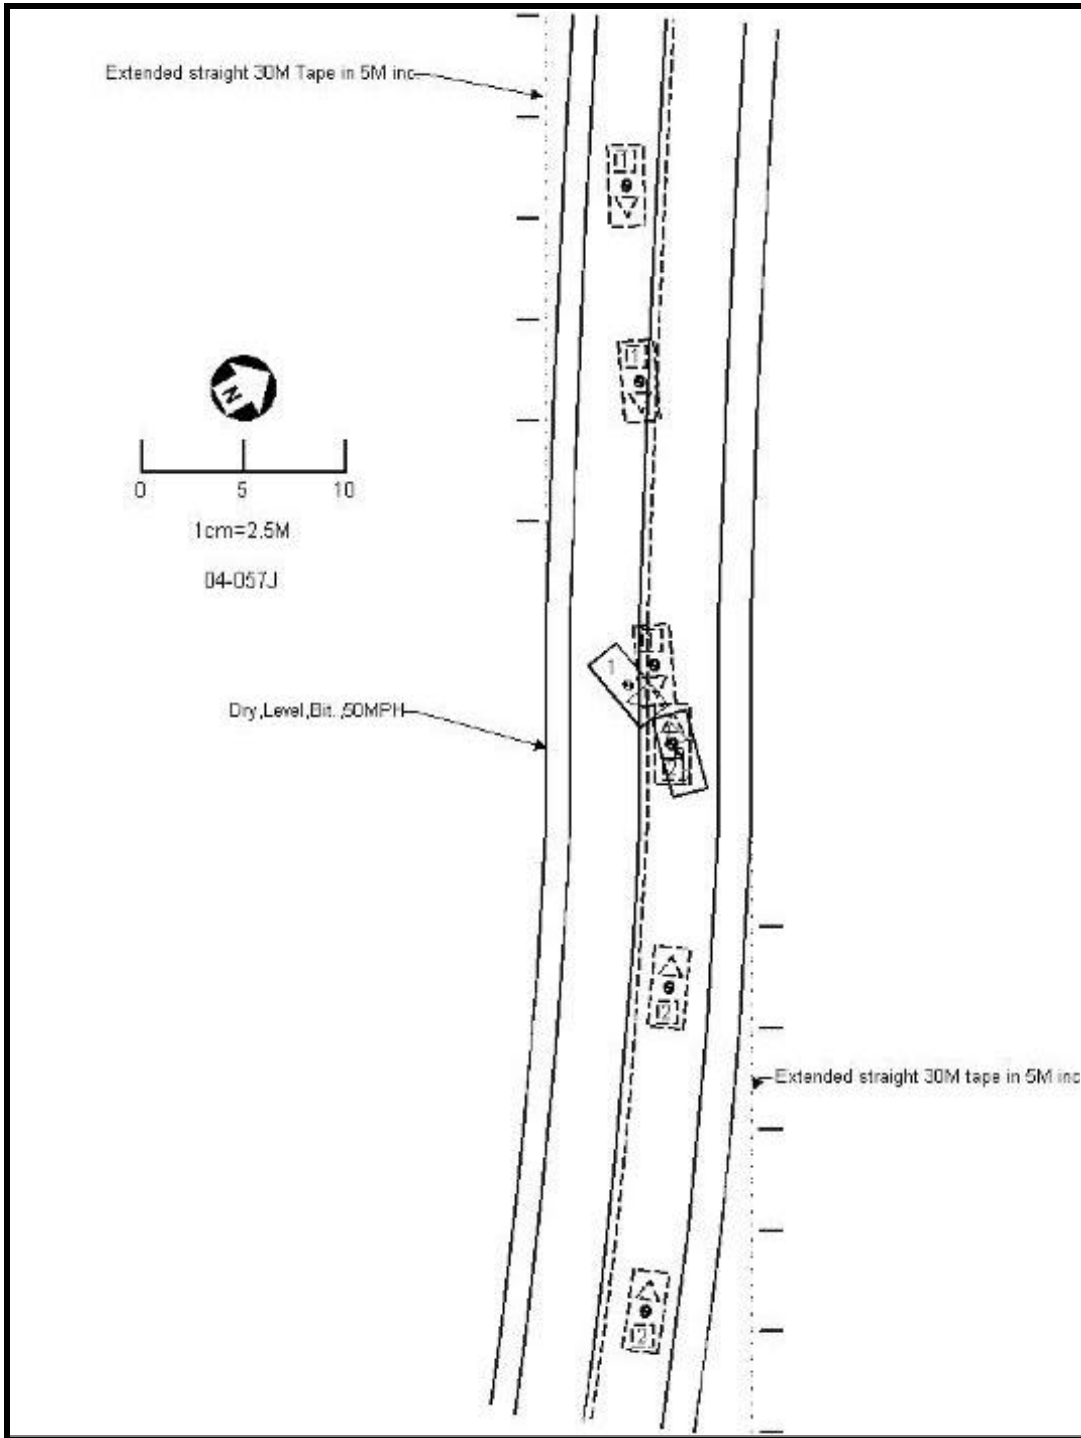
Figure 8. NASS Scene Diagram.

This two vehicle crash occurred during the early morning hours of July, 1999. At the time of the crash, it was dark (street lighted) with no adverse conditions as the road was dry. The crash occurred in the northbound lane of a (level) two lane north/south roadway (see **Figure 8 - page 8**) along the straightaway of an "S" curve. The asphalt roadway was bordered by narrow paved shoulders and utility poles. No traffic control was present at the scene which had a posted speed limit of 80 km/h (50 mph).
