**REDESIGNED AIR BAG SPECIAL STUDY (RABSS)
SCI TECHNICAL SUMMARY REPORT**

NASS CDS CASE NO. 1999-43-067J

RABSS VEHICLE - 1998 CHEVROLET C-1500 PICKUP TRUCK

CRASH DATE - APRIL, 1999

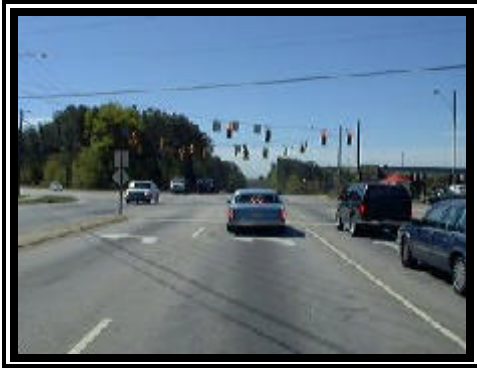
The 16 year old male driver of the 1995 Ford Ranger pickup truck was operating the vehicle southbound (**Figure 1**) when he entered the outboard left turn lane to proceed east at the 4-leg

Figure 1. Southbound approach for the 1995 Ford Ranger pickup truck.

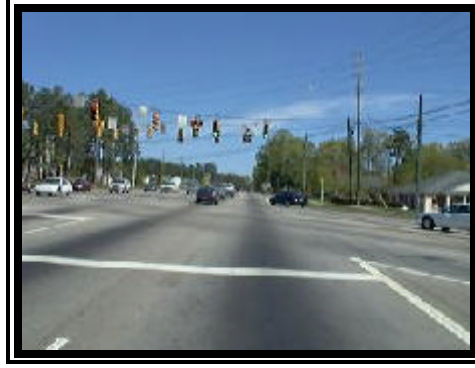
The 24 year old female driver of the 1998 Chevrolet C-1500 pickup truck was operating the vehicle northbound in the outboard lane (**Figure 2**) when she proceeded straight through the 4-leg intersection at a (driver reported) speed of 64 km/h (40 mph) and observed the Ford pickup truck cross her path of travel. The driver reported no avoidance maneuvers in anticipation of the impending crash.

Figure 2. Northbound approach for the 1998 Chevrolet C-1500 pickup truck.

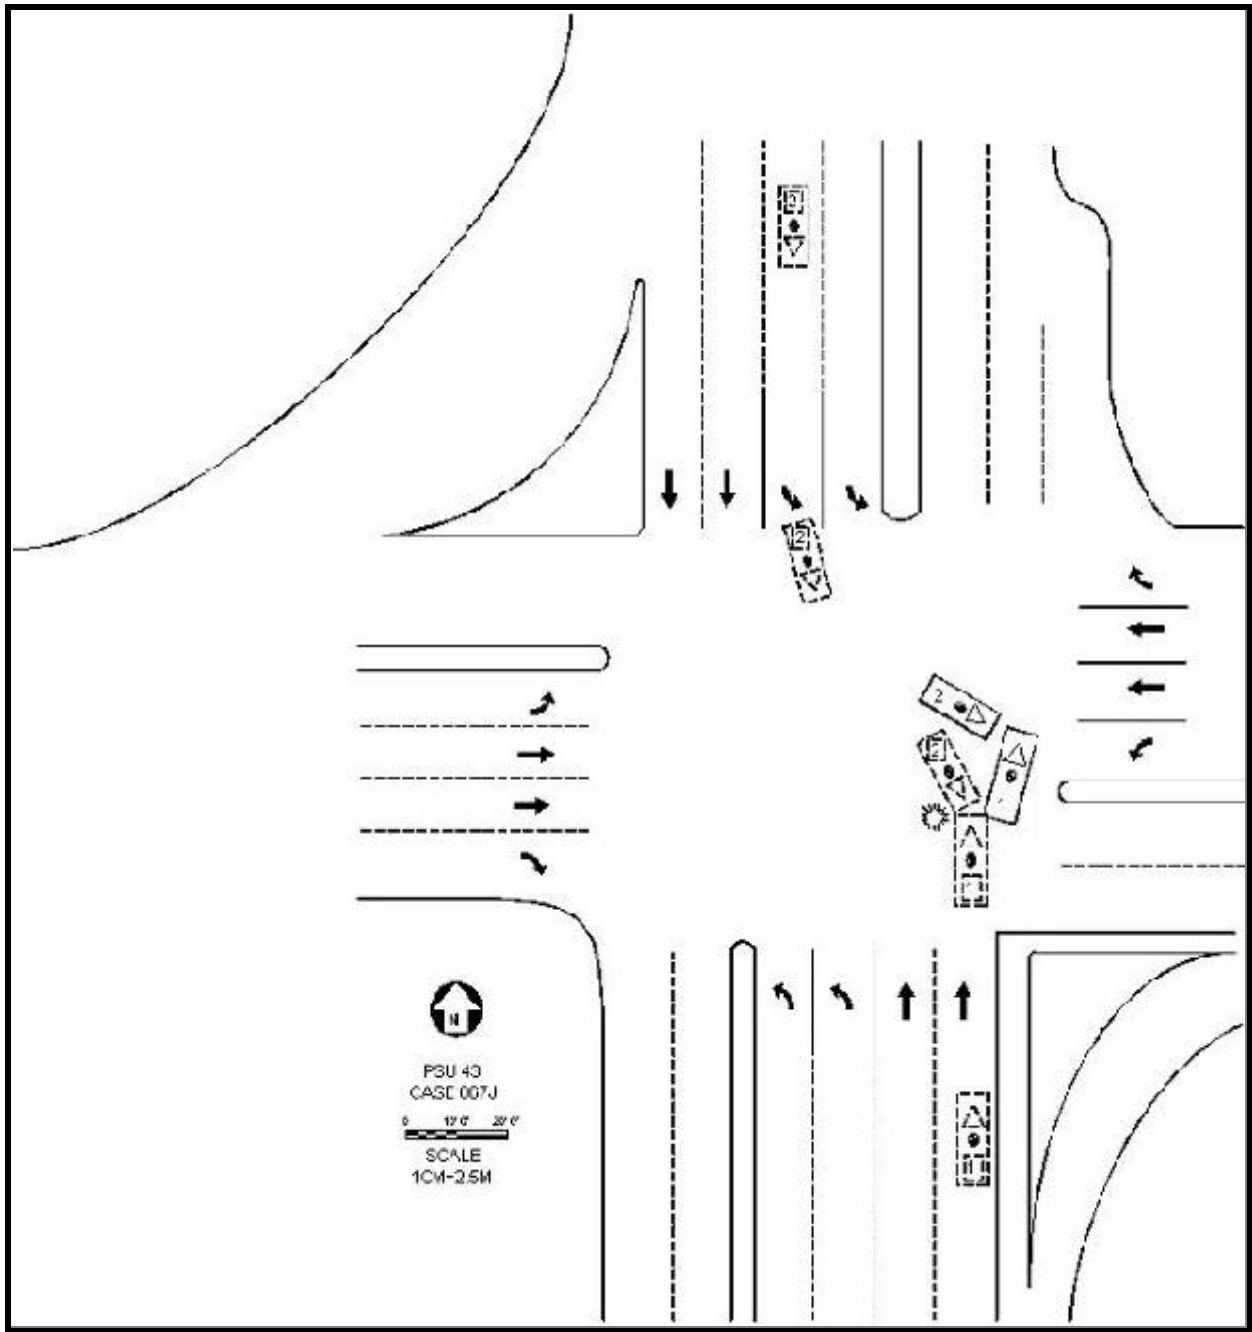
Figure 7. NASS Scene Diagram.

This two vehicle crash occurred during the early morning hours of April, 1999. At the time of the crash, it was dark (street lighted) with no adverse conditions as the roads were dry. The crash occurred in the northbound lanes of a multi-lane (asphalt) urban 4-leg intersection (see **Figure 7 - page 7**) with a positive grade for northbound traffic. The north and south sectors of the intersection were divided by a raised curb median and consisted of two left turn lanes, two through lanes and a channelized right turn lane. Traffic control through the intersection was controlled by an overhead signal system in green phase for north/southbound traffic. The posted speed limit at the crash site was 72 km/h (45 mph).
