Remote, Redesigned Air Bag Special Study

Dynamic Science, Inc., Case Number (1999-48-802C)

1998 Nissan Frontier

Technical Report Documentation Page

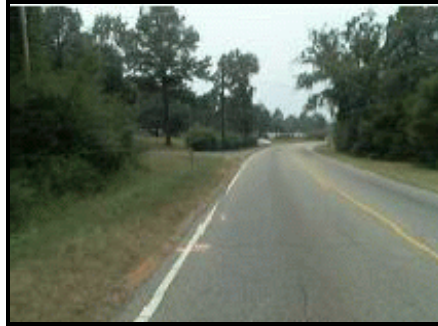
Vehicle 1, a 1989 Mercury Sable four-door sedan was being driven by a 29 year-old-male (unknown height and weight) who reportedly was wearing the lap and shoulder restraint. Driver 1 was traveling westbound and was in the process of passing a tractor-trailer (non-contacted vehicle). Vehicle 1 traversed the no passing center line, entering the eastbound travel lane.

Figure 1. Pre-crash trajectory for Vehicle 1

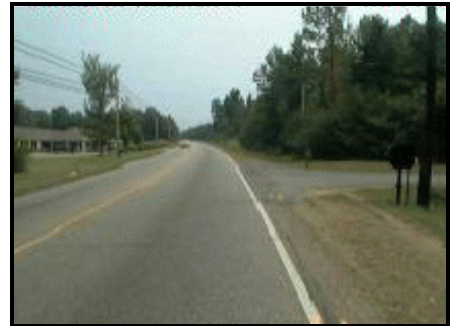
Vehicle 2, a 1999 Nissan Frontier pickup truck was being driven by a 25 year-old-male (190 cm/ 75 in., 100 kg/220 lbs.) who was wearing the available three-point manual lap and shoulder belt. The driver of Vehicle 2 was negotiating the left curve in the roadway, when he detected Vehicle 1 encroaching his lane of travel. Driver 2 braked and steered to the right in an attempt to avoid the impending impact. Vehicle 2 initiated a longitudinal skid pattern. The driver of Vehicle 1 (Mercury Sable) also anticipated the impact by braking and steering to the left. Vehicle 1 initiated a longitudinal skid pattern leading up to the point of impact.

Figure 2. Pre-crash trajectory for Vehicle 2

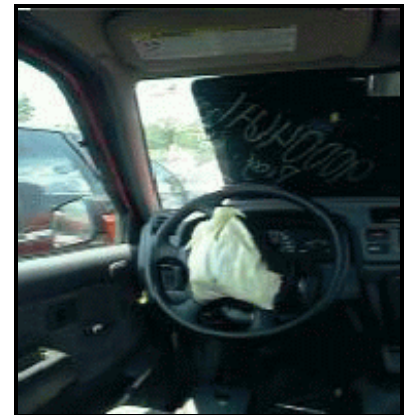
The 25 year-old-male driver of the 1998 Nissan Frontier pickup truck was fully restrained by the available three-point manual lap and shoulder belt. He was in an upright position, facing forward, with both hands on the steering wheel rim (11 o'clock and 1 o'clock respectively). His right foot was depressing the brake pedal while his left foot was on the floor.

Figure 12. Driver's seated position

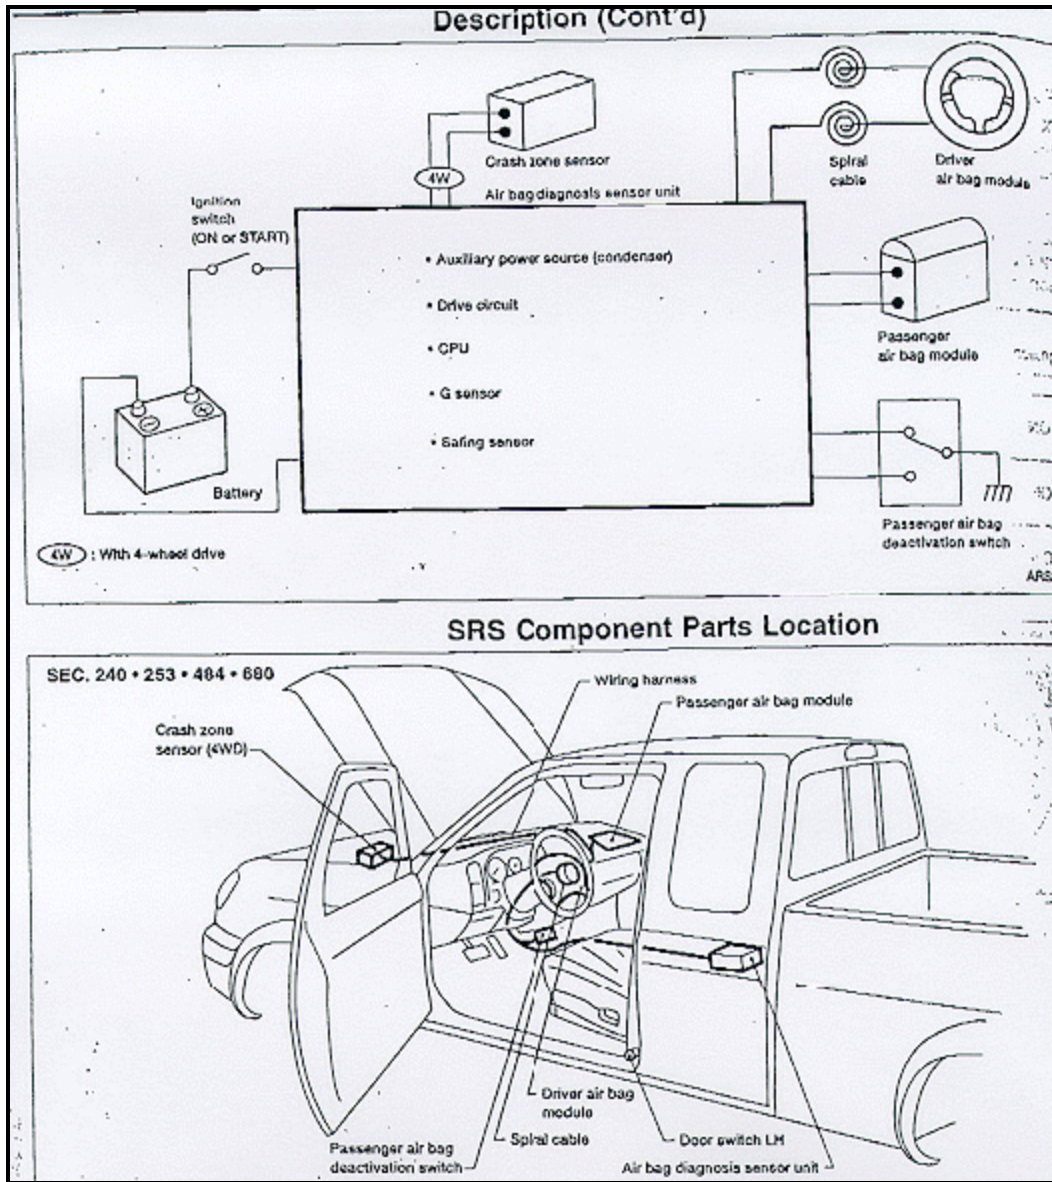
The 1998 Nissan Frontier pickup truck was equipped with redesigned air bag systems. This system consists of three sensors. The front crash zone sensor is located under the hood at the mid-upper radiator support². The G sensor and safing sensor are located in the diagnosis sensor unit. The air bag diagnosis sensor unit is located in the center of the vehicle, concealed within the transmission tunnel/center console. The diagnosis sensor unit is also equipped with an auxiliary power source condenser. The backup power feature is sufficient to deploy the air bags in the event that the battery or battery cables are damaged in a collision before the crash sensors are activated. This system is offered with the passenger air bag deactivation switch which is located in the middle/ lower instrument panel, immediately above the transmission tunnel. The deactivation shut off switch was activated which rendered the passenger air bag inoperative. Subsequently, the front passenger air bag did not deploy. An air bag indicator lamp is located in the front, left instrument panel.

Figure 16. SRS components
