On-scene Investigation / Vehicle to Vehicle
Dynamic Science, Inc. / Case Number: DS99015
1998 Chevrolet Blazer
Arizona
January 1999

| 4. Title and Subtitle In-Depth Accident Investigation | | | | 5. Report Date April 23, 1999 | |

Dynamic Science, Inc.
Accident Investigation
Case Number: DS99015

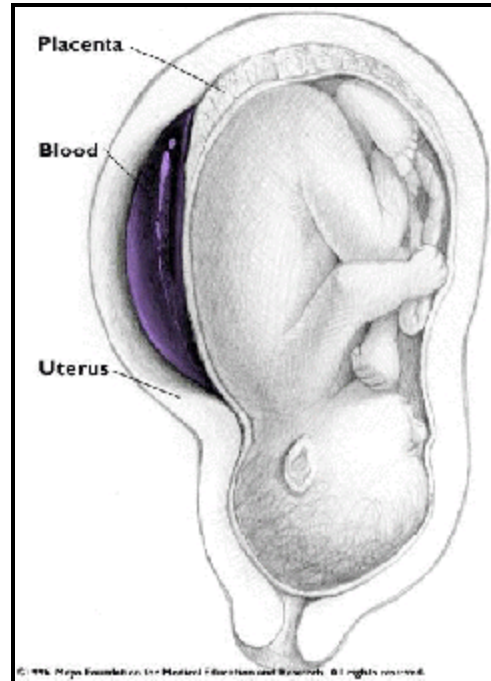
Figure 2. Placental Abruption

The front right occupant of the case vehicle sustained an eventual abruption of the placenta, contusions to both knees, and contusions to the upper chest. This occupant broke her water immediately after the crash. Per EMS personnel, she was having some vaginal bleeding at the scene. She was transported to a local hospital by ground ambulance. She was hemodynamically stable while en route to the hospital, but was complaining of mild lower abdominal pain. She indicated that the bleeding was seat belt related. An examination upon arrival at the hospital revealed the fetal heart tones of an active baby. An ultrasound was performed, but this did not reveal any evidence of an abruption². However, because of the vaginal bleeding and contractions the physicians indicated she had indeed had a placental abruption.

²A placental abruption is an emergent third trimester complication that results from the hemorrhage and accumulation of blood between the placenta and the wall of the uterus. This inevitably interferes with fetal oxygenation and often necessitates the need for emergency cesarean section delivery.
