On-scene Investigation / Vehicle to Vehicle
Dynamic Science, Inc. / Case Number: DS99017
1999 BMW
Arizona
February 1999

1. Report No. DS99017		2. Government Accession No.		3. Recipient Catalog No.	
4. Title and Subtitle In-Depth Accident Investigation				5. Report Date	
				6. Performing Organization Report No.

Description: This case was initiated in response to a report of a side air bag deployment in a 1999 BMW 3 series four-door sedan.

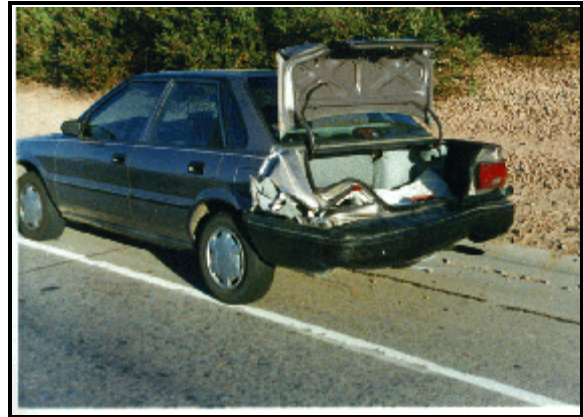
Figure 6. Exterior, Vehicle 3 (1991 Geo Prism)

Description:	1991 Geo Prism four door sedan	
VIN:	1Y1SK546XMZxxxxxx	
Odometer:	Unknown	
Engine:	1.6 L L4	
Reported Defects:	None noted	
Cargo:	Unknown	
Damage Description:	Minor bumper crush to left rear bumper corner.	
CDC:	Impact 2: 06BLEE3	
Delta V:	Total	Unknown
	Longitudinal	Unknown
	Latitudinal	Unknown
	Energy	Unknown

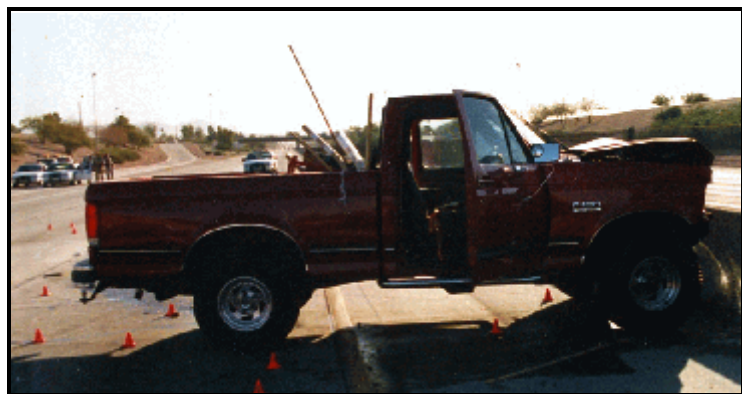
Figure 7. Exterior, Vehicle 4 (1988 Ford pickup)

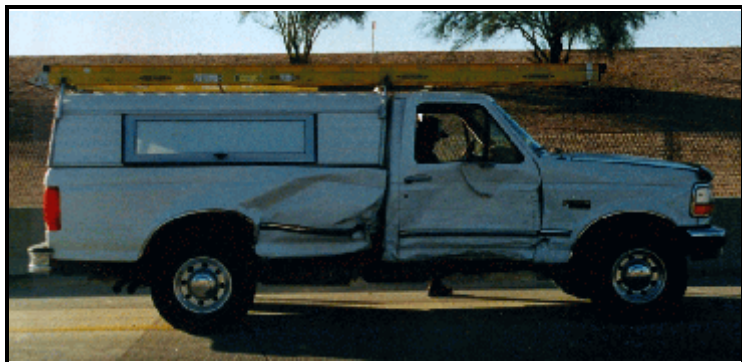
Figure 8. Exterior, Vehicle 5 (1997 Ford pickup)

Description: 1997 Ford F250 4x2 regular cab pickup
 VIN: 1FTHF25G3VEBxxxxxx
 Odometer: Unknown
 Engine: 7.5 l EFI V8
 Reported Defects: None noted
 Cargo: Carrying camper shell. Unknown additional weight.
 Damage Description: Moderate front to rear crush at mid-door level and at frame rail level.
 CDC: Impact 4: 01RDEW2
 Delta V: Total Unknown
 Longitudinal Unknown
 Latitudinal Unknown
 Energy Unknown

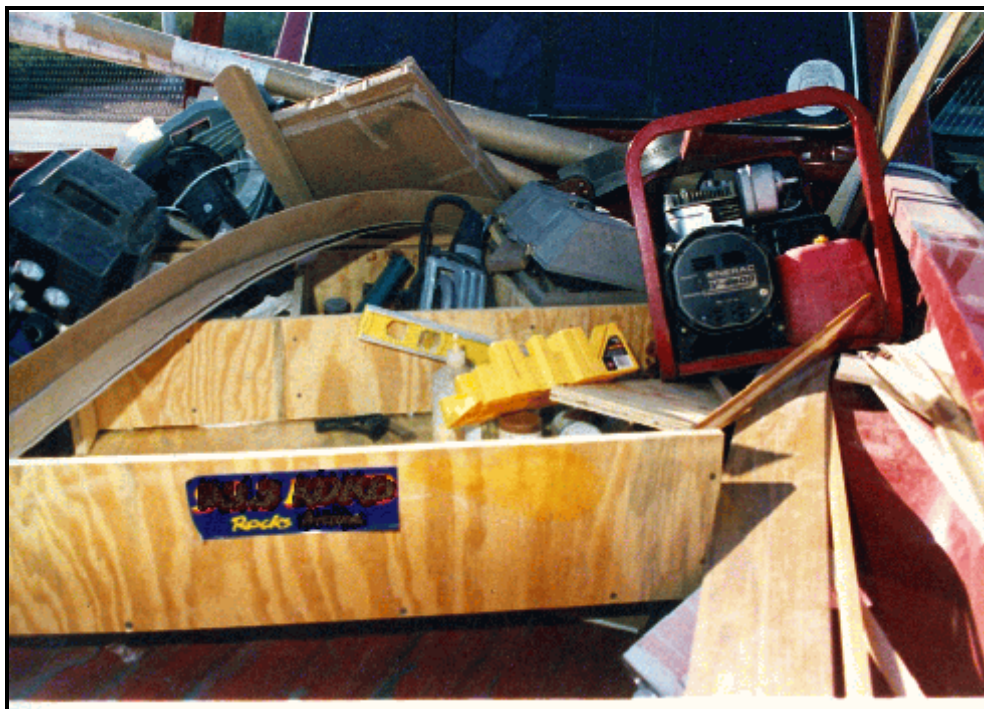
Figure 18. Vehicle 4 (carpentry cargo)

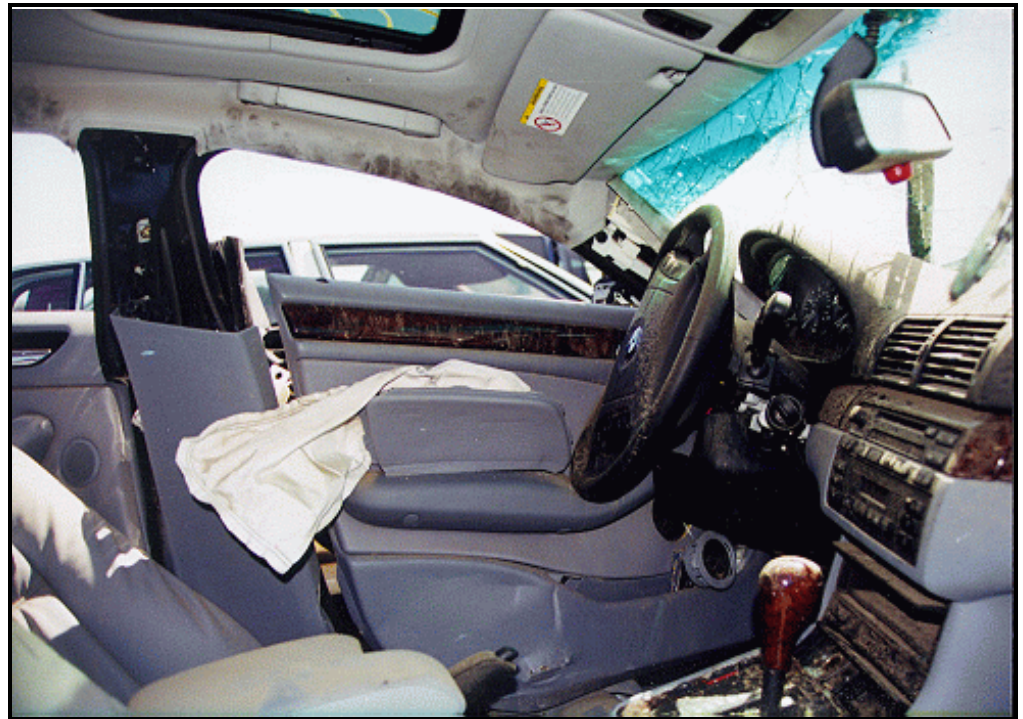
The driver of Vehicle 1 was seated in a normal, upright fashion. She was wearing the available lap and shoulder belt. Her right foot was on the brake and the vehicle was either stopped or slowing. Vehicle 2 struck Vehicle 1 directly from behind. The driver of Vehicle 1 reacted to the 180 degree direction of force by moving rearward into the rear seat back. Vehicle 1 was accelerated forward and to the left and engaged the left rear of Vehicle 3. The driver of Vehicle 1 reacted to this moderate longitudinal impact by moving forward and to the right, possibly loading the lap and shoulder belt to some extent. As Vehicle 1 continued its path across the freeway, it was struck in the left side by Vehicle 4. This was a significant impact and the door mounted left side air bag deployed, as did the left side ITS. The driver reacted to the 260 degree direction of force by moving sharply to the left and striking the intruding left side door surface. Any protection offered by the side air bag was likely offset by the extensive intrusion. All the major torso and abdominal injuries were as a result of the door contact. The ITS had been cut out during extrication. It appears likely, however, that the ITS provided some measure of head protection since there were no reported major head injuries. The driver was entrapped in the vehicle following the left side impact. Vehicle 1 continued on into the next lane and struck the right side of Vehicle 5. The driver did not react much to this collision—she was entrapped to some degree and was likely unconscious. The driver was extricated from the vehicle after the roof was removed by cutting the pillars.

Figure 24. Driver's seated position
