**VERIDIAN ON-SITE AIR BAG RELATED
CHILD PASSENGER FATALITY INVESTIGATION
VERIDIAN CASE NO. CA99-050
VEHICLE: 1998 CHEVROLET TRACKER
LOCATION: MICHIGAN
CRASH DATE: DECEMBER 1999**

1. <i>Report No.</i> CA99-050	2. <i>Government Accession No.</i>	3. <i>Recipient's Catalog No.</i>	
4. <i>Title and Subtitle</i> Veridian On-Site Air Bag Related Child Passenger Fatality Investigation Vehicle: 1998 Chevrolet Tracker Location: Michigan		5. <i>Report Date:</i> June 2002

14. <i>Sponsoring Agency Code</i>	
15. <i>Supplementary Notes</i> On-site investigation of an air bag deployment crash that resulted in the death of a 7 year old female front right passenger of a 1998 Chevrolet Tracker.

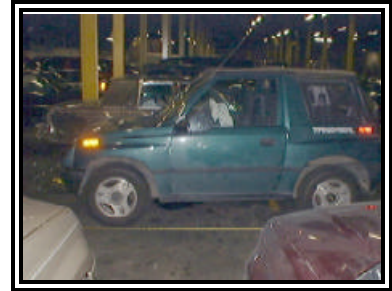
Figure 1. Subject vehicle, 1998 Chevrolet Tracker.

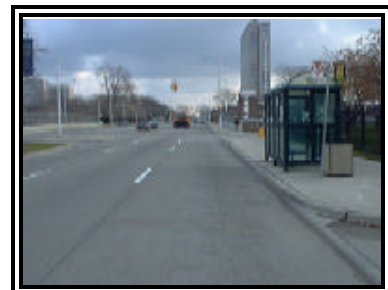
The crash occurred at a signalized four-leg intersection of two city roadways during daylight hours under overcast skies. The environmental surfaces were dry. The Tracker was traveling in an easterly direction on a six lane divided concrete road surface (Figure 2). The eastbound travel lanes were bordered by a curbed south edge line and a curbed grass median. The travel lanes were delineated by broken white lane lines. The Ford Thunderbird was traveling in a westerly direction on the same roadway. The east leg of the intersection consisted of three through lanes in each direction inclusive of designated inboard left turn lanes. The speed limit in the vicinity of the crash was 56 km/h (35 mph).

Figure 2. Overall view of the crash site from the Tracker's path of travel.

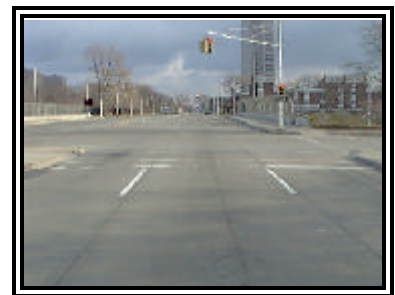
The 35 year old female driver of the Chevrolet was en route to her residence and was transporting her two daughters, ages 7 (front right passenger) and 15 (left rear passenger) years of age, and a 16 year old male seated in the right rear position. Food related artifacts noted in the vehicle suggested that they were returning from a fast food restaurant prior to the crash. The Chevrolet was traveling on the center eastbound lane en route from the downtown area of a large metropolitan region during rush hour traffic (**Figure 3**).

Figure 3. Trajectory of the Chevrolet prior to the POI

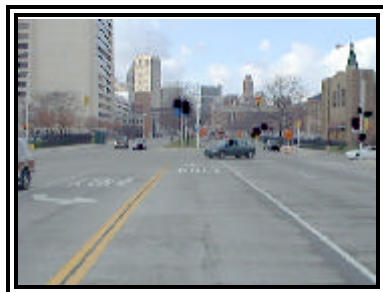
Figure 4. Trajectory of the Ford in the left turn lane.

The 48 year old female driver of the Ford was traveling westbound (**Figure 4**) and was reportedly stopped in the designated left turn lane for the red traffic light. The intersection was controlled by overhead mounted and curbside pole mounted traffic lights which were not equipped with designated left turn arrows. The driver of the Ford proceeded to make a left turn reportedly under the green light and was unaware of the Chevrolet's approach. She was transporting an 84

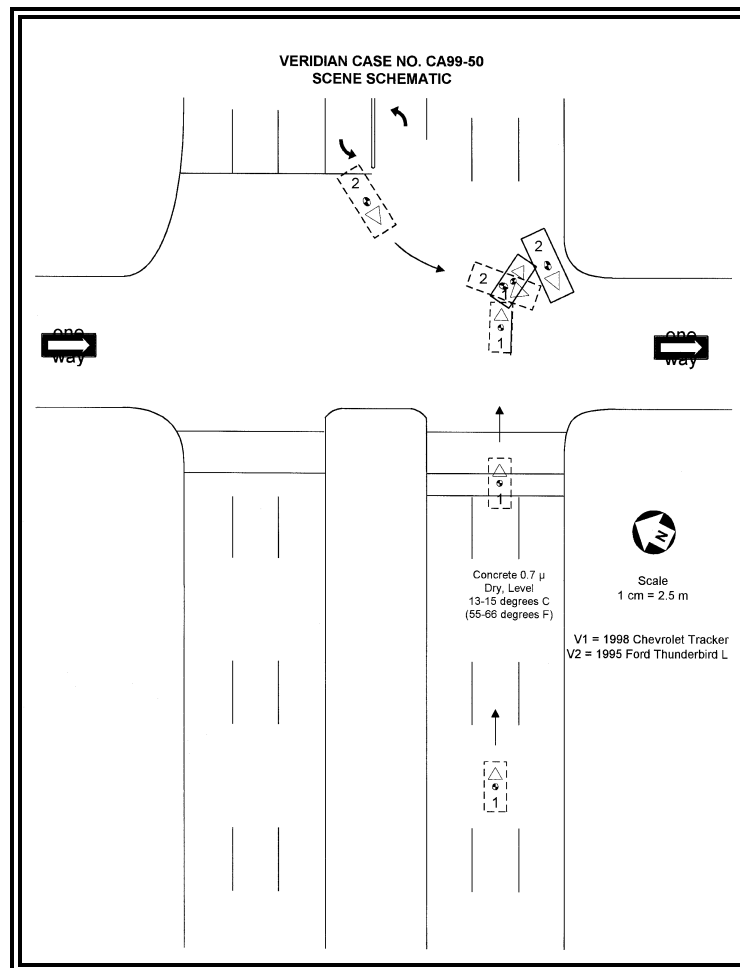
As the driver of the Tracker detected the left turning Ford Thunderbird, she braked in an attempt to avoid the impending impact. There were no visible skid marks on the concrete road surface to support the extent of braking. It was unknown if the driver of the Ford initiated avoidance actions. The Crash Schematic is attached as **Figure 15**, Page 11 of this Summary Report.

Figure 15. Crash scene schematic
