ON-SITE REDESIGNED AIR BAG INVESTIGATION

CASE NUMBER - IN99-089
LOCATION - TEXAS
VEHICLE - 1998 FORD MUSTANG
CRASH DATE - September, 1999

1. <i>Report No.</i> IN99-089		2. <i>Government Accession No.</i>		3. <i>Recipient's Catalog No.</i>	
4. <i>Title and Subtitle</i> On-Site Redesigned Air Bag Investigation Vehicle - 1998 Ford Mustang Location - Texas			5. <i>Report Date:</i> August 21, 2002

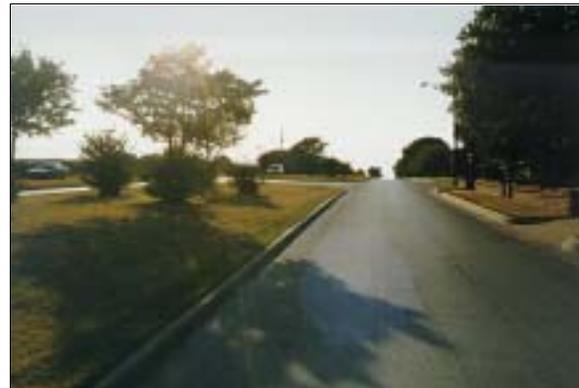
The case vehicle was traveling west in the westbound lane of a two-lane, divided, city boulevard (**Figure 1**) and intended to continue in its westerly travel path through a "Tee" intersection (i.e., both the east and westbound roadways had one wide through lane). The Ford truck had been traveling east on the eastbound roadway and was making a left-hand turn, intending to travel northward across the westbound roadway. The case vehicle's driver steered to the left, braked, and blew the horn attempting to avoid the crash. The crash occurred in the westbound roadway, within the Tee-intersection of the two trafficways; see **CRASH DIAGRAM**.

Figure 1: Case vehicle's westward travel path toward Tee intersection in wide, westbound lane; Note: bushes and trees obstruct view of Tee intersection's extension through median (case photo #02)
