Case 412 : Narrative

Case Vehicle (A): 1998 Ford	Vehicle (B): 2001 Ford
Type: Contour SE, 4-door sedan	Type: Ranger, 4x4, 4-door pickup
Driver: 61-year-old female	Driver: 24-year-old female
CDC: 12-FDEW-2	CDC: 99-0000-0

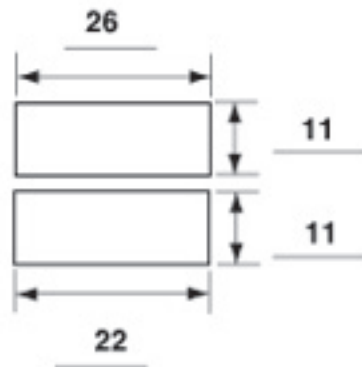
Driver Airbag Doors

Vents: Y N
if yes, how many: 2

at 1 and 11 o'clock

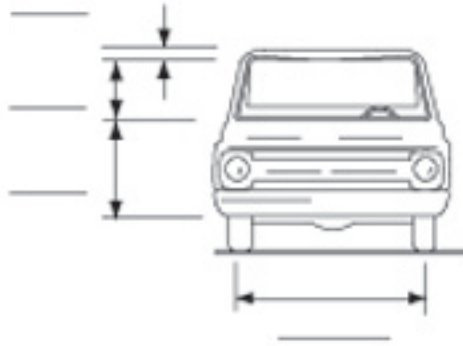
Max. crush to center of front bumper

[3](#) Damage to the front of case vehicle (A) was moderate. [4](#) Direct damage began at the right-front bumper corner and extended across the entire frontal plane. The maximum crush was 35 cm and occurred at the center of the front bumper.
