Case 423 : Narrative

Case Vehicle (A): 2004 Ford
Type: Ranger XLT, 4x4 pickup, 2-door
Driver: 47-year-old male
CDC: 12-FLEE-1, 12-FRAE-7, 12-FCEN-1, 09-LBEW-2

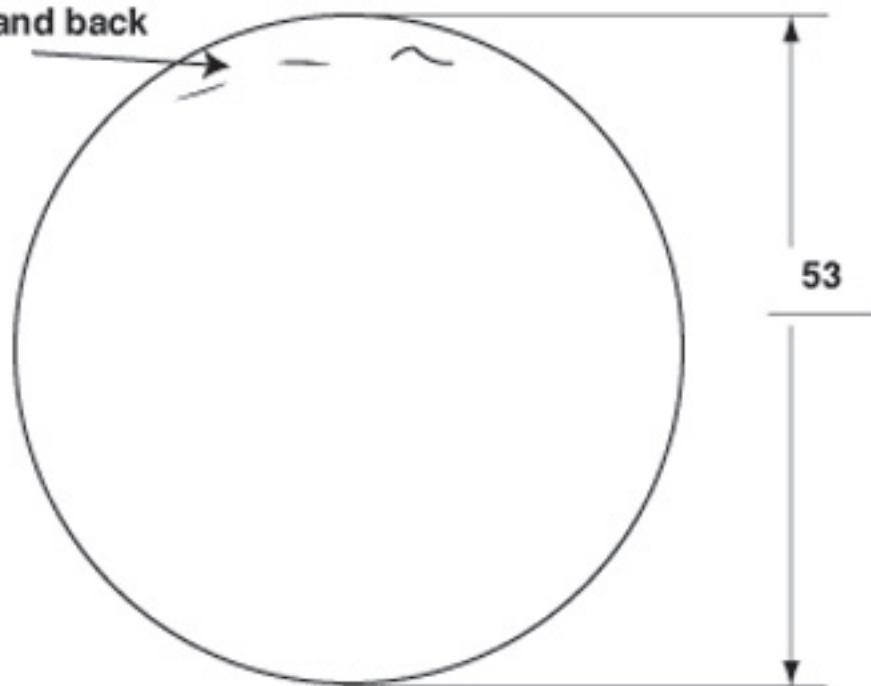
Driver Airbag

Blood or tree sap
on top and back

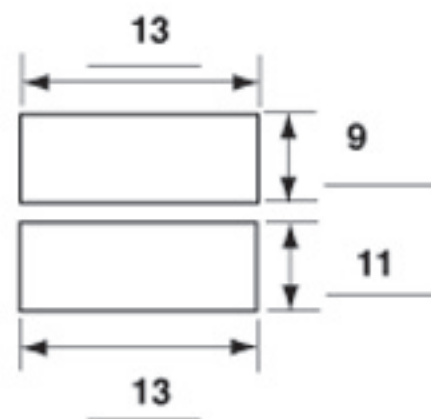
Driver Airbag Doors

H-Pattern

Vents: Y N
if yes, how many: 2

Tethers: Y N
if yes, how many: 2

vents at 2 and 10 o'clock

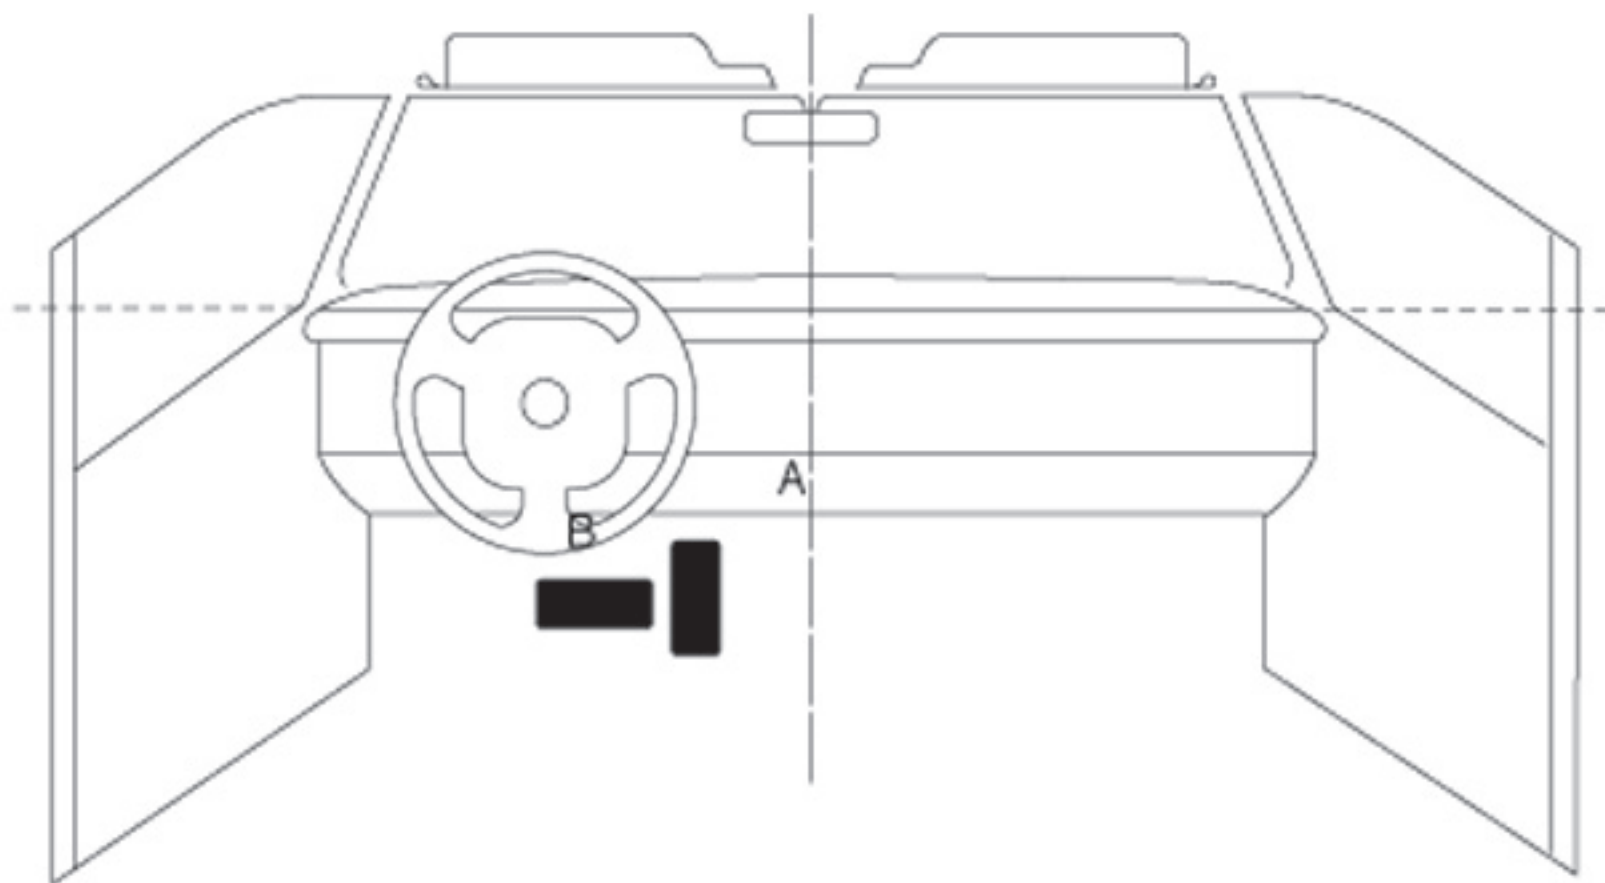
A = Lower instrument panel, scuffmark
B = Steering wheel rim, deflected forward

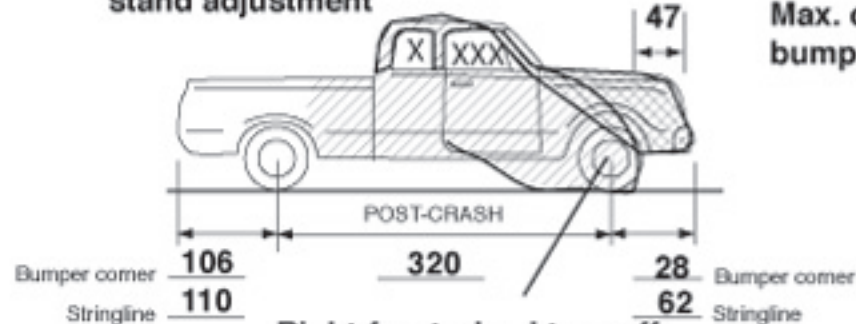
Max. crush to left-front bumper corner

Right-front wheel torn off

Max. crush to right-front bumper corner and center bumper

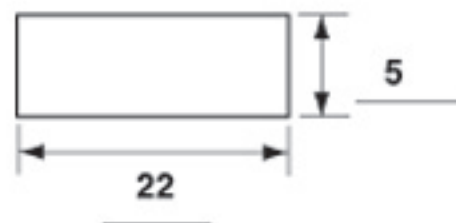
Passenger Airbag Door

Single Door

Vents: Y N
If yes, how many: 2

vents at 3 and 9 o'clock

Tethers: Y N
If yes, how many: 1
