Case 430 : Narrative

Case Vehicle (A): 1999 Pontiac	Vehicle (B): 1999 Dodge
Type: Grand Am SE, 4-door sedan	Type: Ram 1500, 4x4, 2-door pickup
Driver: 20-year-old female	Driver: 38-year-old female
CDC: 12-FRAW-6	CDC: 06-BDEW-1

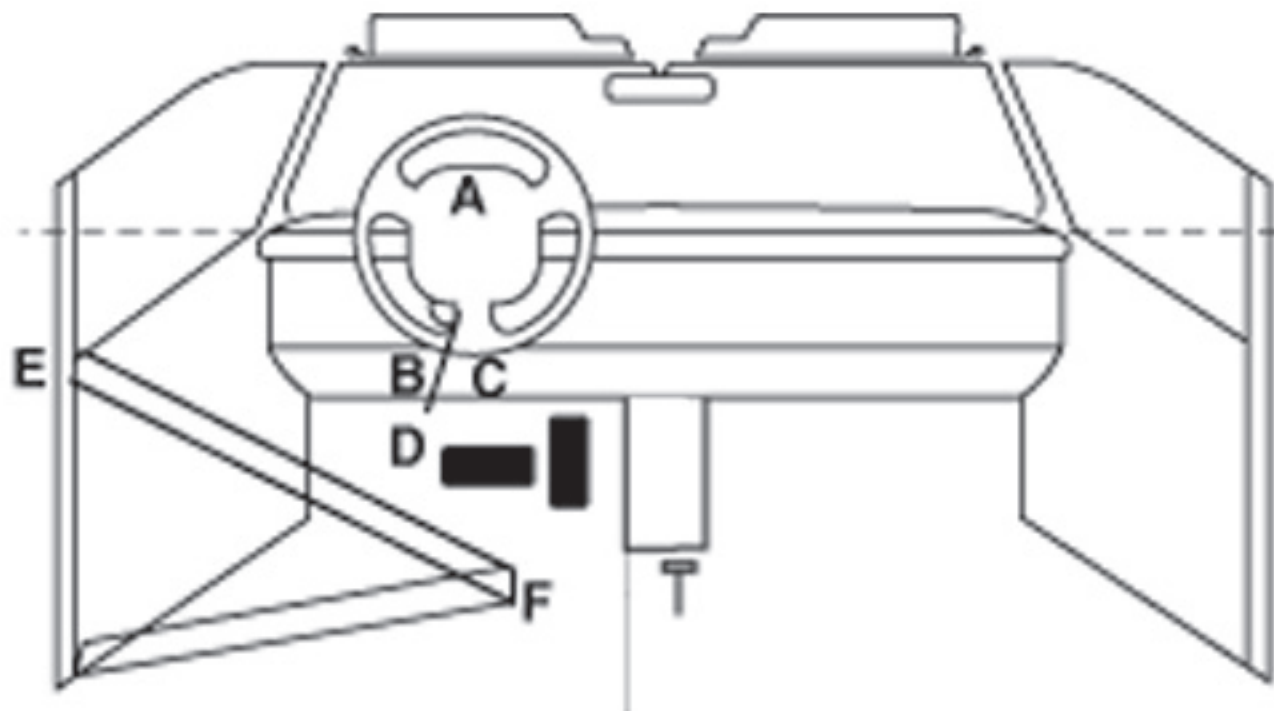
A = airbag, makeup

B = knee bolster, scuffmark

Contact	Interior Component Contacted	Occupant No. if Known	Body Region if Known	Supporting Physical Evidence	Confidence Level of Contact Point
A	Airbag	1	Face	Makeup or dirt	2
B	Knee bolster	1	Lt. knee	Scuffmark	1
C	Knee bolster	1	Rt. LX	Scuffmark	1
D	Steering column cover	1	Rt. LX	Scuffmark	1
E	Seatbelt D-ring	1	Lt. UX	Webbing marks	1
F	Seatbelt loop	1	Abdomen	Webbing marks	1
G					
H					
I					
J

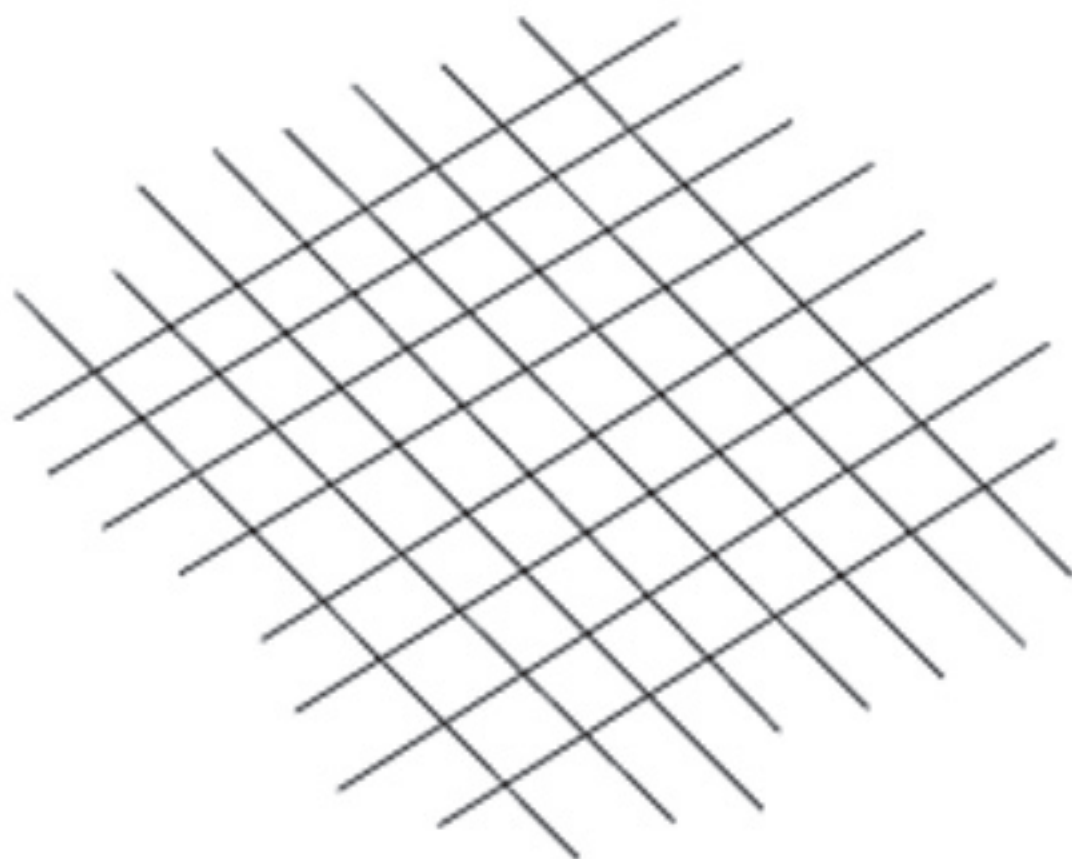
Max. crush to front 39
at right bumper
corner

50 Width of direct damage
to front
