# Case 437 : Narrative

Case Vehicle (A): 2002 Dodge
Type: Stratus SXT, 4-door sedan
Driver: 61-year-old female
CDC: 12-FCEN-3

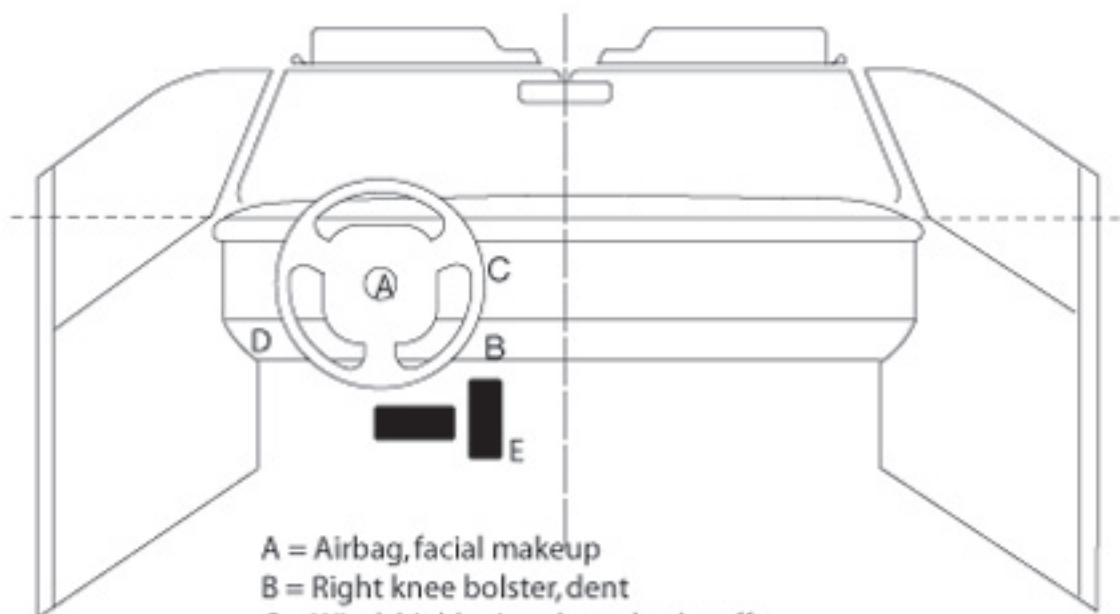
No belt use; pretensioner with no slack

- A = Airbag, facial makeup
- B = Right knee bolster, dent
- C = Windshield-wiper lever, broke off
- D = Left side of knee bolster, scuff
- E = Gas pedal, bent to left
