## Case 459 : Narrative

Case Vehicle (A): 2002 Ford	Vehicle (B): 1990 Ford
Type: F150 XLT, Supercab, 4-door pickup	Type: Taurus LX, 4-door sedan
Driver: 44-year-old male	Driver: 43-year-old female
CDC: 01-FZEW-3	CDC: 99-0000-0

# Case 459: Vehicle Report

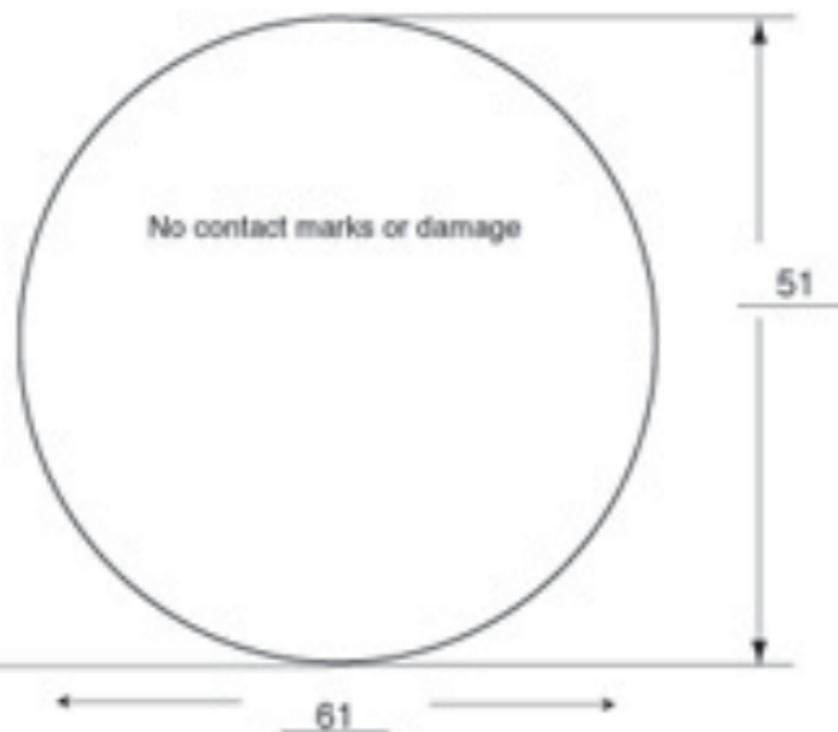
Driver Airbag

Vents:  Y  Nif yes, how many: 2

Vents @ 11 and 1 o'clock

Tethers:  Y  Nif yes, how many: 1

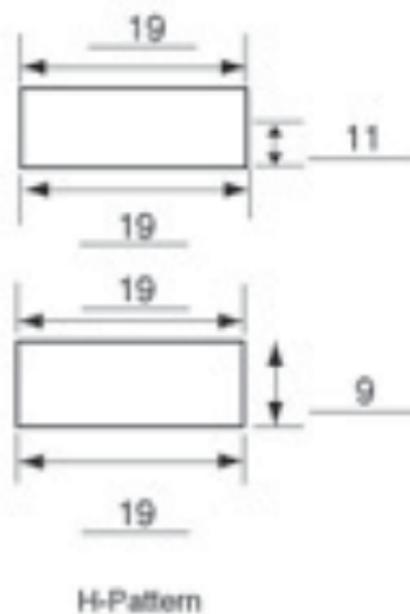
Driver Airbag Doors

- A: steering-wheel rim, deformation**
- B: grab handle on A-pillar, scuffmark**
- C: mid IP, scuffmark**
- D: knee bolster - right, scuffmarks**
- E: knee bolster - left scuffmarks**
