Case 468 : Narrative

| Case Vehicle (A): 1999 Mitsubishi |
| Type: Galant, 4-door sedan |

This is a fatal crash. The 4-year-old left-rear male passenger of case vehicle (A) died from head/neck injuries sustained during this pole-type frontal crash.

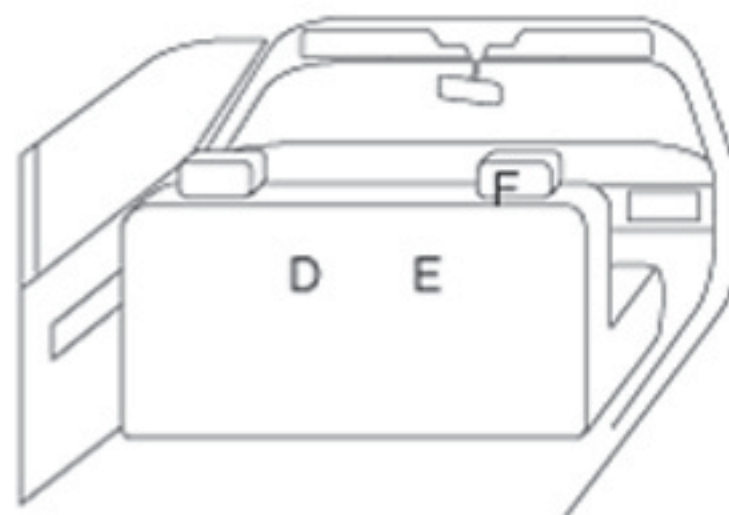
- A = blood on LR seat belt**
- B = blood on CR lap belt**
- C = blood on LR/CR seat cushion**
- D = scuff on DR seatback**
- E = scuff on RF seatback**
- F = blood/scuff on RF seat headrest**
- G = blood on roof above RR**
- H = blood smear on roof above CR**
- I = scuff/blood on roof above LR**
- J = blood on LR latchplate**
- K = blood on LR roof siderail**
- L = blood on roof over CR, near sunroof**
- M = blood on roof over RR, near sunroof**
- N = blood on DR visor**
- P = blood on CR backrest**
- Q = blood on RR backrest**
- R = load mark on DR d-ring**
- S = DR knee bolster, left, deformed**
- T = DR knee bolster, right, deformed**
- U = upper SW rim deflected forward**
- V = scuff on LF door**
- W = blood on RF seat backrest**
- X = RF airbag scuff**

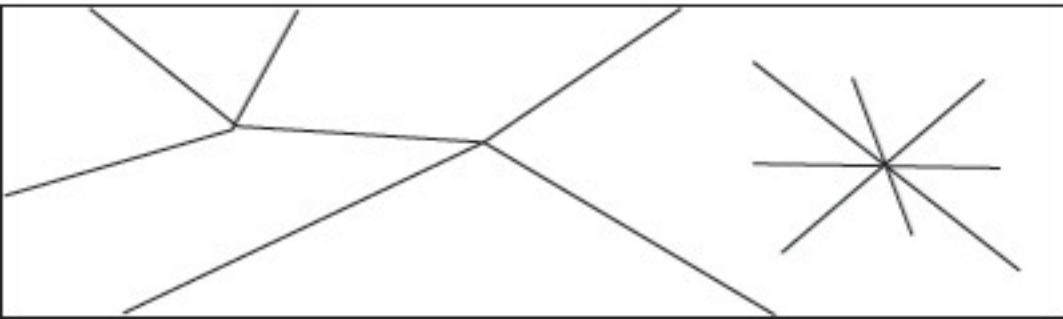
Damage from RF airbag deployment
