REPORT NUMBER 111-GTL-06-001

SAFETY COMPLIANCE TESTING FOR FMVSS NO. 111 REARVIEW MIRRORS

HYUNDAI MOTOR COMPANY
2006 HYUNDAI SONATA, PASSENGER CAR
NHTSA NO. C60502

FINAL REPORT

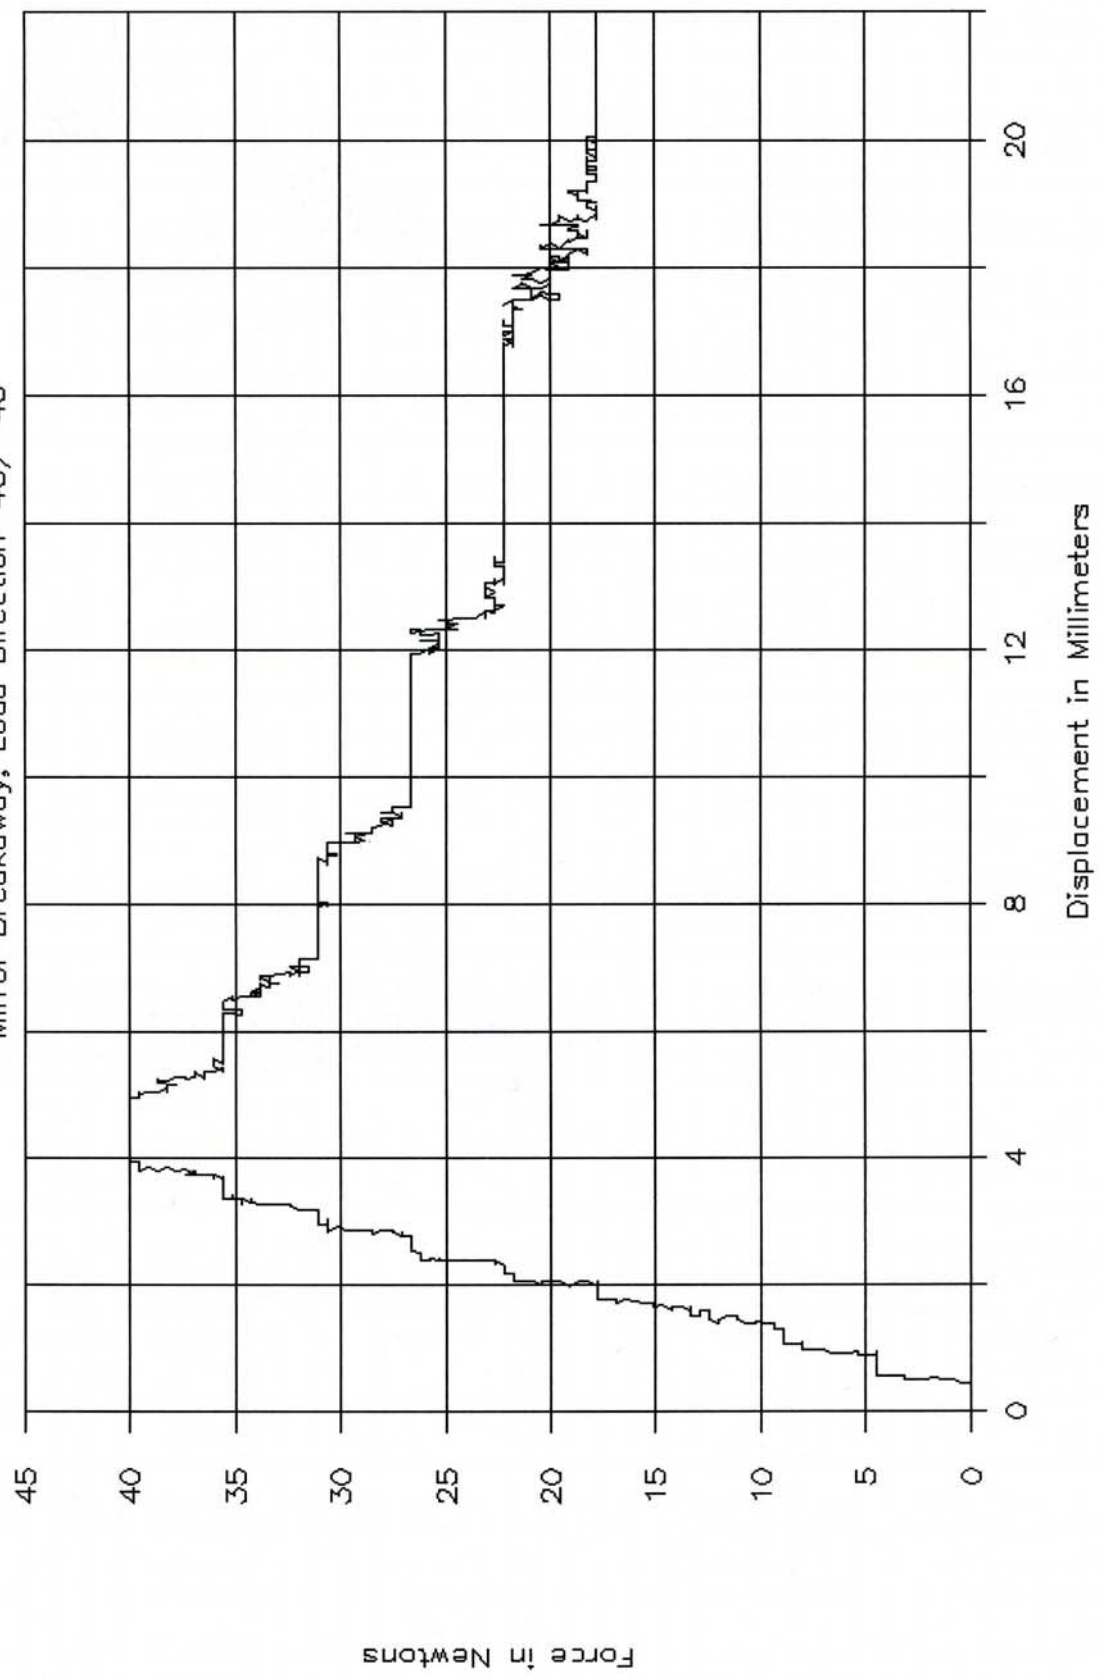
GTL 5540

TEST NO	LOAD DIRECTION (Vertical/Horizontal)	MAXIMUM FORCE (N)	PASS	FAIL
1 (GTL 5538)	0°/90°	155	X	
2 (GTL 5539)	-45°/90°	38	X	
3 (GTL 5540)	-45°/-45°	40	X	
4 (GTL 5541)	-45°/+45°	160	X	
5* (GTL 5542)	10°/+45°	222	X	
6* (GTL 5543)	10°/90°	125	X	
7* (GTL 5544)	10°/-45°	160	X

Mirror Breakaway, Load Direction -45/-45

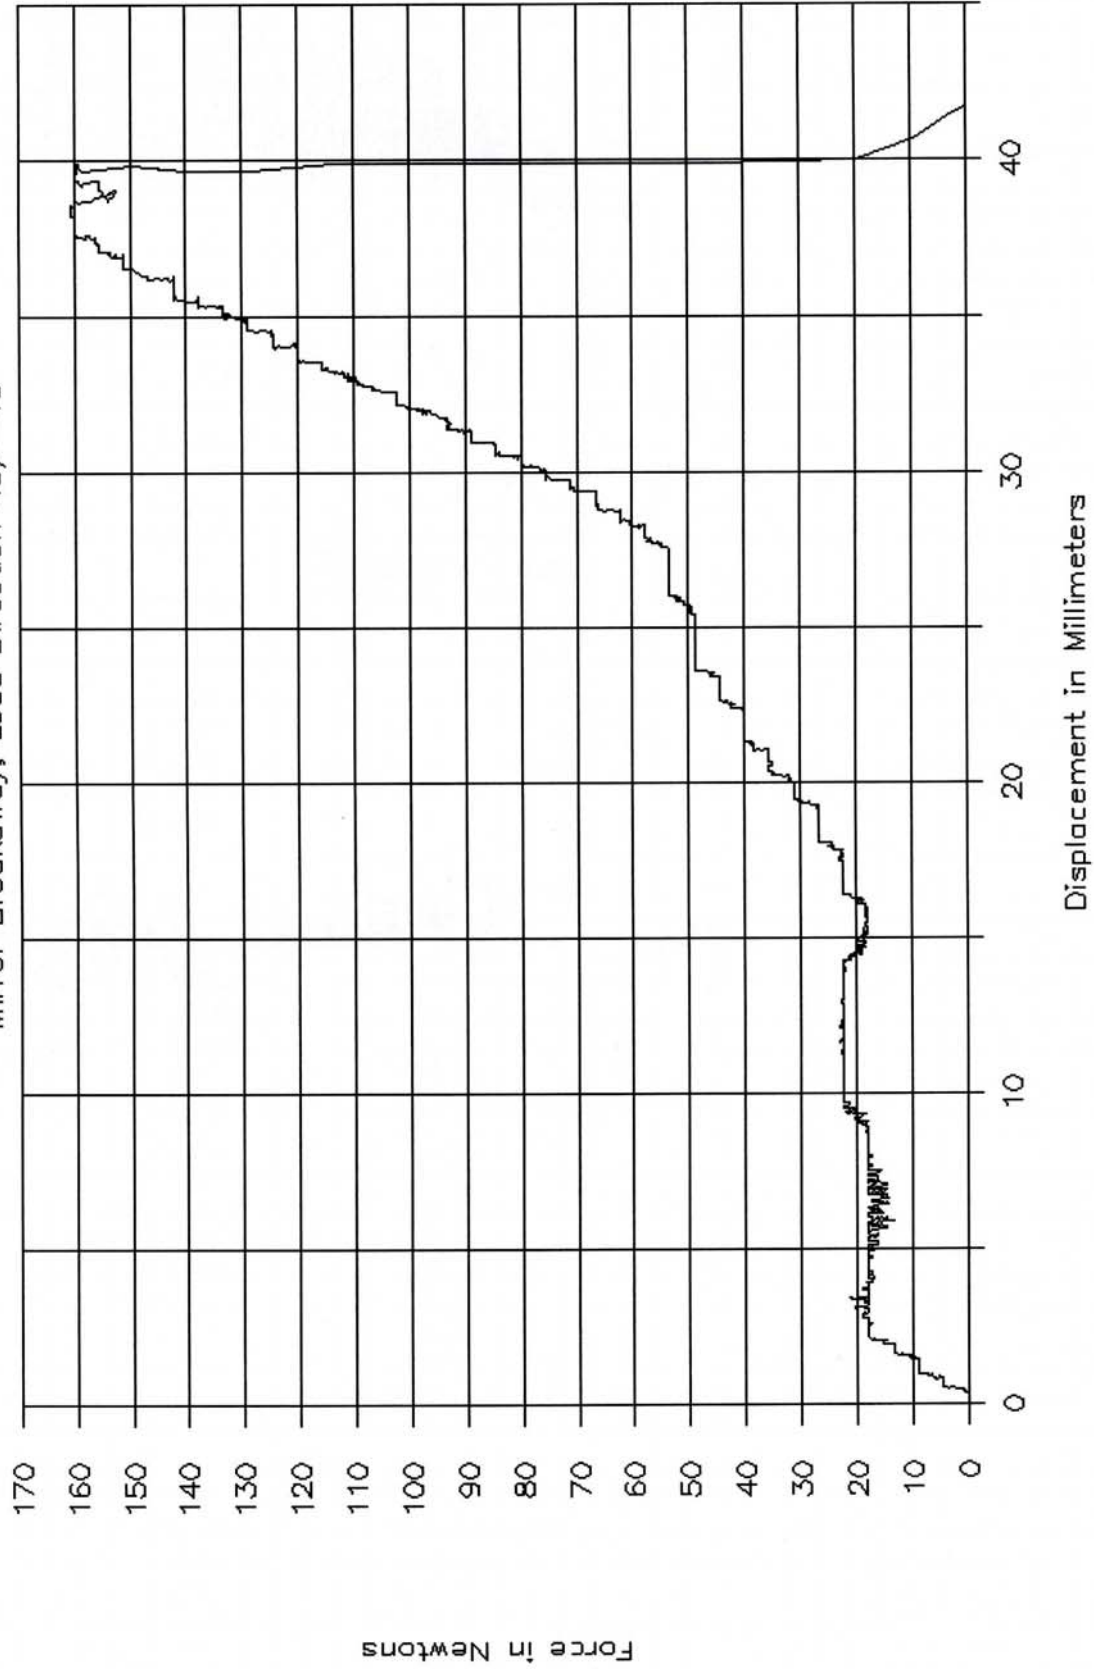
GTL 5541

Mirror Breakaway, Load Direction 45/-45
