REPORT NUMBER 111-GTL-06-003

SAFETY COMPLIANCE TESTING FOR FMVSS NO. 111 REARVIEW MIRRORS

MITSUBISHI MOTORS NORTH AMERICA, INC.
2006 MITSUBISHI ECLIPSE, PASSENGER CAR
NHTSA NO. C65600

FINAL REPORT

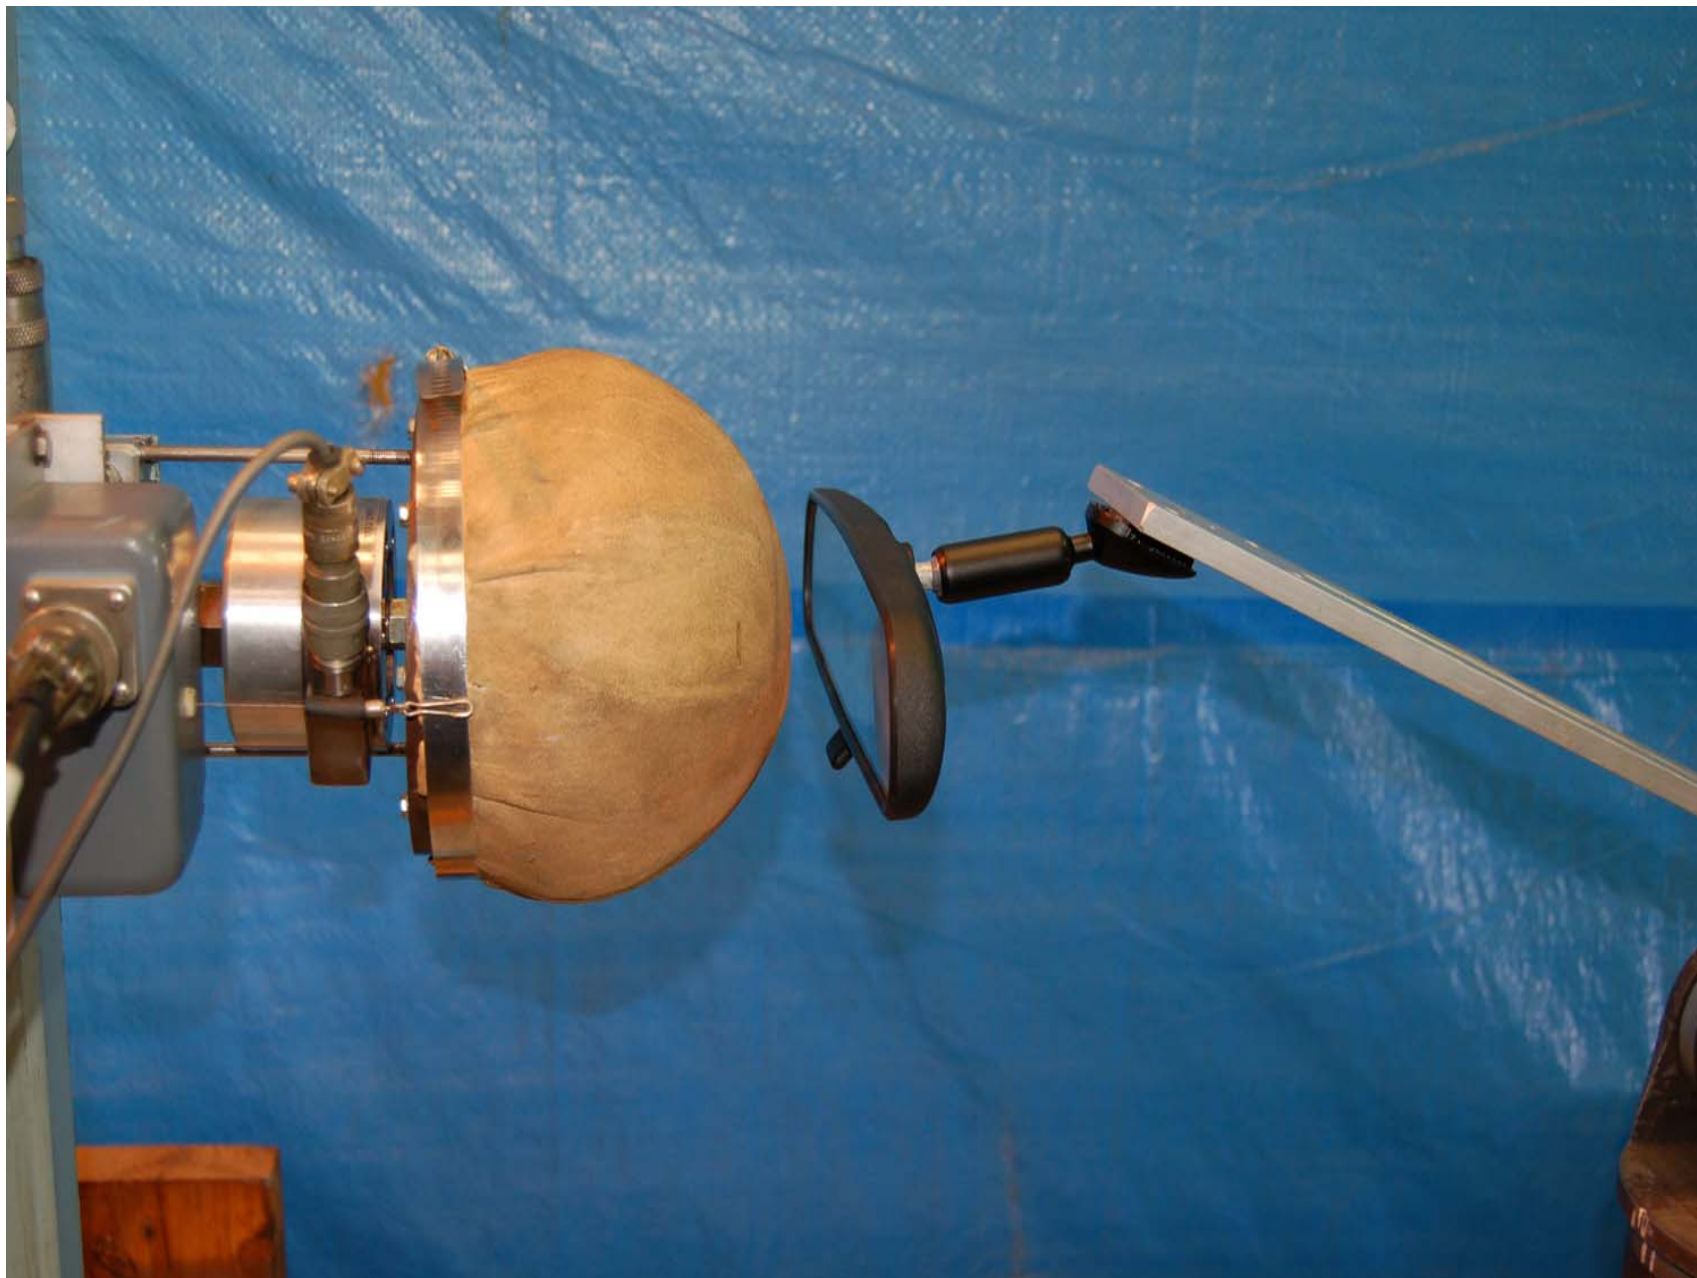
FIGURE 5.12
BREAK AWAY TEST SET-UP

TEST NO	LOAD DIRECTION (Vertical/Horizontal)	MAXIMUM FORCE (N)	PASS	FAIL
1 (GTL 5552)	0°/90°	396	X	
2 (GTL 5553)	+45°/90°	67	X	
3 (GTL 5554)	+45°/+45°	89	X	
4 (GTL 5555)	+45°/-45°	85	X	
5 (GTL 5556)	-45°/-45°	43	X	
6 (GTL 5557)	-45°/90°	45	X	
7 (GTL 5558)	-45°/+45°	22	X
