Safety Recall Circular

Code: 97V3

Subject: 2011 Jetta Sedan (6th Generation)
Converter Box Wiring

March 2011

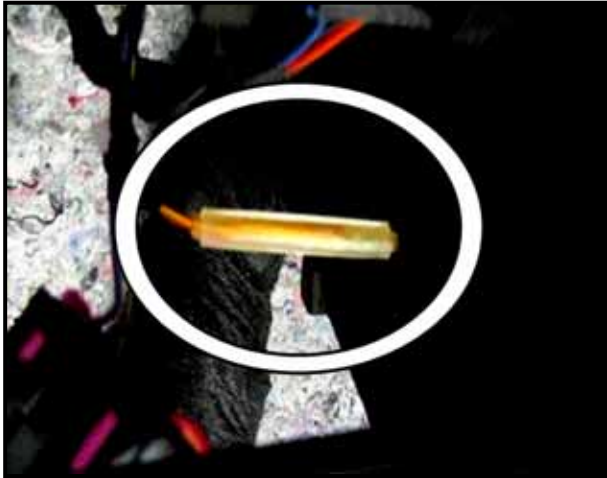
Tip: Once the repair is implemented, the wire previously removed does not serve any useful function

⇐ Cut the terminal end from the previously removed wire and install heat shrink tubing from repair kit (5C0 971 321) over the exposed end <circle> as shown

- Shrink the heat shrink tubing using the UTI-100SI Ultratorch (or equivalent) until glue starts to protrude from the end

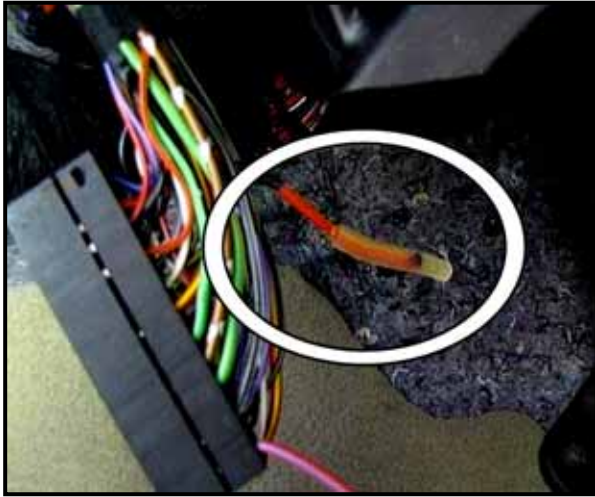
Tip: Once the repair is implemented, the wire previously removed does not serve any useful function

- ⇐ Cut the terminal end from the previously removed wire and install heat shrink tubing from repair kit (5C0 971 321) over the exposed end <circle> as shown
- Shrink the heat shrink tubing using the UTI-100SI Ultratorch (or equivalent) until glue starts to protrude from the end
- Reassemble contact housing
