**REMOTE REDESIGNED AIR BAG DEPLOYMENT INVESTIGATION
SCI TECHNICAL SUMMARY REPORT**

NASS/SCI COMBO CASE NO. 00-11-078J

VEHICLE - 1999 FORD F150 PICKUP TRUCK

CRASH DATE - JULY 2000

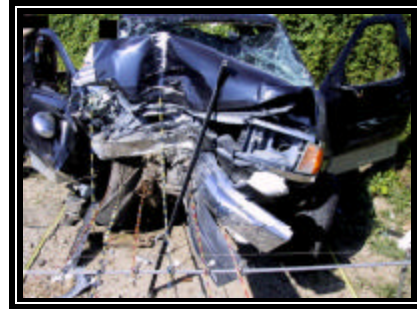
This remote investigation of NASS CDS Case No. 00-11-078J focused on a single vehicle crash that involved a 1999 Ford F150 pickup truck that was occupied by a 22-year-old male driver (**Figure 1**). The driver was not restrained by the 3-point belt system. The driver was operating the Ford pickup truck westbound on a two-lane roadway at a high rate of speed while being pursued by police. The pickup truck departed the roadway on the right side while entering a left curve. The pickup truck struck a tree with the front right area, and continued on the roadside across a driveway and lawn area. The vehicle struck a commercial sign post with the front right area and traveled across another driveway and a lawn. The driver was probably displaced from the initial impacts with the first tree and commercial sign post, but probably resumed an upright posture prior to the final impact with a large diameter tree cluster. The front area impacted the tree cluster resulting in severe damage to the pickup truck that was sufficient to deploy the redesigned air bag system. Due to the severe impact force, the driver initiated a forward trajectory and loaded the through the redesigned driver's air bag. He uniformly loaded the steering wheel and steering column which resulted in bilateral rib fractures with a right hemothorax, a right liver contusion, and a capitae fracture of the right humerus. His head flexed over the steering wheel rim and struck the windshield header which resulted in an indirect contact distraction injury of C1 with anterior ring fracture and dislocation of C1-C2, a brain stem injury with subarachnoid/subdural hemorrhage, and loss of consciousness. He was removed from the vehicle by rescue personnel and transported by ambulance to a local trauma center and admitted.

Figure 1. 1999 Ford F150 pickup truck

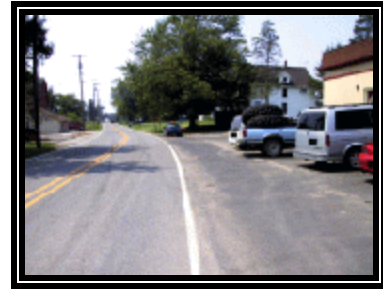
The 1999 Ford F150 pickup truck was traveling westbound on a two-lane roadway at a high rate of speed while being pursued by police. As the pickup truck entered the curve to the left, the vehicle drifted to the right and departed the roadway on the right side (**Figure 2**). The Ford pickup truck traveled onto the asphalt parking lot and then onto a lawn which had a negative slope toward the roadway. Due to the negative slope to the left, the front right undercarriage area of the pickup truck gouged the lawn (**Figure 3**).

Figure 2. Approach #1 for the pickup truck showing parking lot

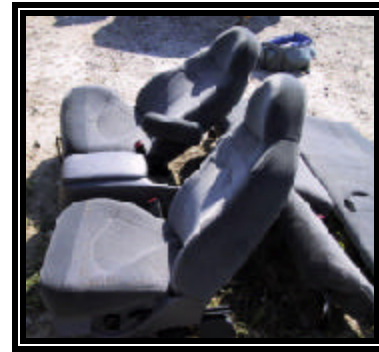
The 1999 Ford F150 pickup truck was identified by the Vehicle Identification Number (VIN): 1FTZX1726XN (production sequence omitted). The vehicle was a 4-door super cab full size 4 x 2 pickup truck with a 2.0 m (6.5') long box. The pickup truck was equipped with a 4.6 liter, 6 cylinder engine, automatic transmission, tilt steering column, and anti-lock brakes. The seating was configured with front bucket seats with integrated head restraints and a 60/40 split rear bench seat (**Figure 7**). The front and rear seats were removed from the vehicle by police. The front seating positions were equipped with manual 3-point lap and shoulder belts. The rear outboard seating positions were equipped with manual 3-point lap and shoulder belts and the rear center position was equipped with a 2-point lap belt.

Figure 7. Front and rear seats
