**REMOTE NASS/SCI COMBINATION  
SIDE IMPACT INFLATABLE OCCUPANT PROTECTION INVESTIGATION**

**VERIDIAN CASE NO. 2000-12-177J**

**VEHICLE - 2000 CHEVROLET VENTURE**

**CRASH DATE - OCTOBER 2000**

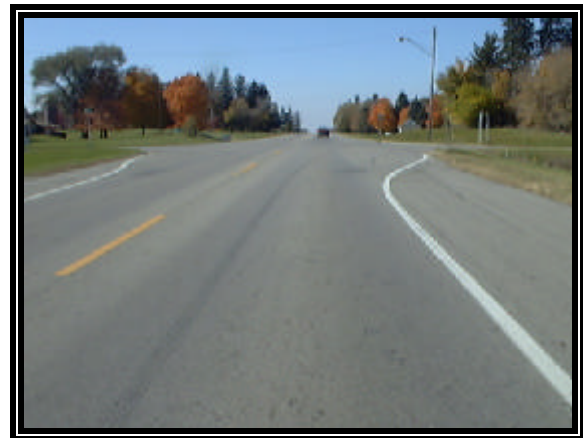
**Figure 1:** Westbound trajectory view of the 2000 Chevrolet Venture into the intersection.

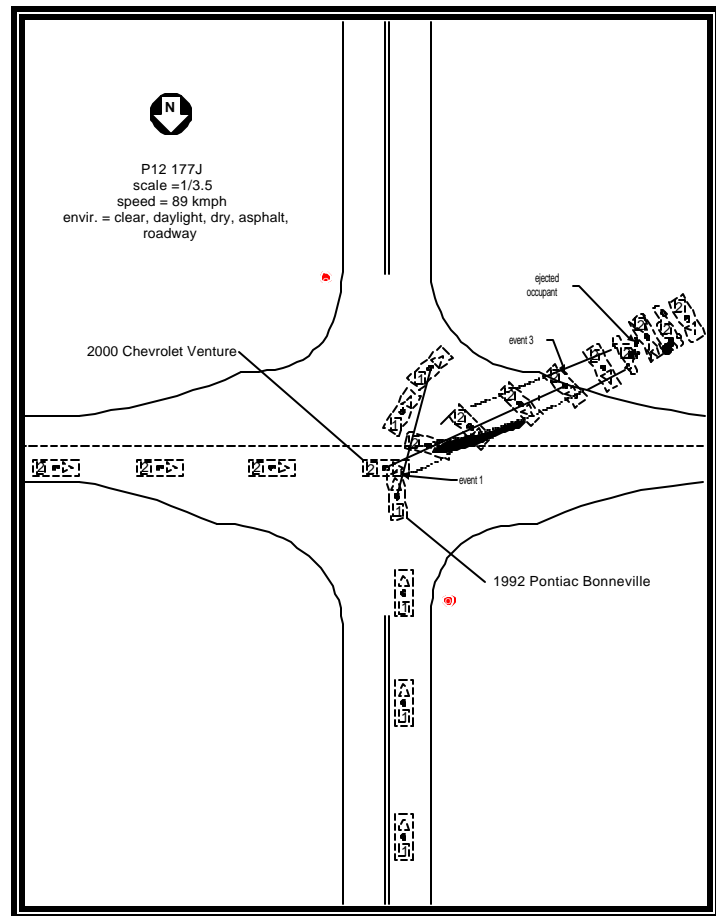
The crash occurred with the front plane of the Pontiac striking the right side plane of the Chevrolet in a 12/3 o'clock impact configuration. The direct vehicular contact occurred in the area of the Chevrolet's right front door. Refer to the crash scene schematic, **Figure 2**. The force of the impact caused the front right side impact air bag in the Chevrolet Venture to deploy from the seat back. The Venture's frontal air bags did not deploy. The delta V calculated by the Damage algorithm of the WINSMASH model was 23.4 km/h (14.5 mph). The longitudinal and lateral components were -11.7 km/h (-7.3 mph) and -20.3 km/h (-12.6 mph), respectively. The barrier equivalent speed was 35.6 km/h (22.1 mph). The Collision Deformation Classification (CDC) coded by the researcher was 02-RYEW-4.

**Figure 2:** Crash schematic.

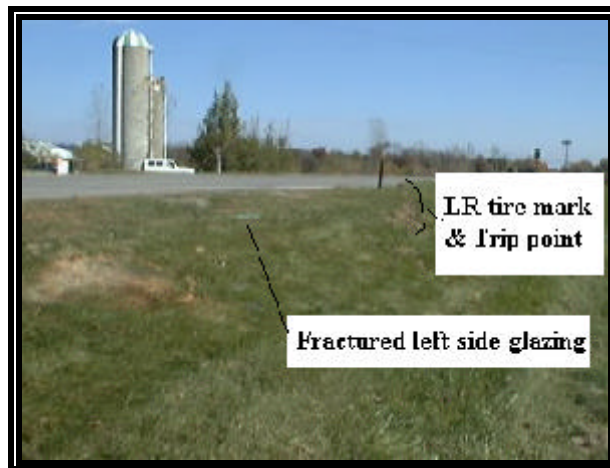
right front of the Chevrolet. Additional evidence documented during the NASS investigation included a large fluid spill and a series of tire marks along the Chevrolet's southwest trajectory. The Chevrolet slid laterally across the center line, through the eastbound traffic lane and into the southwest quadrant of the intersection over a 22 m (72 ft) distance. The Chevrolet had also rotated clockwise approximately 45 degrees. Upon leaving the pavement, the vehicle began to furrow on the sloping earthen shoulder with its left side tires. The vehicle tripped and initiated a left side leading roll. The Chevrolet rolled 4 quarter turns, coming to rest on its wheels. The roll sequence was evidenced by the furrow and the fractured left side window glazing. During the roll sequence, the unrestrained 10 year old female passenger was ejected through the left side window. **Figure 3** is a look back view from the area of the Chevrolet's final rest toward the intersection.

**Figure 3:** Look back view from the Chevrolet's final rest toward the intersection.
