**VERIDIAN REMOTE KNEE BOLSTER AIR BAG DEPLOYMENT INVESTIGATION
SCI TECHNICAL SUMMARY REPORT**

NASS/SCI COMBO CASE NO. 00-41-152C

VEHICLE - 2000 KIA SPORTAGE

CRASH DATE - SEPTEMBER 2000

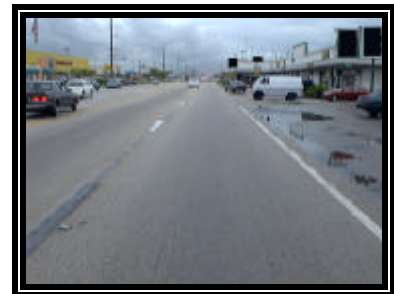
Figure 2. Southbound approach for the Kia Sportage

The driver of the Kia Sportage was operating the vehicle southbound on the outboard travel lane on approach to the four-leg intersection (**Figure 2**). The front right passenger stated in an interview that the approximate pre-impact travel speed was 56 km/h (35 mph). The 1998 Ford Van was traveling northbound in the inboard lane on approach to the four-leg intersection. The van traveled into the center left-turn lane with the intent to turn left onto the east/west roadway (**Figure 3**). The driver of the Ford van initiated a left turn across the path of the Kia Sportage. The driver of the van stated that he estimated his pre-impact travel speed to have been 56 km/h (35 mph). There were no skid marks in either vehicle's trajectory indicative of pre-crash braking. The front right passenger of the Kia Sportage stated that the driver of the Sportage did not attempt any avoidance maneuver prior to the crash.
