On-scene Advanced Occupant Protection Systems
Dynamic Science, Inc. / Case Number: DS00-018
2000 Ford Taurus SE 4-door
Texas
June, 2000

1. Report No. DS00-018		2. Government Accession No.		3. Recipient Catalog No.	
4. Title and Subtitle In-Depth Accident Investigation				5. Report Date .

**Dynamic Science, Inc.
Accident Investigation
Case Number: DS00-018**

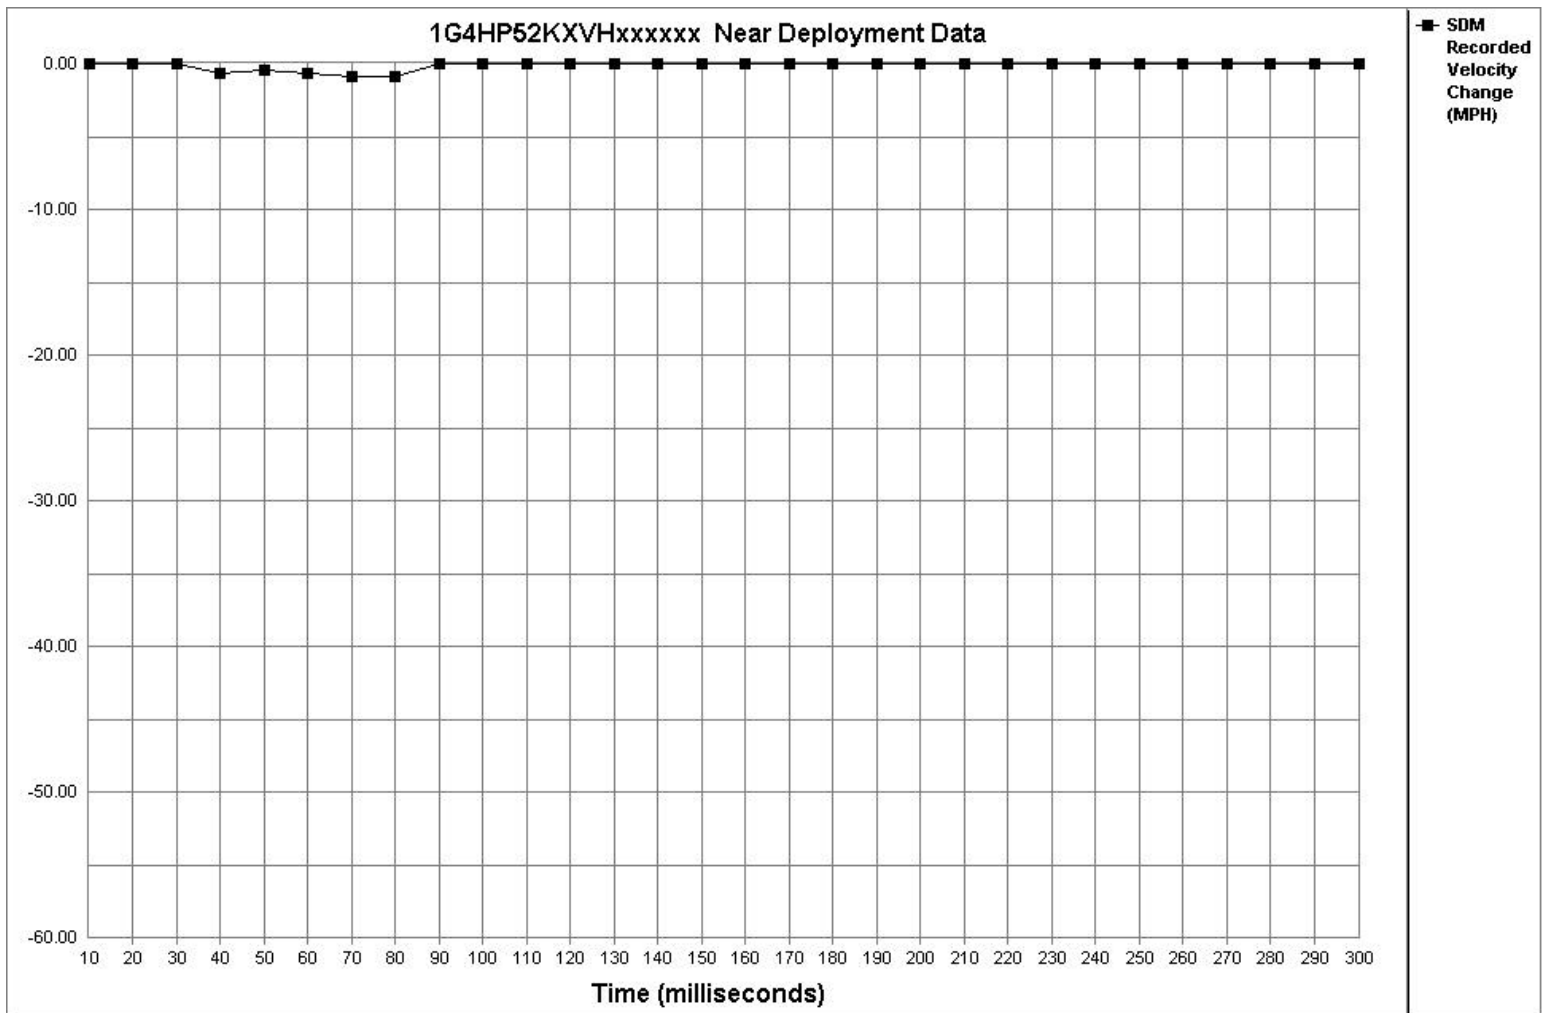
Attachment 2. SDM Report (Buick)

SIR Warning Lamp Status	OFF
Driver's Belt Switch Circuit Status	BUCKLED
Passenger Front Air Bag Suppression Switch Circuit Status	Air Bag Not Suppressed
Ignition Cycles At Near Deployment	7301
Ignition Cycles At Investigation	7318
Algorithm Enable to Maximum SDM Recorded Velocity Change (msec)	62.5
Maximum SDM Recorded Velocity Change (MPH)	-0.88
A Deployment was Commanded Prior to this Event	No

Time (milliseconds)	10	20	30	40	50	60	70	80	90	100	110	120	130	140	150
Recorded Velocity Change (MPH)	0.00	0.00	0.00	-0.66	-0.44	-0.66	-0.88	-0.88	0.00	0.00	0.00	0.00	0.00	0.00	0.00
Time (milliseconds)	160	170	180	190	200	210	220	230	240	250	260	270	280	290	300
Recorded Velocity Change (MPH)	0.00	0.00	0.00	0.00	0.00	0.00	0.00	0.00	0.00	0.00	0.00	0.00	0.00	0.00	0.00
