ON-SITE ADAPTIVE CONTROL-EQUIPPED VEHICLE INVESTIGATION

CASE NUMBER - IN00-018
LOCATION - INDIANA
VEHICLE - 1997 DODGE RAM 2500
CRASH DATE - October, 2000

March 11, 2003

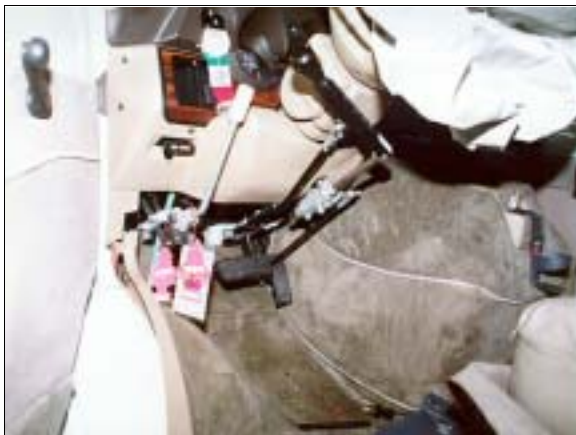
Figure 9: Case vehicle’s driver seating area viewed from driver’s door sill area showing vehicle’s adaptive equipped hand controls for parking brake and brake and throttle controls (case photo #39)

Because the driver was paraplegic, the case vehicle was equipped with several adaptive controls designed specifically for drivers with disabilities. A **Mobility Products & Design** 3500 series hand control was used for both the brake and throttle controls and, in addition, a **Mobility Products & Design** raised parking brake handle was added (**Figures 9** through **11** above). Also installed was a **Ricon** six-way, power seat base (**Figure 12** above and **Figure 13**). This contractor's inspection of these adaptive controls showed no evidence of malfunction. The driver's interview confirmed this contractor's assessment of these items. The case vehicle was also equipped with a wheelchair lock-down (see **SELECTED PHOTOGRAPHS, Figure 16** below), a **Ricon** internal power swing-door operator, and a **Ricon Personal Use** wheelchair lift (see **SELECTED PHOTOGRAPHS, Figure 17** below). According to the interview with the case vehicle's driver, the adaptive controls did not affect the vehicle's control loss.

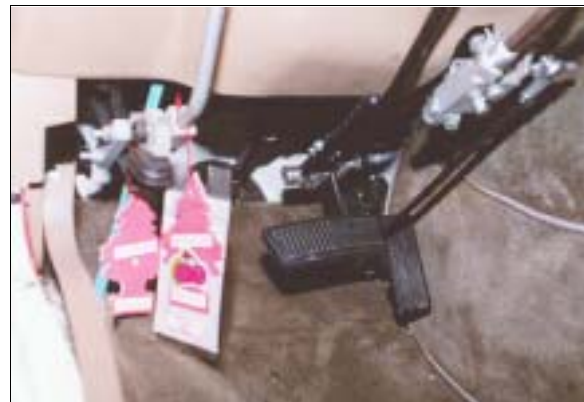
Figure 10: Close-up from left of center of case vehicle’s adaptive equipped control linkages for parking brake and brake and throttle controls (case photo #41)

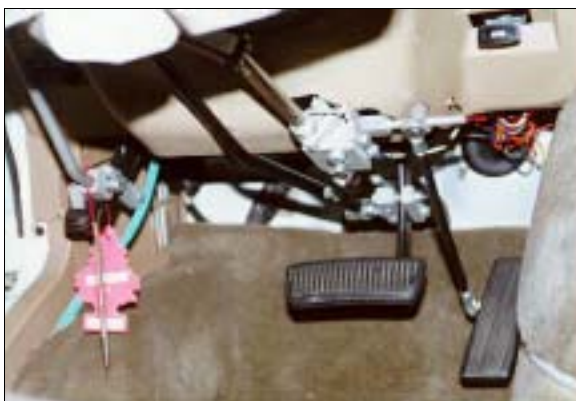
Figure 11: Close-up from right of center of case vehicle’s adaptive equipped hand control linkages for parking brake and brake and throttle controls (case photo #42)

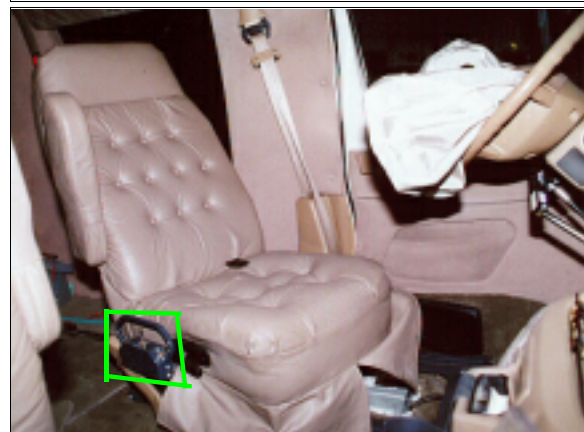
Figure 12: Case vehicle’s driver seat showing seat’s six-way powered hand controls (highlighted) along right side of seat; Note: deployed driver’s air bag and three-point safety belt system (case photo #47)

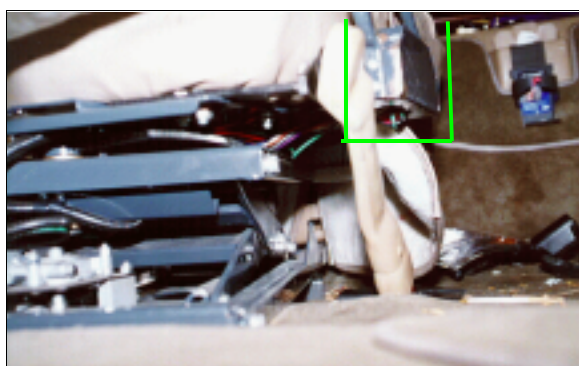
Figure 13: Close-up from floor level of case vehicle's driver seat showing (highlighted) six-way power control unit and seat belt post (case photo #49)

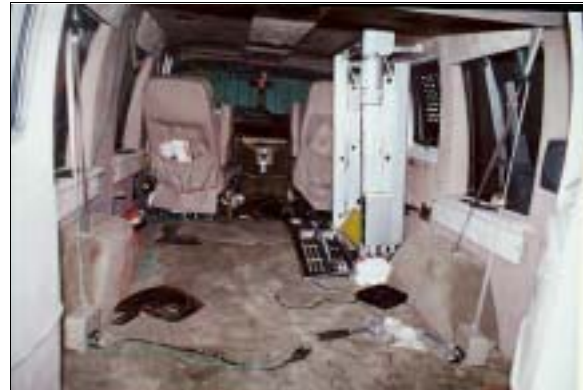
The case vehicle's departure off the west edge of the roadway and down a short incline had no effect on the unrestrained driver's torso. When the driver steered sharply to the left, attempting to get his vehicle back onto the roadway, his over-corrective steering maneuver combined with the nonuse of his available safety belts, resulted in the driver moving to his right while the case vehicle traveled transversely across the roadway. There was extra weight on the case vehicle's right side from the vehicle's wheelchair lift and power swing doors (**Figure 15** and see **SELECTED PHOTOGRAPHS, Figure 17** below). This extra weight may have caused the vehicle to tip further

Figure 15: Case vehicle's interior "cargo area" viewed from back showing wheelchair lift and powered right side doors (case photo #59)

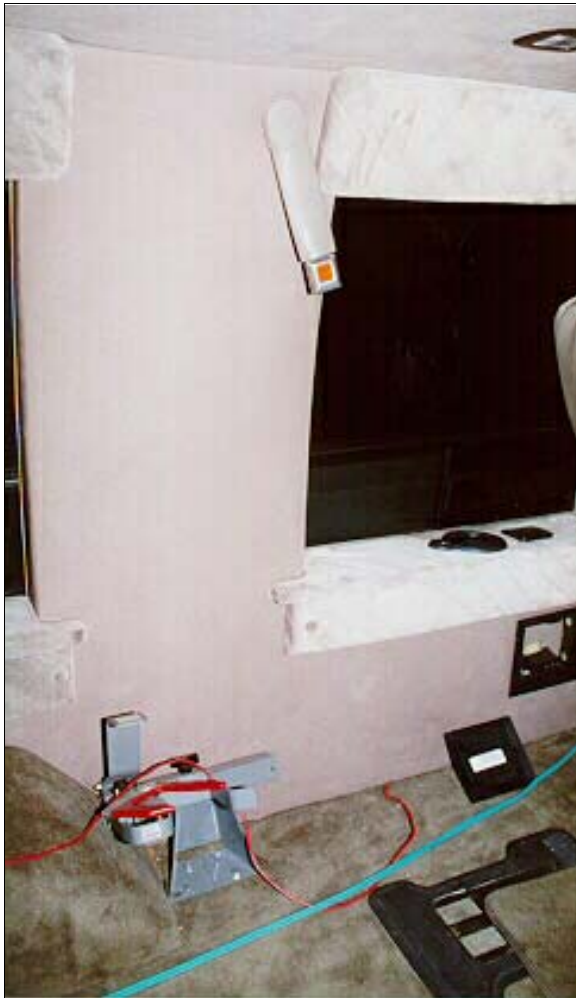
Figure 16: Case vehicle's floor mounted, wheelchair lock-down system located behind driver's seat and forward of left rear wheel well (case photo #60)
