ON-SITE CHILD AIR BAG-RELATED FATALITY INVESTIGATION

CASE NUMBER - IN00-019
LOCATION - TEXAS
VEHICLE - 1996 FORD CONTOUR GL
CRASH DATE - December, 2000

IN00-019

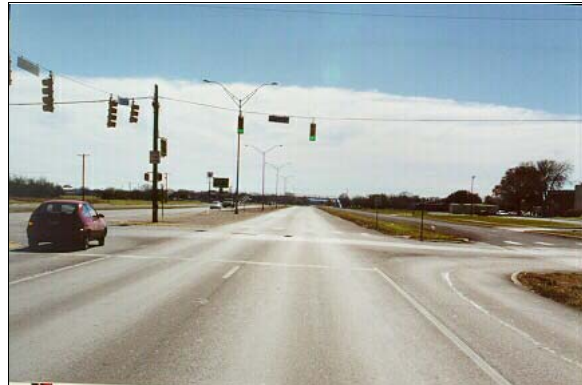
Figure 1: Case vehicle's southward travel path in inside through lane of southbound roadway prior to entering intersection; Note: frontage road on right (case photo #02)

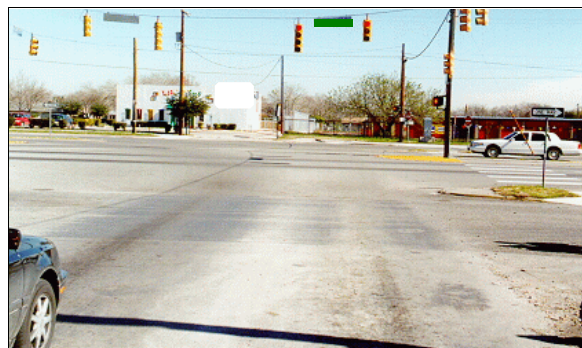
Figure 2: Chevrolet pickup's eastward travel path across first, southbound frontage road, and second, across southbound roadway of state highway (case photo #08)

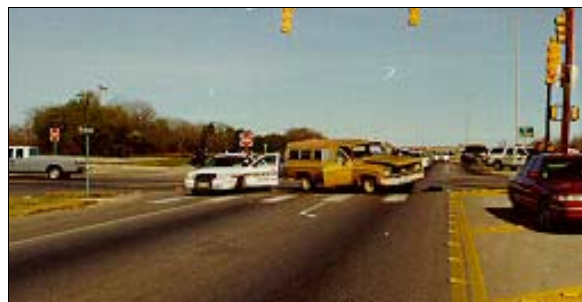
Figure 3: On-scene view looking north in southbound roadway at final rest positions of case vehicle and Chevrolet pickup; Note: case vehicle is hidden behind pickup (case photo #79)

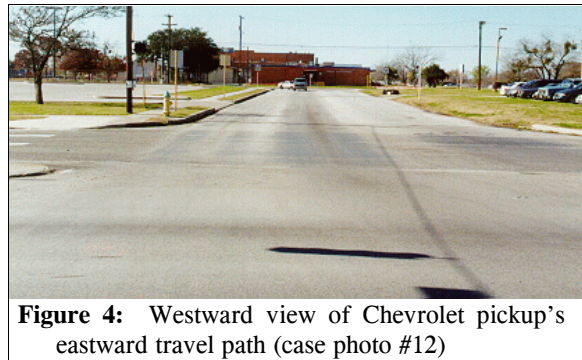
Figure 4: Westward view of Chevrolet pickup’s eastward travel path (case photo #12)

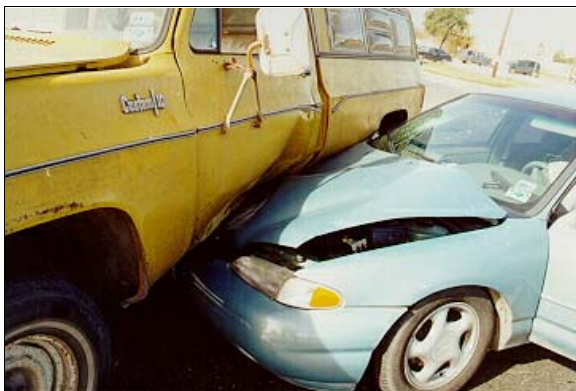
Figure 5: On-scene westerly view of case vehicle and Chevrolet pickup at final rest (case photo #78)

The front of the case vehicle impacted the left side of the Chevrolet pickup (**Figures 5 and 6**), causing the case vehicle’s driver and front right passenger supplemental restraints (air bags) to deploy (**Figure 7** below). Upon impact the case vehicle’s front underrode the Chevrolet

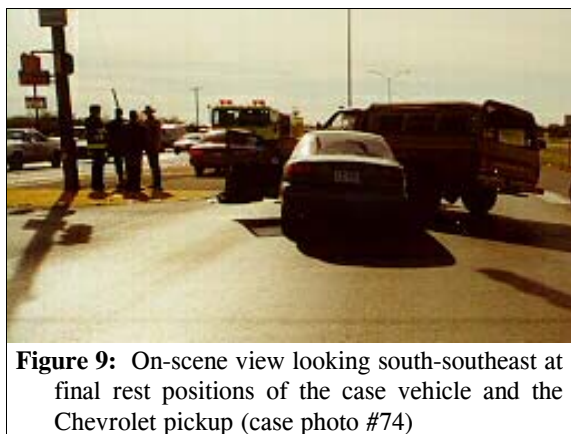
Figure 9: On-scene view looking south-southeast at final rest positions of the case vehicle and the Chevrolet pickup (case photo #74)

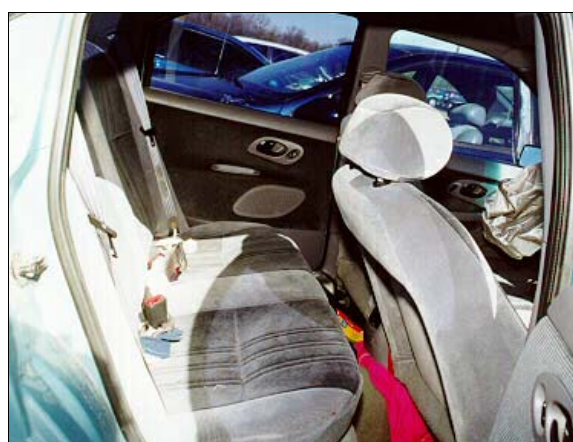
The case vehicle’s back left passenger [7-year-old, White (Hispanic) male; 122 centimeters and 25 kilograms (48 inches, 55 pounds)] was seated in an upright posture with his back against the seat back and his feet hanging down over the front edge of the seat’s cushion; however, the exact position of his hands is unknown. His seat track and seat back were not adjustable (**Figure 18**).

Figure 18: Case vehicle’s back seating area viewed from outside right rear door showing where back left (7-year-old) and back right (9-year-old) passengers were seated; Note: front right seat was positioned at rearmost location at time of inspection (case photo #55)
