VERIDIAN ON-SITE AIR BAG NON-DEPLOYMENT INVESTIGATION

NASS/SCI COMBO CASE NO. 2001-12-116A

VEHICLE - 2000 GMC SONOMA PICKUP TRUCK

CRASH DATE - JULY, 2001

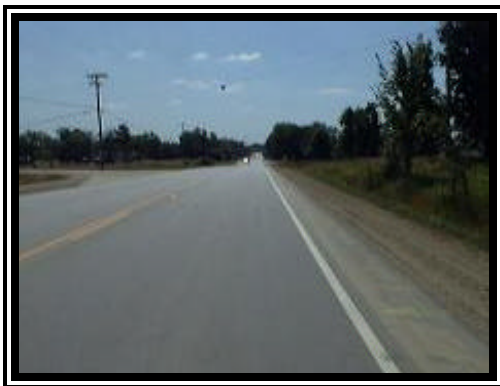
Figure 1. Southbound approach view for the 1995 Lincoln Mark VIII (V3) and the 2000 GMC Sonoma pickup truck (V2).

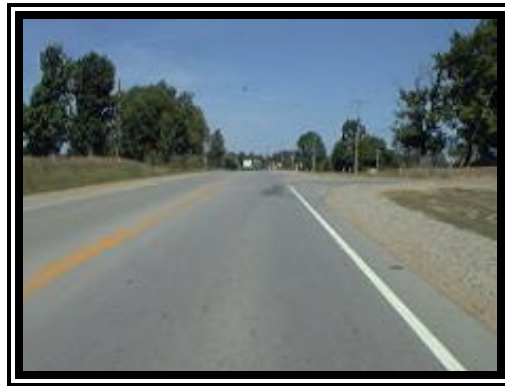
Figure 2. Northbound approach view for the 1989 Oldsmobile Delta 88 (V1).

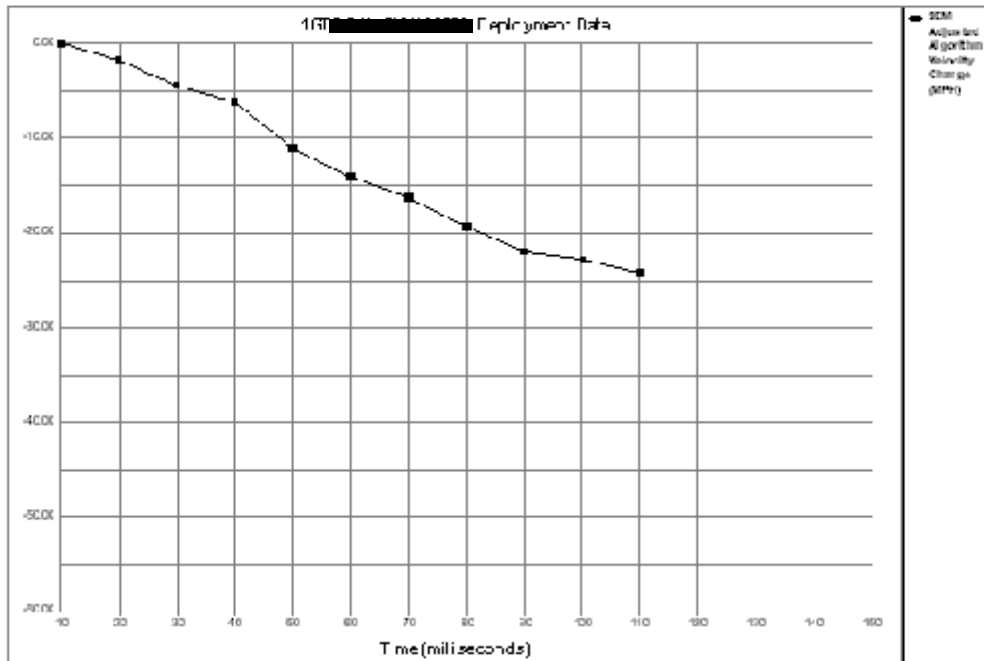
Time (milliseconds)	10	20	30	40	50	60	70	80	90	100	110	120	130	140	150
Adjusted Algorithm Velocity Change	0.00	-1.76	-4.39	-6.14	-10.57	-14.34	-16.24	-19.31	-21.94	-22.82	-24.15	N/A	N/A	N/A	N/A

Figure 11. 2000 GMC Sonoma EDR report (deployment event).

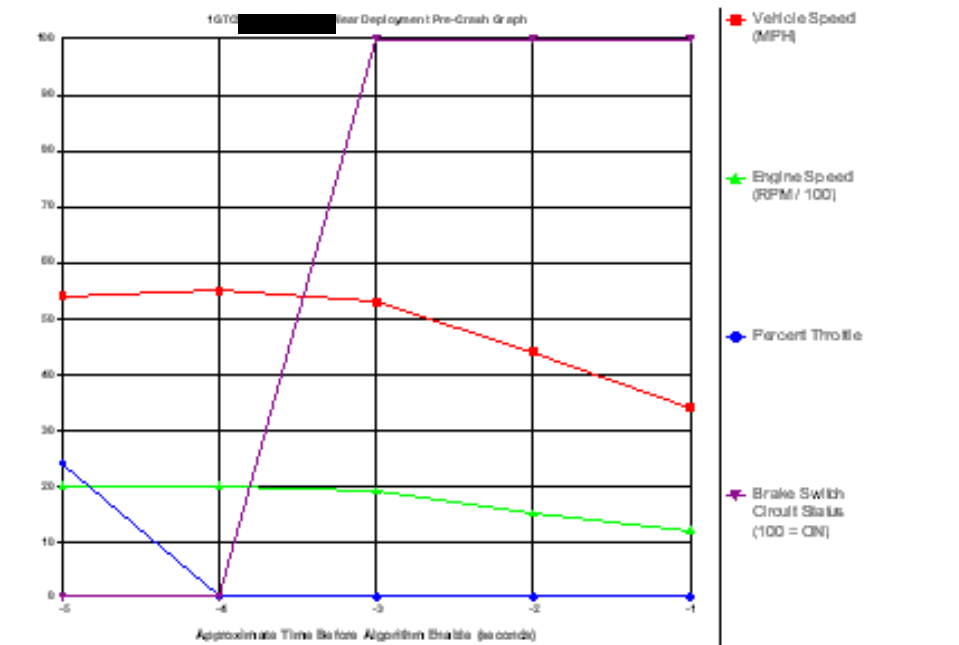
Seconds Before AE	Vehicle Speed (MPH)	Engine Speed (RPM)	Percent Throttle	Brake Switch Circuit Status
-5	54	1984	24	OFF
-4	55	1984	0	OFF
-3	53	1856	0	ON
-2	44	1536	0	ON
-1	34	1152	0	ON

Figure 12. 2000 GMC Sonoma pickup truck EDR report (near deployment event).
