SCI/NASS COMBINATION CASE REPORT

CASE NUMBER - NASS-2001-73-041B

VEHICLE - 1994 GMC SAFARI

CRASH DATE - March 2001

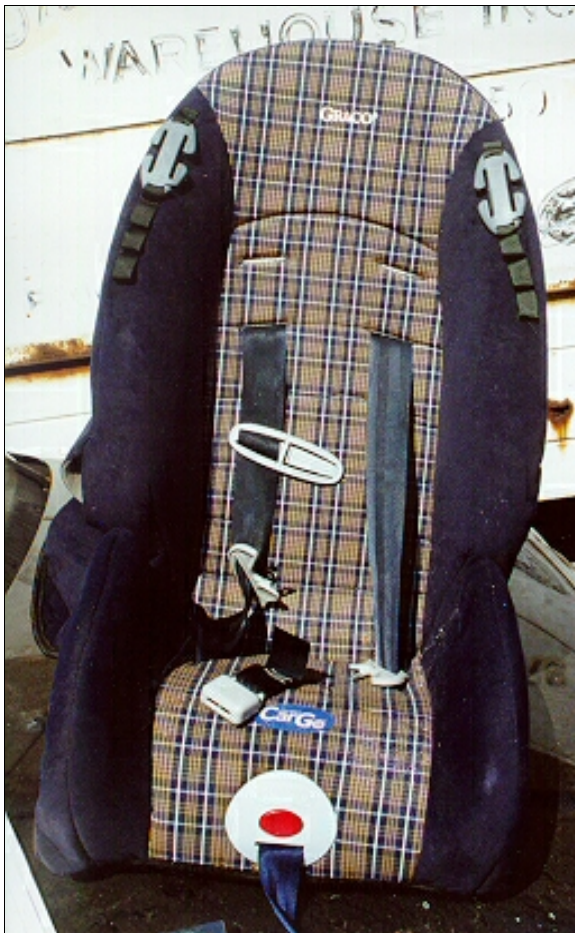
Only the left-seated 4-year-old female's FFCSS was available to be inspected, because she got out of the seat when she was removed from the case vehicle and the seated stayed in the minivan (**Figures 9 and 10**). (The right-seated 2-year-old male was removed from the case vehicle and was transported to the hospital in his FFCSS, which was discarded by the hospital.)

Figure 9: Front of Graco FFCSS used by case vehicle's second seated left passenger
