ON-SITE AIR BAG INVESTIGATION

CASE NUMBER - IN01-004
LOCATION - ARIZONA
VEHICLE - 2000 CHEVROLET CORVETTE
CRASH DATE - February, 2001

1. <i>Report No.</i> IN01-004		2. <i>Government Accession No.</i>		3. <i>Recipient's Catalog No.</i>	
4. <i>Title and Subtitle</i> On-Site Redesigned Air Bag Investigation Vehicle - 2000 Chevrolet Corvette Location - Arizona			5. <i>Report Date:</i> January 30, 2002; April 23, 2002

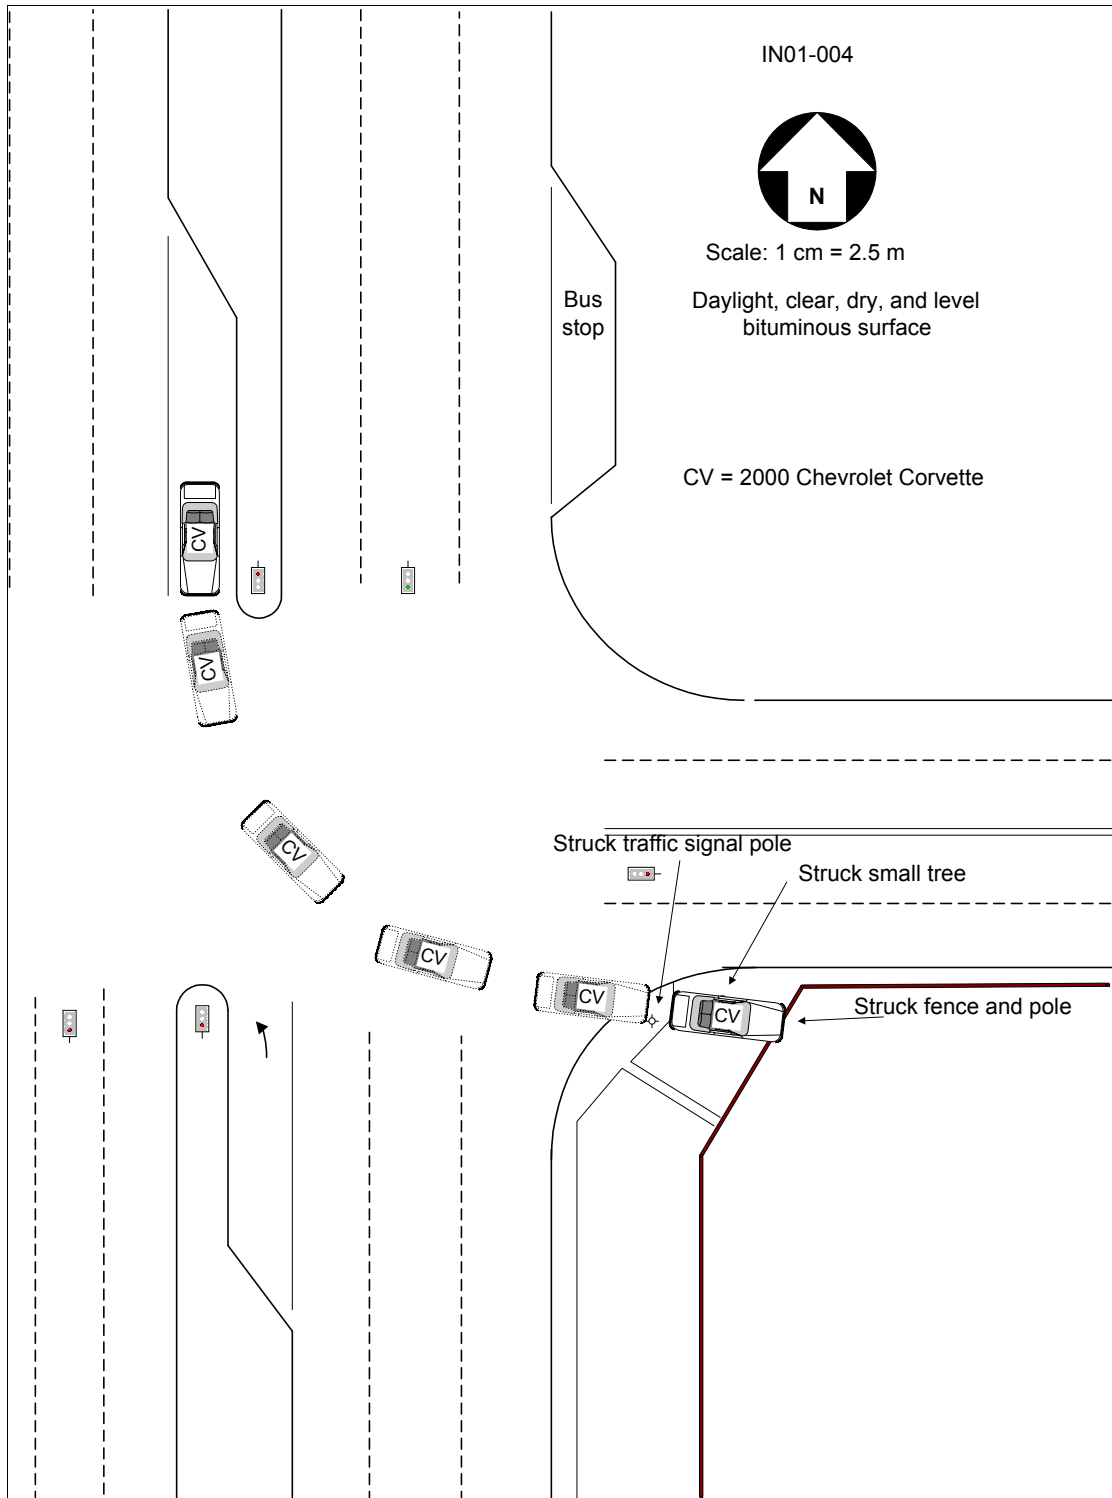
Figure 17: The case vehicle sustained a velocity change of approximately 9.5 km.p.h. (5.9 m.p.h.) during the first 150 milliseconds after deployment
