ON-SITE AIR BAG INVESTIGATION

CASE NUMBER - IN01-010
LOCATION - Illinois
VEHICLE - 1996 PLYMOUTH VOYAGER
CRASH DATE - April 2001

1. Report No. IN01-010		2. Government Accession No.		3. Recipient's Catalog No.	
4. Title and Subtitle On-Site Air Bag Fatality Investigation Vehicle - 1996 Plymouth Voyager Location - Illinois			5. Report Date: July 1, 2002

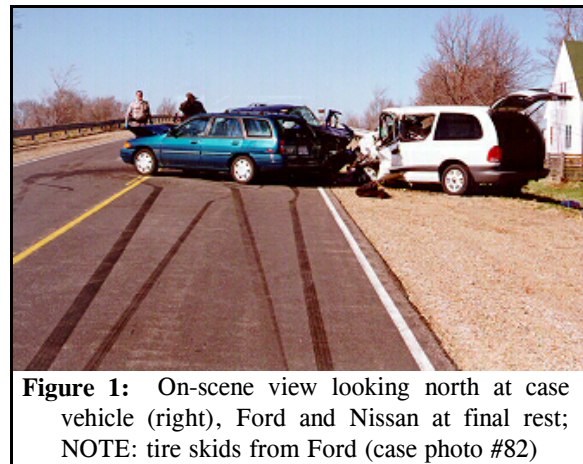
the case vehicle, and the Ford Escort (3rd other vehicle) was traveling north in the northbound lane, behind the case vehicle, both intending to continue traveling northbound. The roadway was relatively new asphalt, with wide gravel shoulders (**Figure 1**). The travel lanes were divided by a solid yellow painted line for northbound traffic and a broken yellow painted line for southbound traffic, with solid white edge lines along both roadway edges. It was daylight, the weather was clear, the roadway was without defects and the speed limit was 86 km.p.h. [55 m.p.h.]. The Police Crash Report notes that it was windy, with breezes at 42 km.p.h. [26 m.p.h.] from the southwest, gusting to 64 km.p.h. [40 m.p.h.]. The surrounding area was flat, open farmland and the roadway was generally level and straight. The stretch of road immediately north of the crash site, however, was an overpass, with W-beam guardrails along the outside of the shoulder on both sides of the built-up slope. The grade was measured as 3.5 percent, positive for northbound traffic. The coefficient of friction is estimated as 0.70 for the relatively new bituminous road surface.

The southbound Nissan pickup was traversing the overpass, having just crested the rise and beginning the downhill slope. The northbound Oldsmobile was just beginning to travel up the slope when the Nissan came over the centerline. The police investigators speculated that the gusting wind may have caused a problem for the Nissan's driver, but there was insufficient evidence to support a definitive conclusion as to whether the wind gusts were strong enough to push the Nissan sideways. The front left corner and left side of the Nissan impacted the left side of the Oldsmobile (event #1) in a shallow, swiping-type engagement, with the Nissan's front left corner snagging and tearing off the Oldsmobile's left rear wheel and tire. The Oldsmobile rotated counterclockwise approximately 180 degrees and came to rest 36.4 meters [120 feet] north of the point of impact, on the east gravel shoulder heading south. The sideswipe caused the Nissan to go into a slight counterclockwise yaw while continuing to travel south in the northbound lane, where it impacted the case vehicle approximately 27 meters [90 feet] south of the first impact (event #2). The case vehicle and the Nissan both were rotating counterclockwise when the front of the Ford struck the right rear side of the Nissan (event #3) (**Figures 1 and 2**).
