On-scene Investigation / Vehicle versus Power Pole
Dynamic Science, Inc. / Case Number: DS01-011
2001 Toyota Prius Hybrid
California
March, 2001

1. Report No. DS01-011		2. Government Accession No.		3. Recipient Catalog No.	
4. Title and Subtitle In-Depth Accident Investigation				5. Report Date	
				6. Performing Organization Report No.

Dynamic Science, Inc.
Accident Investigation
Case Number:DS01-011

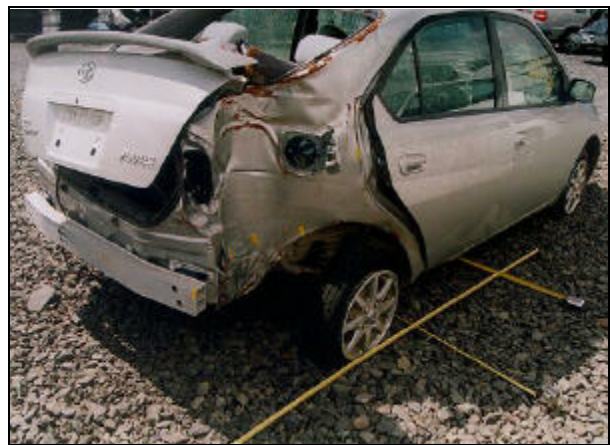
Damage Description: Severe lateral crush to the right rear fender beginning just forward of the right rear axle and extends rearward to the right rear bumper corner. Both rear door jammed shut. Rear left door forced open by investigator. Minor longitudinal intrusion of the 2nd seat back.

Total	29.0 km/h (18.0 mph)
Longitudinal	0.0 km/h (0.0 mph)
Latitudinal	-29.0 km/h (-18.0 mph)
Energy	139,370 joules (102,794 ft-lbs)
