On-scene Investigation / Vehicle to Vehicle  
Dynamic Science, Inc. / Case Number: DS01-012  
2001 Toyota Prius  
California  
March, 2001

**Dynamic Science, Inc.**  
**Accident Investigation**  
**Case Number:DS01-012**

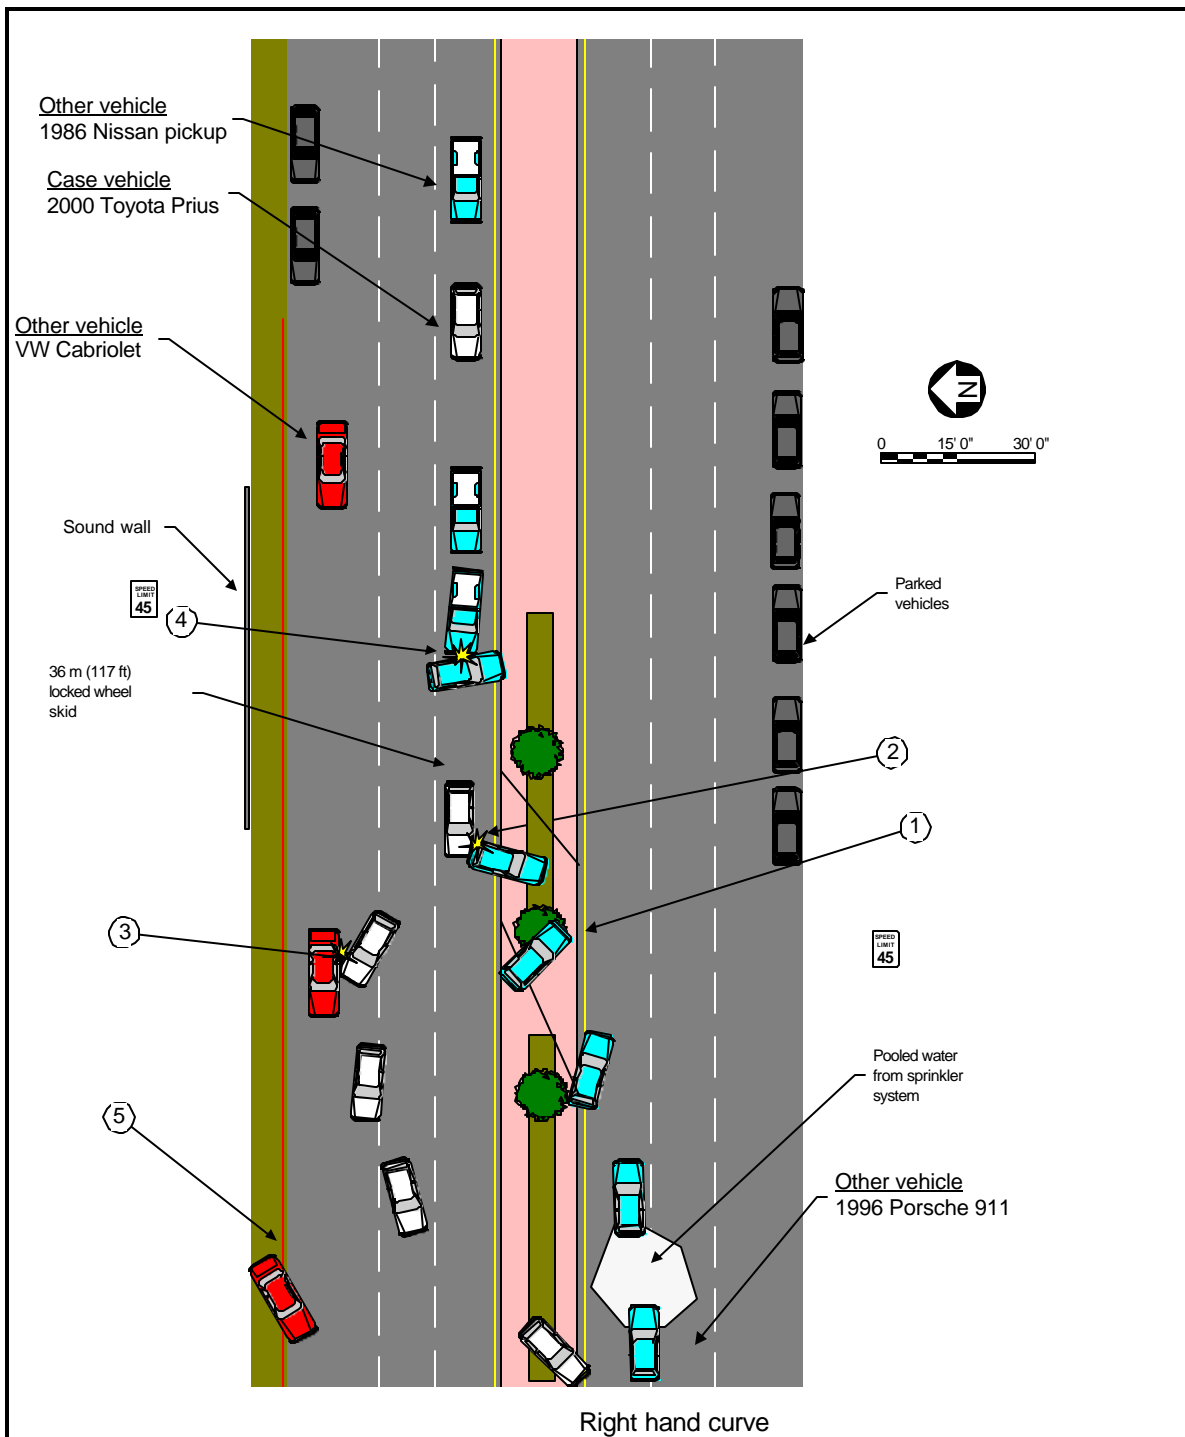
Figure 3. Scene diagram

<b>COLLISION MEASUREMENTS</b>						
<b>Reference point:</b>	Break in median					
<b>Reference line:</b>	Median edge					
<b>Data Point</b>	<b>Distance and Direction from RP</b>			<b>Distance and Direction from RL</b>		
	ft	m	d	ft	m	d
End skid A (Porsche)	56	17	W	15	4.5	S
Tree 1	59	17.9	W	7.5	2.3	S
Start skid A (Porsche)	74	22.5	W	0	0	S
End skid B (Porsche)	84	25.6	W	15	5.5	S
Tree 2	89	27.1	W	7.5	2.3	S
Start skid B (Porsche)	120	36.6	W	0	0	S
