**VERIDIAN REMOTE SIDE IMPACT INFLATABLE
OCCUPANT PROTECTION SYSTEM INVESTIGATION
VERIDIAN CASE NO. CA01-021
VEHICLE: 2000 BMW 328Ci
LOCATION: NEW JERSEY
CRASH DATE: DECEMBER 2000**

Contract No.
DTNH22-94-D-07058

<p>14. <i>Sponsoring Agency Code</i></p>	
<p>15. <i>Supplementary Notes</i> Remote investigation of a side impact crash that involved a 2000 BMW 328Ci.</p>			
<p>16. <i>Abstract</i> This remote investigation focused on the performance of the side impact inflatable occupant protection system of a 2000 BMW 328Ci, 2-door coupe that was involved in a single vehicle run-off-road crash with breakaway luminaire pole. The impact was located on the driver's door and deployed the door mounted side impact air bag and the Head Protection System (HPS), tubular head air bag. The driver sustained multiple abdominal injuries and pelvic fractures. He was admitted to a regional trauma center for six days for treatment of his injuries.</p>			
<p>17. <i>Key Words</i> Remote investigation Side impact air bag deployment Head Protection System (HPS)</p>		<p>18. <i>Distribution Statement</i> General Public</p>	
<p>19. <i>Security Classif. (of this report)</i> Unclassified</p>	<p>20. <i>Security

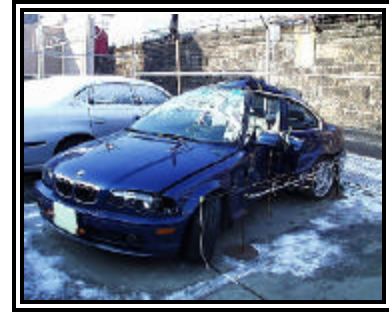
This remote investigation focused on the performance of the side impact inflatable occupant protection system of a 2000 BMW 328Ci (**Figure 1**), 2-door coupe that was involved in a single vehicle run-off-road crash with breakaway luminaire pole. The impact was located on the driver's door and deployed the door mounted side impact air bag and the Head Protection System (HPS), tubular head air bag. The driver sustained multiple abdominal injuries and pelvic fractures. He was admitted to a regional trauma center for six days for treatment of his injuries.

Figure 1. Overall view of the BMW 328Ci.

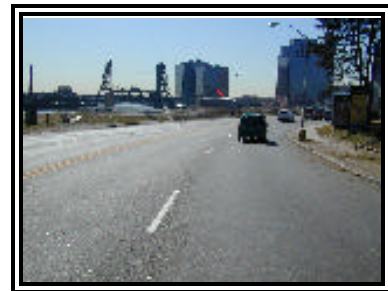
The crash occurred on a four lane road in a commercial area during nighttime hours (**Figure 2**). In the vicinity of the crash site, the roadway curved to the right with respect to the BMW's path of travel. The asphalt road surface was wet with a posted speed limit of 56 km/h (35 mph). Although the environmental surfaces were wet, the police report noted that the weather was clear and the area was lit by overhead luminaires. The edges of the road were bordered by shallow barrier curbs and concrete sidewalks. The struck luminaire was located outboard of the sidewalk on a grassy area that was level to the roadway. The luminaire consisted of a frangible base with an aluminum pole and a mast arm with the light fixture that extended over the road edge. The travel lanes were delineated by broken white lane lines and a double yellow center line.

Figure 2. Southbound approach of the BMW.
