**TRANSPORTATION SCIENCES
CRASH DATA RESEARCH CENTER**

**VERIDIAN ON-SITE ADVANCED OCCUPANT
PROTECTION SYSTEM STUDY (AOPSS) AND SIDE IMPACT
OCCUPANT PROTECTION INVESTIGATION**

VERIDIAN CASE NO. CA01-028

**VEHICLES - 2000 FORD TAURUS LX
2001 BMW 325xi**

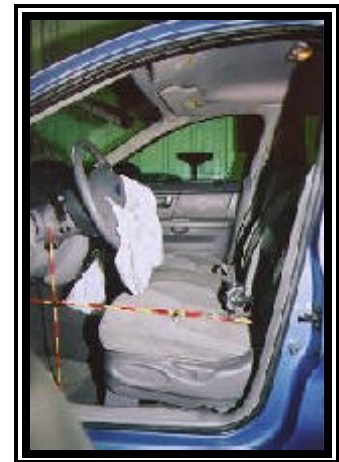
Figure 10. Interior view of the 2000 Ford Taurus LX.

At impact, the driver initiated a forward trajectory in response to the 12 o'clock impact force and loaded the manual restraint resulting in a small contusion to the right mid-lateral chest area. This injury mechanism was evidenced by the location of the injury relative to the placement of the shoulder harness diagonally across the chest. She also sustained a small thermal burn to the posterior aspect of the right forearm from venting driver air bag gases. This injury mechanism was evidenced by the driver's stated placement of the right hand at the 5 o'clock position on the steering wheel rim pre-crash, which exposed the posterior aspect of the forearm to the adjacent

air bag vent port during the deployment sequence. The driver reported that the burn mark went completely through the sweater and long sleeve blouse (not charred), however, she referred to the injury as more of a “welt” or “mosquito bite”. She also complained of facial skin irritation post-crash, which was treated (with a towel and saline solution) by ambulance personnel. She refused further treatment. The Advanced Occupant Protection System provided adequate protection against further contact to the steering wheel hub/rim, thus preventing serious injury.

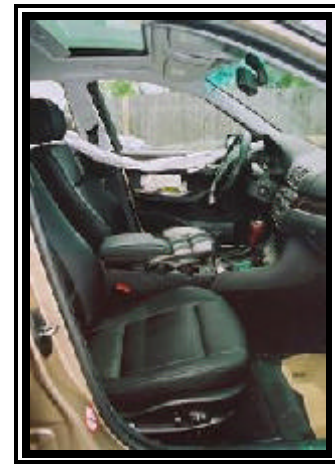
The 17 year old female driver of the 2001 BMW 325xi was restrained by the available 3-point manual lap and shoulder belt system, and seated in an upright posture (out-of-position) leaned slightly forward with her head turned left to observe on-coming traffic. Her hands were placed at the 10 o’clock and 2 o’clock positions on the steering wheel rim. The seat track was adjusted to a mid-to-forward position with the seat back angled 15 degrees off vertical (**Figure 11**).

At impact, the driver initiated a lateral trajectory in response to the 9 o’clock impact force. Her head loaded the deployed head protection air bag and the lateral aspect of her torso loaded the deployed thorax side impact air bag. She sustained bilateral contusions to the medial (inside) aspect of the knees which was probably an indirect result of *lateral* knee contact to the left front door panel (knees “knocking” together). The BMW driver did not seek treatment for her injuries. The deployed head and thorax air bags provided adequate protection against direct contact to left side components, thus preventing potential injury.

Figure 11. Interior view of the 2001 BMW 325xi.
