**VERIDIAN ON-SITE ADAPTIVE AND EVENT DATA  
RECORDER (EDR) EQUIPPED VEHICLE INVESTIGATION**

**VERIDIAN CASE NO. CA01-036**

**VEHICLE - 2000 CHEVROLET G2500 EXPRESS VAN**

**CRASH DATE - JUNE, 2001**

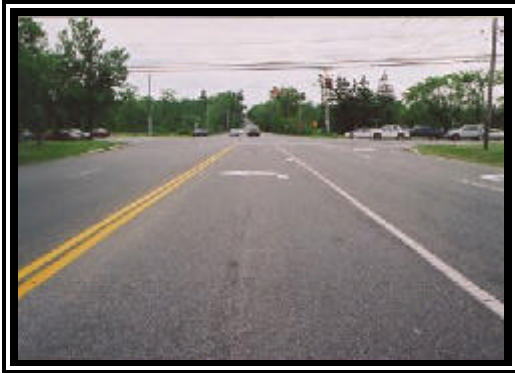
The 16 year old female driver of the 1998 Mazda 626 was operating the vehicle southbound (**Figure 1**) when she approached the 4-leg intersection and came to a stop in anticipation of a left turn (east). The driver failed to observe the northbound Chevrolet as she initiated the left turn at a (police reported) speed of 16 km/h (10 mph).

**Figure 1. Southbound approach for the 1998 Mazda 626.**

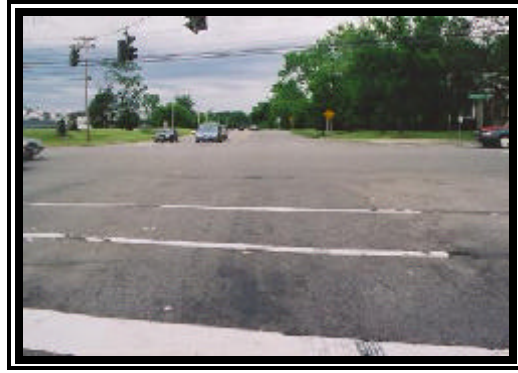
The 58 year old male driver of the 2000 Chevrolet G2500 Express van was operating the vehicle northbound (**Figure 2**) at a (police reported) speed of 72 km/h (45 mph) when he proceeded through the 4-leg intersection and observed the Mazda cross his path of travel. The police reported no pre-impact tire marks at the scene indicative of driver avoidance maneuvers.

**Figure 2. Northbound approach for the 2000 Chevrolet Express van.**
