**VERIDIAN ON-SITE SIDE IMPACT OCCUPANT PROTECTION
INVESTIGATION**

VERIDIAN CASE NO. CA01-041

VEHICLE - 2001 VOLKSWAGEN JETTA

CRASH DATE - FEBRUARY, 2001

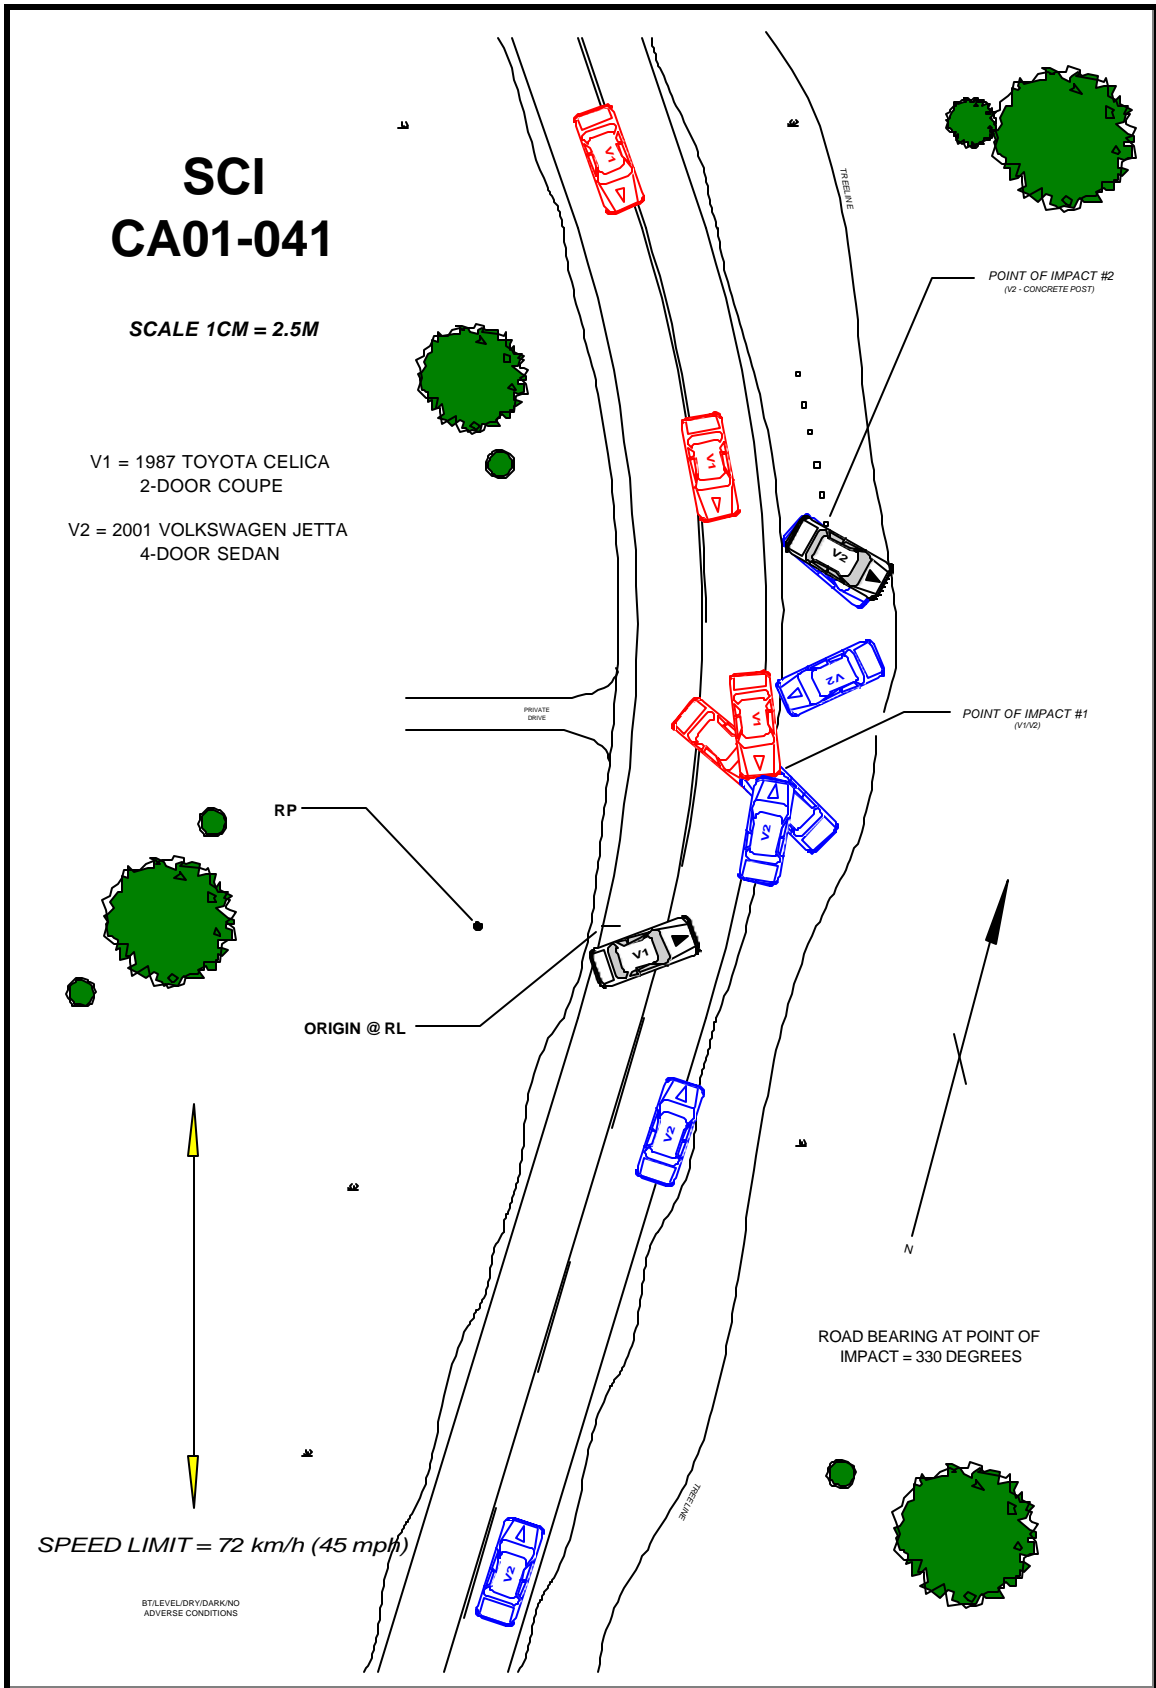
Figure 11. Scene Diagram.

This two vehicle crash occurred during the evening hours of February, 2001. At the time of the crash, it was dark (street not lighted) with no adverse conditions as the roads were dry. The crash occurred in the westbound lane of a (level) two lane east/west rural roadway which curved left for westbound traffic (see **Figure 11 - page 8**). The asphalt surfaced roadway was bordered to the north by narrow paved shoulders, large rocks, and a cluster of concrete posts spaced 1.3 meters (4.3 feet) apart. No traffic control was present at the scene which had a posted speed limit of 72 km/h (45 mph).
