**ON-SITE SIDE IMPACT OCCUPANT PROTECTION SYSTEM CRASH
INVESTIGATION
SCI TECHNICAL SUMMARY REPORT**

VERIDIAN CASE NO. CA01-048

VEHICLE - 1999 BMW 328i

CRASH DATE - OCTOBER 2001

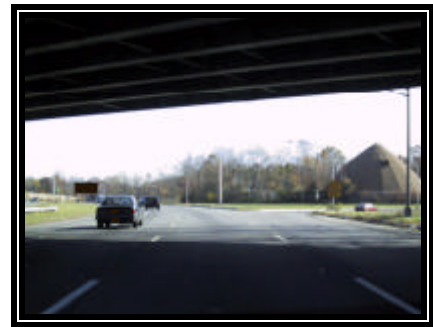
Figure 2. Eastbound approach for the BMW

The 22-year-old driver of the BMW 328i was operating the vehicle on the outboard lane of a six-lane divided highway (**Figure 2**) and a driver-estimated speed of 89 km/h (55 mph). The driver stated that due to wet road conditions, the rear aspect of the vehicle began to rotate. Although the BMW was equipped with All Season Traction control, the BMW initiated a counterclockwise (CCW) yaw. The driver attempted to regain control of the vehicle through right steer inputs and by applying the brakes, but was unsuccessful. The BMW departed the right roadside in a CCW yaw.
