**VERIDIAN ON-SITE REAR SEAT ADULT PASSENGER
SEAT BELT FATALITY INVESTIGATION**

VERIDIAN CASE NO. CA01-055

VEHICLE - 2000 CHRYSLER CONCORDE LXI

CRASH DATE - DECEMBER, 2001

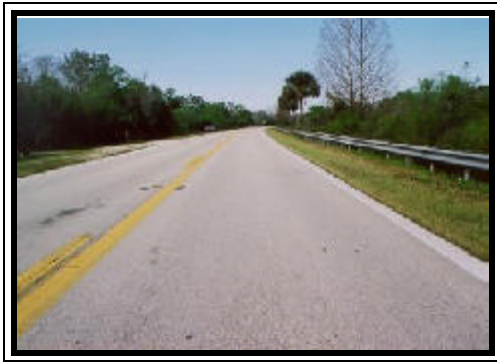
The 42 year old male driver of the 2000 Toyota Tundra SR5 pickup truck was operating the vehicle westbound (**Figure 1**) at a (driver reported) speed of 89 km/h (55 mph), and negotiating a right curve on wet pavement. As the Toyota reached the apex of the curve, the driver reportedly observed a westbound (non-contact) vehicle ahead begin to slow in the roadway. The Toyota driver “tapped” his brakes in response and allowed the vehicle to cross the centerline into the path of the eastbound Chrysler. The driver stated during the SCI interview that he felt the truck just “lift up” and begin to hydroplane into the opposing travel lane. Upon recognition of the impending harmful event, the Toyota driver steered left in avoidance (increased braking unknown). The front right passenger position of the Toyota was occupied by a restrained 7 year old male child. The rear right position was occupied by a 3 year old male child who was restrained within a forward facing child safety seat.

Figure 1. Westbound approach for the 2000 Toyota Tundra pickup truck.

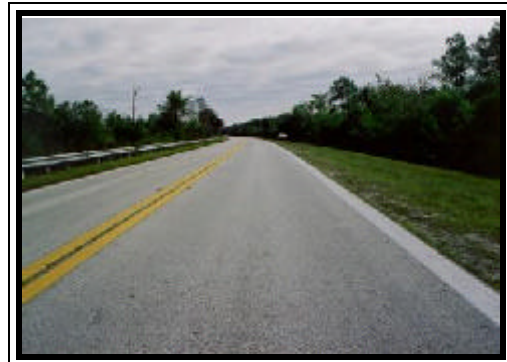
The 75 year old male driver of the 2000 Chrysler Concorde Lxi was operating the vehicle eastbound (**Figure 2**) at a (driver reported) speed of 72 km/h (45 mph) when he observed the Toyota Tundra encroach into his lane of travel. Upon recognition of the impending harmful event, the Chrysler driver steered left and braked in avoidance, partially entering the westbound lane prior to the collision. This pre-impact trajectory was evidenced by the physical evidence documented at the crash site during the SCI inspection.

Figure 2. Eastbound approach for the 2000 Chrysler Concorde Lxi.

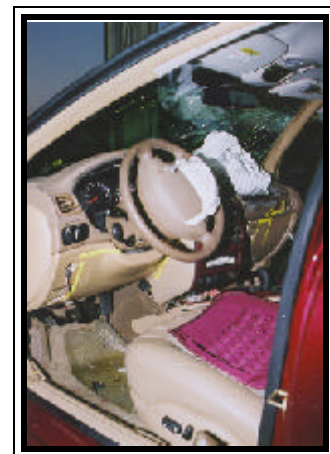
At impact, the driver initiated a forward and slightly lateral trajectory in response to the 11 o'clock impact force and loaded the manual restraint, knee bolster, and deployed redesigned driver air bag. Loading of the knee bolster resulted in a comminuted and displaced fracture of the right femur as evidenced by the scuff marks and indentations documented on this component (**Figure 14**). Contact to the deployed driver air bag was confirmed by the abrasion pattern identified across the face of the air bag. His (posterior) left hand struck the vent louvers which resulted in a small contusion, evidenced by the scuff marks identified to the mid-instrument panel area. He also sustained a contusion to the (inside) ankle,

Figure 14. Interior view of the driver space.

and fracture of the right heel from brake pedal loading, as evidenced by the location of the injury relative to the driver's stated placement of the right foot on the brake pedal during pre-crash avoidance maneuvers. The driver rebounded into the front left seat back, confirmed by the deformation documented to this component and pre-crash placement of the (lodged) ice cooler. The driver reported no resulting injury. Following the crash, the driver was removed from the vehicle by rescue personnel due to perceived serious injury, and transported by ambulance to a nearby hospital and admitted for three days. Treatment included placement of an intra medullary rod to repair the right femur. The redesigned driver air bag provided additional protection against further contact to the steering wheel hub/rim, and potential serious injury.
